ON-SITE SIDE IMPACT INFLATABLE OCCUPANT PROTECTION INVESTIGATION

CASE NUMBER - IN08024

LOCATION - TEXAS

VEHICLE - 2008 FORD FOCUS SE

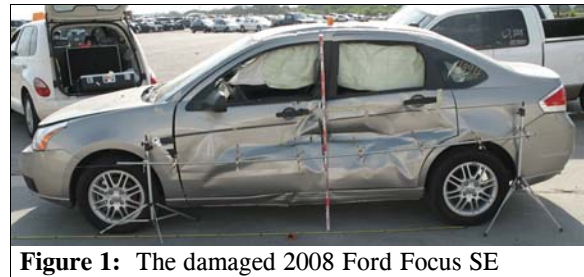
Figure 1: The damaged 2008 Ford Focus SE

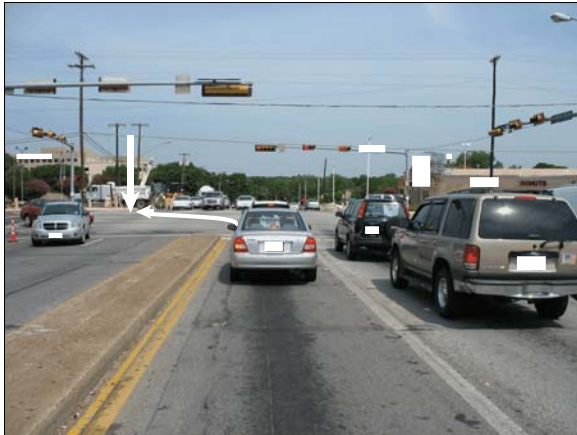
Pre-Crash: The Ford was occupied by a restrained 36-year-old female driver. She was traveling northwest in the left turn approaching the intersection on a green light (**Figure 2**) and intended to turn left. The Toyota was occupied by a restrained 61-year-old female driver. She was traveling southeast in the outside through lane (**Figure 3**) and intended to continue straight through the intersection. The Chevrolet was stopped at the mouth of the intersection (**Figure 4**) heading

northeast waiting for the traffic signal to change. The initial impact occurred within the intersection as the Ford was turning left (**Figure 2**).

Figure 2: Approach of the Ford in the left turn lane; arrow on left shows area of initial impact; arrow on right shows approach of Ford turning left

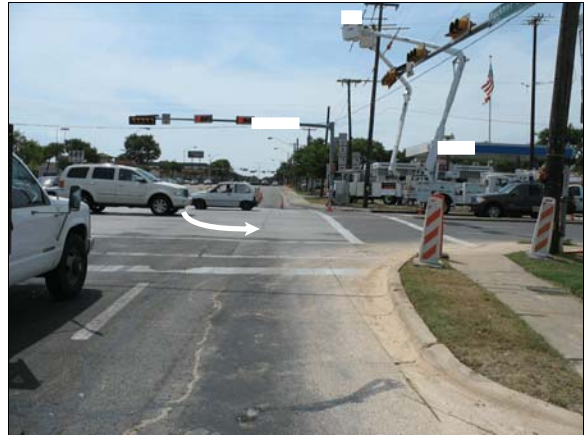
Figure 3: Approach of Toyota traveling southeast in outside through lane; arrow shows approach of Ford as it turned left

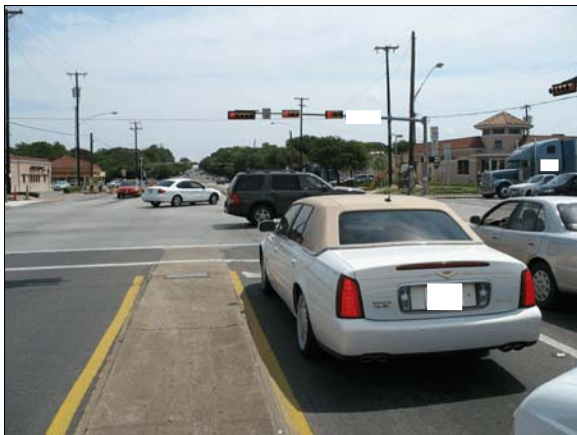
Figure 4: Location of Chevrolet stopped heading northeast in the left turn lane

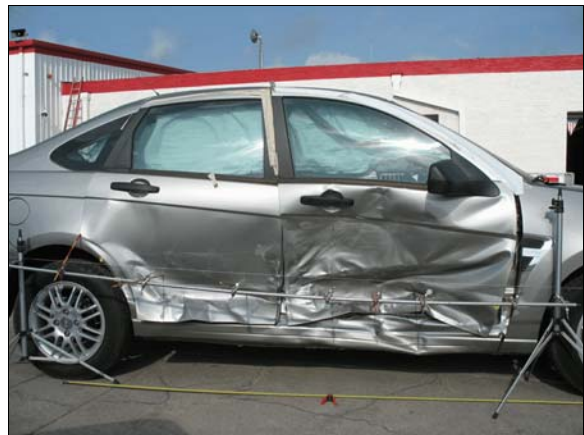
Figure 5: Damage to Ford's right side from impact with the Toyota

Crash: As the Ford's driver was turning left, the front of the Toyota impacted its right side plane (**Figure 5**, event 1). The Ford's direction of principal force was within the 1 o'clock sector and the impact force was sufficient to trigger a deployment of the vehicle's right side impact curtain air bag. The deployment of the Ford's front right seat back-mounted side impact air bag was suppressed because there was no passenger on the seat. The impact caused the Ford to rotate clockwise and redirected it south toward the Chevrolet. The left side plane of the Ford (**Figure 6**) impacted the front of the Chevrolet (event 2). The Ford's direction of principal force was within the 9 o'clock sector and the impact force was

Exterior Damage: The Ford’s impact with the Toyota involved the right side plane. Both of the right side doors, sill, and the lower B-pillar sustained direct damage. The direct damage began 56 cm (22.1 in) rear of the right front axle and extended 185 cm (72.3 in) rearward along the right side. The residual maximum crush was 24 cm (9.4 in) occurring 19 cm (7.5 cm) rear of C₅ (**Figure 7**), and the height of the maximum crush was 53 cm (20.9 in). The sill height was 36 cm (14.2 in) and the Door Sill Differential (DSD) was 18 cm (7.1 in). The table below shows the vehicle’s right side crush profile.

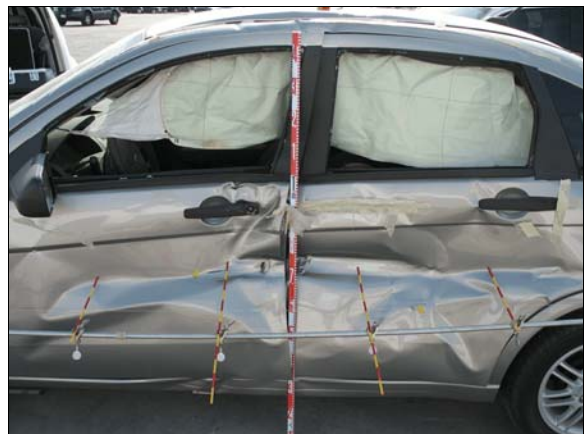
Figure 6: Damage to the Ford's left side from impact with the Chevrolet

sufficient to trigger a deployment of the Ford’s left side impact curtain air bag and the driver’s seat back-mounted side impact air bag. The Ford came to final rest against the front of the Chevrolet heading northwest. The Toyota rotated clockwise and came to final rest within the intersection heading south.

The Ford’s impact with the Chevrolet involved the left side plane. Both of the left side doors and the B-pillar sustained direct damage, which began 125 cm (49.2 in) rear of the left front axle and extended 70 cm (27.6 in) rearward along the left side. The residual maximum crush was 19 cm (7.4 in) occurring at both C₃ and C₄ (**Figure 8**), and the height of the maximum crush was 68 cm (26.8 in). The sill height was 36 cm (14.2 in) and the DSD was 10 cm (7.1 in). The table below shows the vehicle’s left side crush profile.

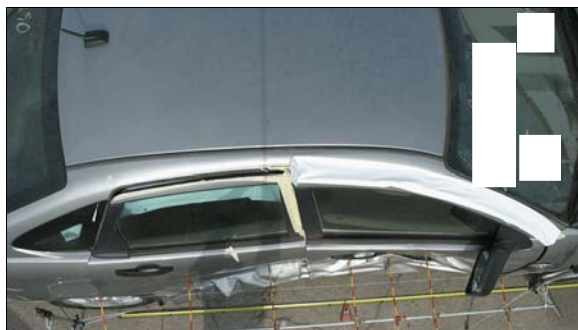
Figure 7: Top view of Ford’s right side crush from impact with the Toyota; each increment on rods is 5 cm (2in)

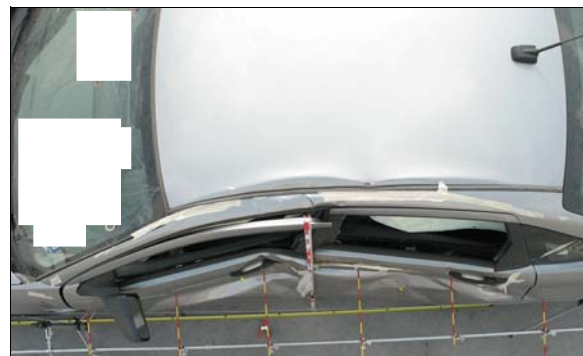
Figure 8: Top view of Ford’s left side crush from impact with the Chevrolet

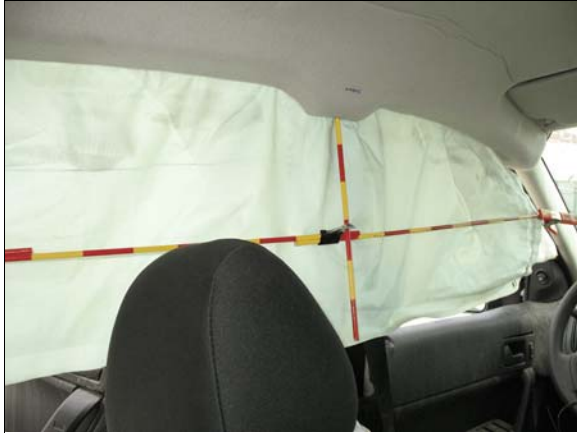
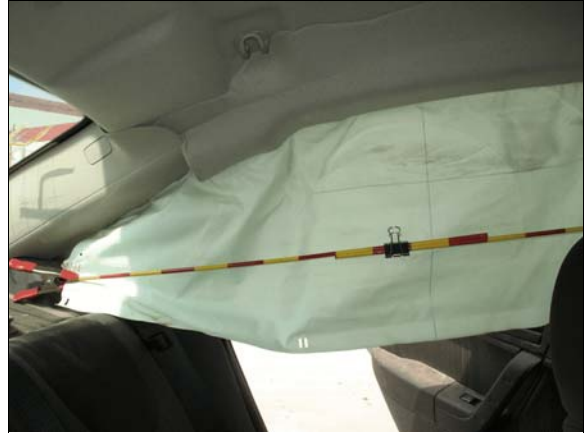
The left side curtain air bag was located along the left roof side rail (**Figures 9 and Figure 10**), within the head liner and extended from the A-pillar to the C-pillar. The air bag was 150 cm (59.1 in) in width and 36 cm (14.2 in) in height and was anchored to the A-pillar by a nylon rope tether and a triangular section of fabric. The nylon rope was 12 cm (4.7 in) in length and the

fabric was 28 cm (11.0 in) in length. The distance between the air bag and the A-pillar was 40 cm (15.7 in) at the bottom of the tether. The air bag was anchored to the C-pillar by a nylon rope tether 5 cm (2 in) in length and was designed without any external vent ports. Inspection of the air bag revealed no evidence of occupant contact and there was no damage to the air bag.

Figure 9: Front portion of Ford's left side impact curtain air bag

Figure 10: Back portion of Ford's left side impact curtain air bag

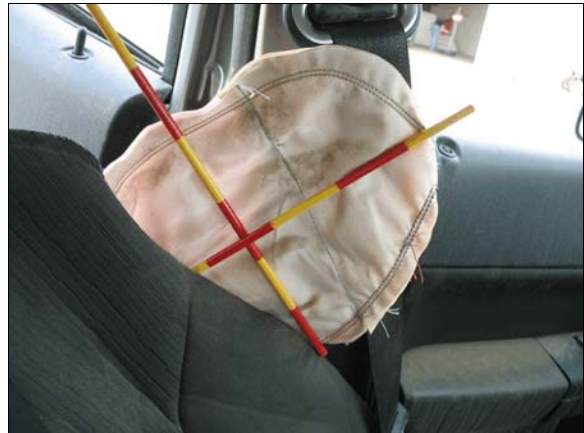
The driver's seat back-mounted side impact air bag was located within the left side of the driver's seat back and deployed through a tear seam. The deployed air bag (**Figure 11**) was oval and measured 25 cm (9.8 in) in width and 19 cm (7.5 in) in height. It was designed without tethers or vent ports. Inspection of the air bag revealed no evidence of occupant contact and there was no damage to the air bag.

Figure 11: Driver's seat back-mounted side impact air bag

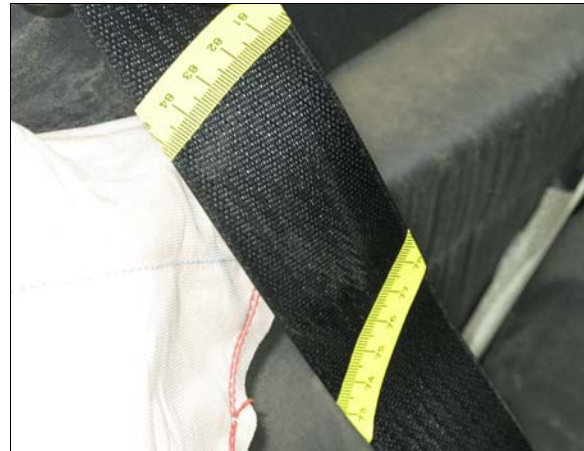
The inspection of the driver's seat belt assembly revealed friction marks on the webbing (**Figure 12**) and the buckle-mounted pretensioner had actuated (**Figures 13**). The actuation of the pretensioner reduced the length of the buckle stalk by 6 cm (2.4 in). The evidence indicated that the driver was restrained in this crash.

Figure 12: Abrasions on driver's seat belt

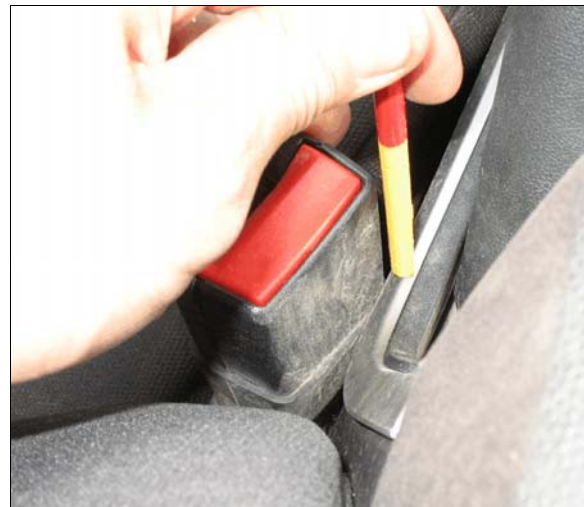
Figure 13: Driver's buckle-mounted pretensioner actuated
