## ON-SITE CHILD SAFETY SEAT INVESTIGATION

CASE NUMBER - IN08026

VEHICLE - 2000 CHRYSLER CONCORDE LX

CRASH DATE - May 2008

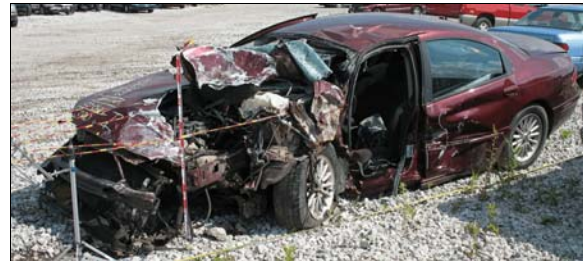
**Figure 1:** The damaged 2000 Chrysler Concorde LX

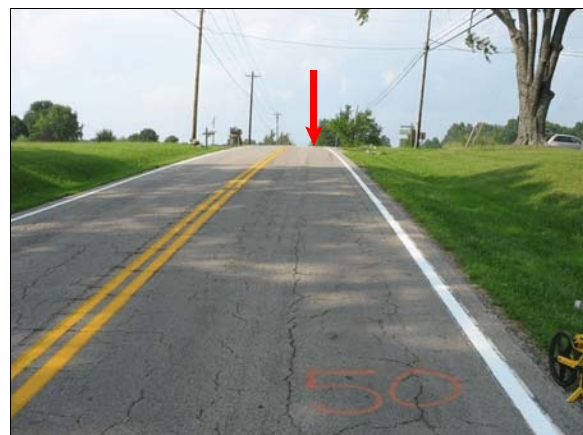
**Figure 2:** Approach of Chrysler northbound to impact (arrow); number on pavement shows meters to impact

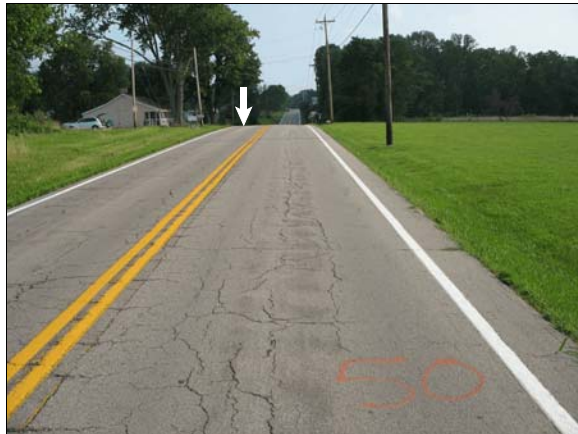
**Figure 3:** Approach of the Ford southbound; arrow shows area of impact

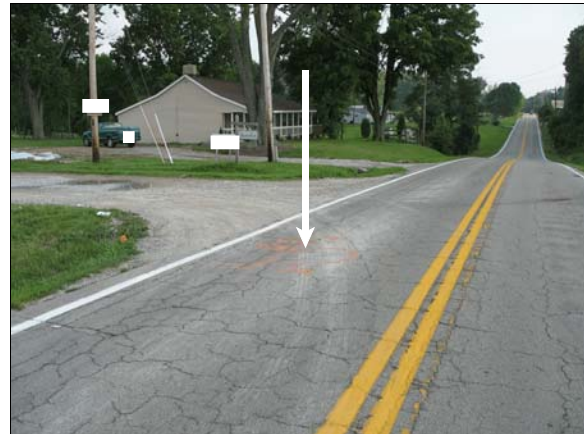
**Figure 4:** Arrow shows impact gouges in northbound lane

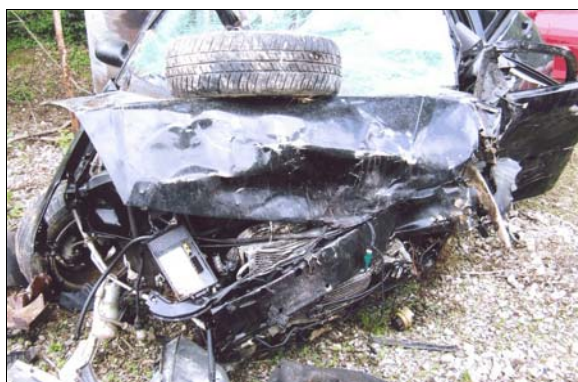
**Crash:** The front of the Ford (**Figure 5**) impacted the front of the Chrysler (event 1, **Figure 6**) in a front left offset configuration on each vehicle. The Chrysler’s direction of force was within the 12 clock sector and the impact force was sufficient to trigger a deployment of the vehicle’s driver and front right passenger frontal air bags. The Ford’s driver’s frontal air bag also deployed. The Chrysler traveled 7.4 m (24.3 ft) and rotated 115 degrees to its final rest position heading southwest on the east side of the roadway (**Figure 7**). Following the impact with the Chrysler, the Ford rotated counterclockwise, departed the west side of the roadway, and the front plane impacted a mailbox and two newspaper boxes (events 2,3, and 4). The Ford entered a ditch and rolled over, left side leading, two quarter turns (event 5) and the right quarter panel impacted a second mailbox (event 6) during the rollover. The Ford came to final rest on its top heading northwest (**Figure 7**). The Ford traversed a distance of 18.3 m (60 ft) and rotated 215 degrees counterclockwise from the point of impact to its final rest position.

**Figure 5:** Police photograph showing damage to the front of the Ford from impact with the Chrysler

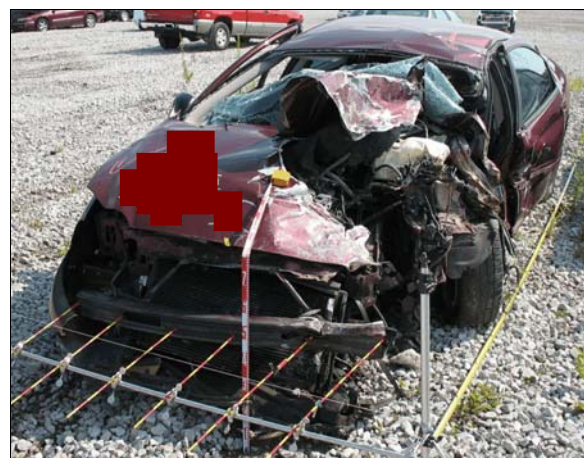
**Figure 6:** Damage to front and left side of the Chrysler from the impact with the ford; a second set of crush measurements was also taken above the bumper level

**Exterior Damage:** The Chrysler’s impact with the Ford involved the front plane (**Figure 6**). The direct damage also extended onto the Chrysler’s left side doors due to the post impact rotation of the Ford. The direct damage to the Chrysler’s front plane involved the bumper, left headlamp/turn signal assembly, hood, and the left fender. The direct damage began at the front left bumper corner and extended 71 cm (28 in) along the front bumper. The bumper bar extended only slightly beyond the unibody frame rails, and the engagement at the front left corner missed the frame rail and involved the left fender, hood and left front wheel, which were significantly crushed rearward. As a result, it was necessary to take one set of crush measurements on the bumper bar and a second set at the upper radiator support level. The maximum residual crush at the bumper level was 59 cm (23.2 in) occurring at C<sub>1</sub>. The maximum residual crush at the upper radiator support level was 106 cm (41.7 in) and also occurred at C<sub>1</sub>. The two sets of crush measurements were averaged according to the vehicle measurement techniques protocol, and the table below shows the crush profile.

The left side wheelbase was reduced 55 cm (21.7 inches) while the right side wheelbase was extended 8 cm (3.1 in). Induced damage involved the hood, roof, left rear door, left quarter panel, right fender, and right front door.

**Damage Classification:** The Chrysler's Collision Deformation Classification was **12-FYEW-5 (350 degrees)**. The Missing Vehicle algorithm of the WinSMASH program calculated the Chrysler's total Delta V as 37 km/h (23 mph). The longitudinal and lateral velocity changes were -36 km/h (-22 mph) and 6 km/h (4 mph), respectively. The results were based only on the Chrysler's crush profile and should be considered as a borderline reconstruction of the Chrysler's Delta V.

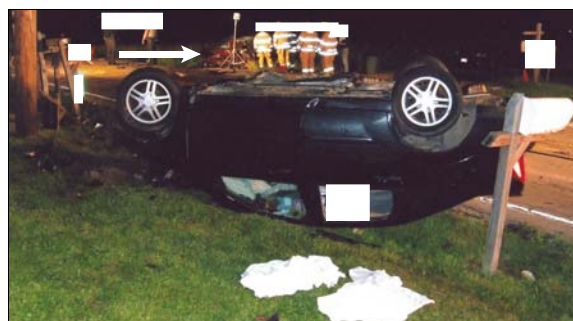
**Figure 7:** Police on-scene photograph showing the final rest position of the Ford; arrow shows final rest position of the Chrysler

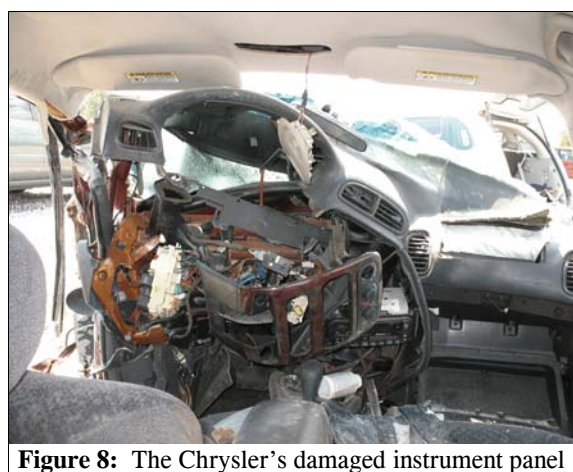
**Vehicle Interior:** The Chrysler's instrument panel was extensively deformed and broken (**Figure 8**) as a result of the crash. The right half of the steering wheel was deformed and it had been cut out of the vehicle. The left lower instrument panel was deformed on the left side of the steering column as a result of loading by the driver's left knee. While the driver's right knee also probably loaded the left lower instrument panel, it was not possible to determine the extent of contact due to the damage to the instrument panel. Both the driver and front right passenger seat backs were nearly fully reclined, which was probably related to the extrication of the driver and front right passenger.

**Figure 8:** The Chrysler's damaged instrument panel

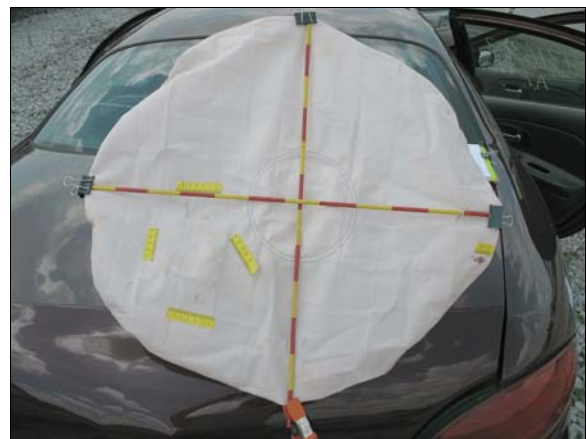
The driver's frontal air bag module cover was a two-flap configuration constructed of pliable vinyl. The cover flaps separated at the designated tear seams during the deployment. The top cover flap was 18 cm (7.1 in) in length and 9 cm (3.5 in) in height. The bottom cover flap was 13 cm (5.1 in) in length and 5 cm (2.0 in) in height. There was no evidence of damage to the cover flaps. The deployed driver's air bag (**Figure 9**) was round with a diameter of 62 cm (24.4 in). There was no evidence of damage to the air bag. Body fluid transfers were present on the air bag's lower left quadrant. The center of the transfers was located 17 cm (6.7 in) to the left and 8 cm (3.1 in) below the center of the air bag. A blood transfer was also present on the right lower quadrant located 27 cm (10.6 in) to the right and 7 cm (2.8 in) below the center of the air bag.

**Figure 9:** The driver's deployed air bag; yellow tape shows body fluid deposit on left

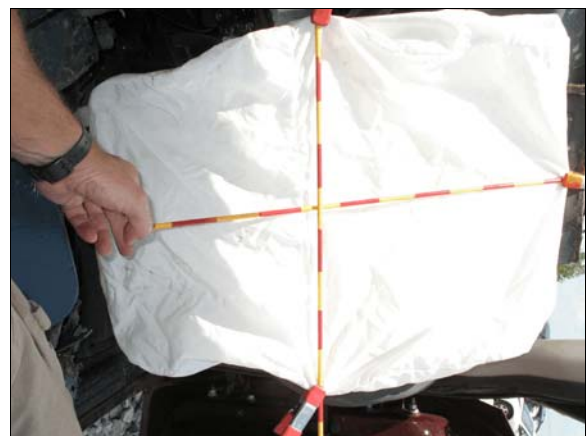
**Figure 10:** The front right passenger's deployed air bag

height. The cover flap separated at the designated tear seams during the deployment and there was no evidence of damage. The deployed front right passenger air bag was rectangular (**Figure 10**) and was 65 cm (25.6 in) in width and 46 cm (18.1 in) in height. There was no discernable evidence of occupant contact on the air bag and the air bag was not damaged. Isolated grease smears unrelated to the deployment were present on the air bag fabric.

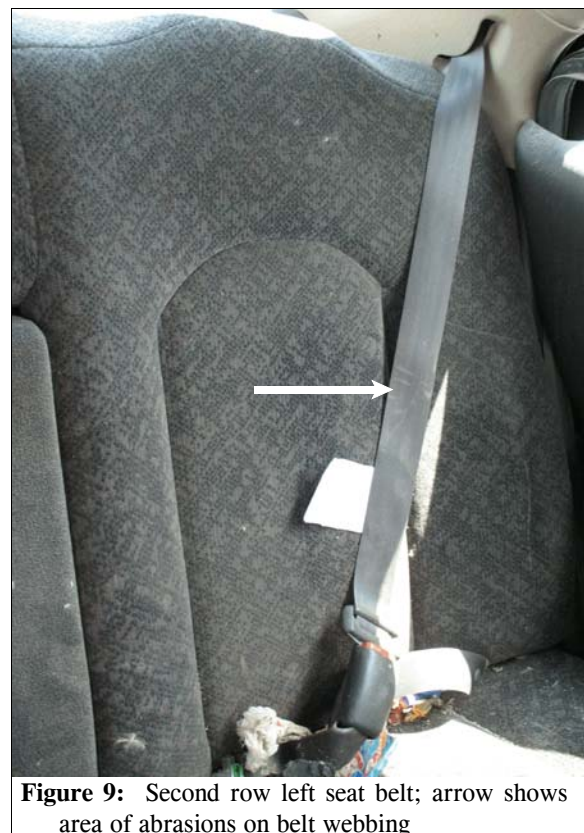
The inspection of the second row left seat belt assembly revealed extensive historical usage scratches on the latch plate. The belt webbing had a slight stretched appearance and abrasions were present on the belt webbing 46 cm (18.1 in) above the stop button (**Figure 9**). The evidence indicated that the second row left passenger was restrained in the CSS by the lap-and-shoulder belt.

**Figure 9:** Second row left seat belt; arrow shows area of abrasions on belt webbing

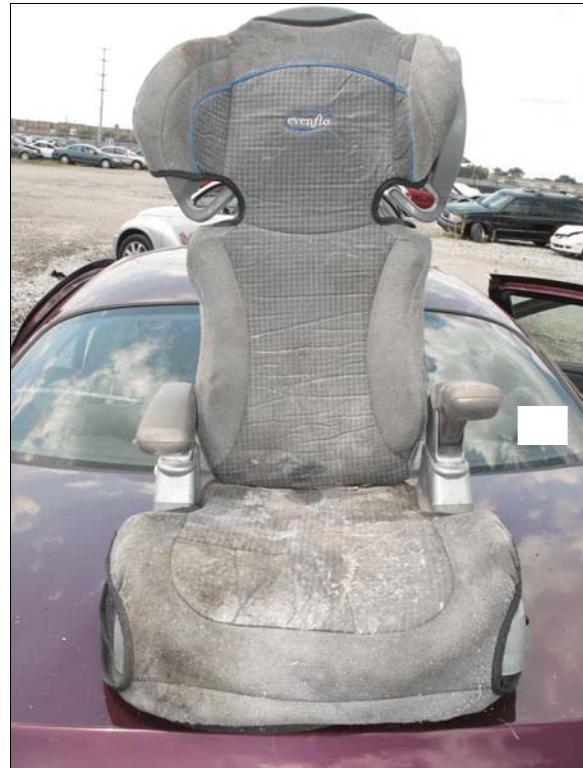
Inspection of the CSS revealed only a black scuff on the right side of the cushion. No other damage or evidence of loading was observed. The CSS was found in the second row left seating position along with numerous components that had been jammed into the second row seat post-

Figure 10: The Evenflo High Back Booster CSS

crash. It is probable that this was the source of the scuff. The second row left shoulder belt was also found routed through the CSS's left shoulder belt guide at that time.

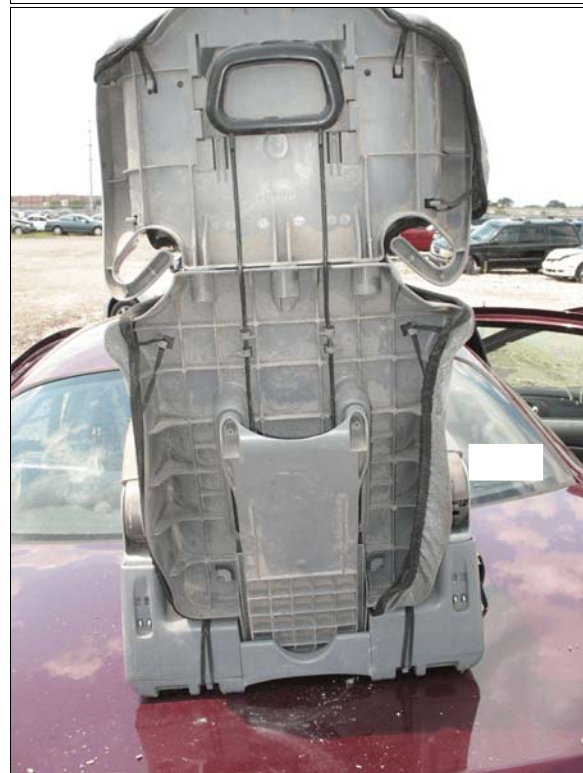
Figure 11: Back of the CSS
