ON-SITE NOT IN TRAFFIC SURVEILLANCE BACK OVER INVESTIGATION

CASE NUMBER - IN08027
LOCATION - INDIANA
VEHICLE - 2004 NISSAN TITAN 4x4 CREW CAB
CRASH DATE - June 2008

1. <i>Report No.</i> IN08027		2. <i>Government Accession No.</i>		3. <i>Recipient's Catalog No.</i>	
4. <i>Title and Subtitle</i> On-Site Not In Traffic Surveillance Back Over Investigation Vehicle - 2004 Nissan Titan 4x4 Crew Cab Location - Indiana			5. <i>Report Date:</i> August 19, 2008

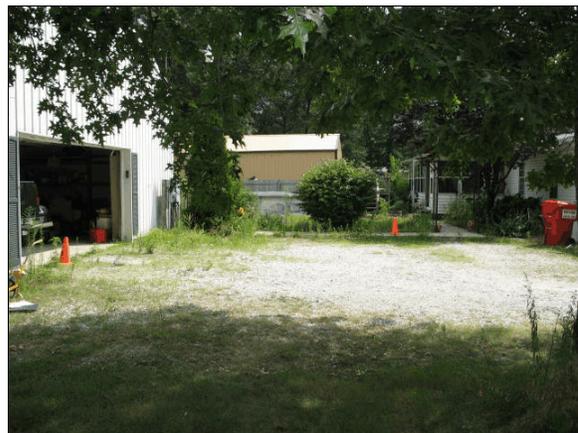
Crash Environment: The Nissan was parked within the driver's detached garage, which was located 12.2 meters (40 feet) east of his residence (**Figure 2**). A gravel driveway was located on the north side of the residence and connected to the garage. A gravel parking area was located between the residence and the garage, and a concrete sidewalk connected the residence to the parking area and the garage. The concrete garage floor was level and the driveway had a negative 2% grade in the direction the vehicle was backing.

Figure 2: Overview of incident scene from north side of driveway; orange cone on left is driver reported final rest position of nonmotorist; orange cone on right is location of bag of clothes; driver was intending to back up to the bag of clothes when the incident occurred.

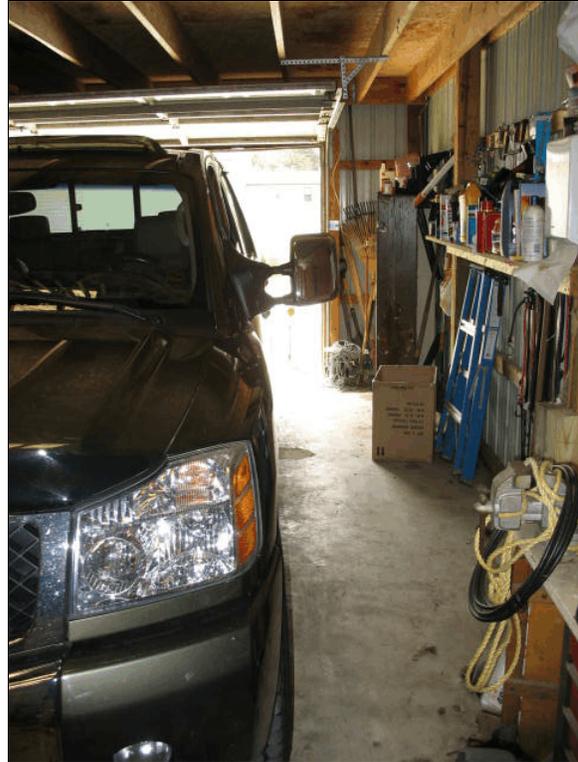
Figure 3: View down left side of the Nissan to the garage door

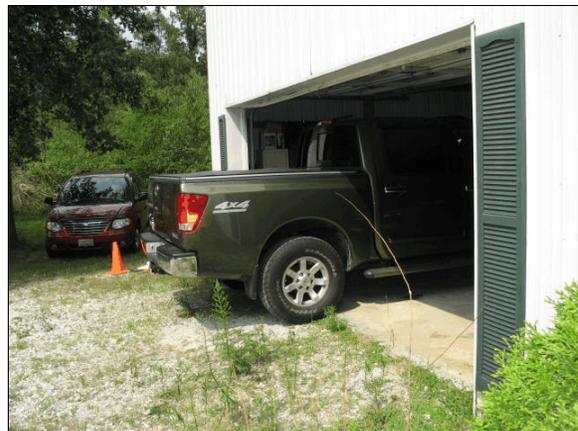
Figure 4: Driver placed vehicle in position where he stopped after feeling a bump

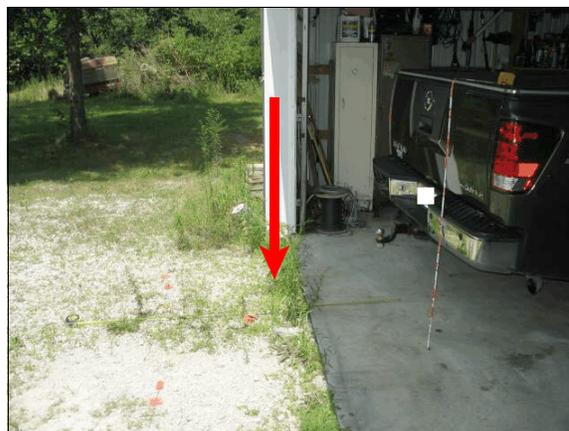
exited the vehicle and found the nonmotorist laying on the ground (**Figure 5**). She was located 0.5 meter (1.6 feet) behind and near the center of the vehicle with her head toward the vehicle's right side. She told the driver she had fallen down and the vehicle ran over her. She also complained of extreme pain to her abdomen. Based on the information obtained from the driver and the on-site investigation, the vehicle traveled backward 1.7 meters (5.6 feet) where the right rear tire rolled onto the nonmotorist's torso. It did not pass completely over the nonmotorist. The driver stopped the vehicle and drove forward 1.7 meters to the final rest position. The driver estimated that his speed while backing was 2 km/h (1 mph).

Figure 5: Arrow shows driver reported final rest position of nonmotorist after he pulled vehicle forward

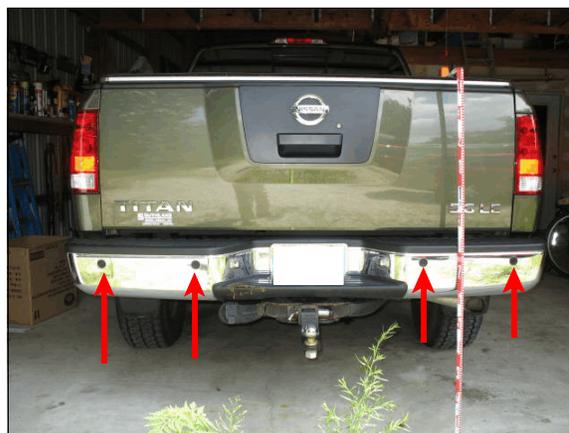
The RSS was designed with four sensors, each located on the back bumper (**Figure 6**). The distance from the ground to each of the four RSS sensors was 71 centimeters (27.9 inches). The sensors were located 43 centimeters (16.9 inches) and 79 centimeters (31.1 inches) from each side of the vehicle's centerline. When the sensors detect a large stationary object within 1.8 meters (6 feet) of the back bumper, a beeping tone alerts the driver. The RSS may not detect objects close to the bumper or on the ground. The pages from a 2004 Nissan Titan owner's manual, which

Figure 6: Arrows show each of the four RSS sensors

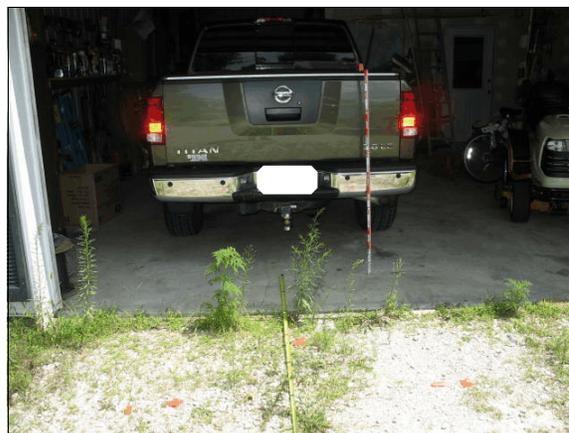
Figure 7: The orange squares on the ground show the locations where the RSS detected the approach of the SCI investigator; also see Figure 5

The SCI investigator conducted tests to determine the size of the RSS detection zone for an adult of the investigator's height and weight [185 centimeters (73 inches) and 84 kilograms (185 pounds)]. The investigator slowly approached the back of the vehicle from each corner as well as along the vehicle's centerline while the driver sat in the driver's seat with his foot on the brake and the transmission in reverse. The driver honked the horn when the RSS warning sounded and the investigator marked and measured each location (**Figure 7**). The investigator also approached each back corner from the side until the warning sounded and noted those positions as well. When approaching each corner from the back, the warning sounded when the investigator was 155 centimeters (61 inches) from the bumper. When the vehicle was approached along the centerline, the warning sounded when the investigator was 99 centimeters (39 inches) from the bumper. When approached from the side at the corner detection points, the warning sounded when the investigator was 12 centimeters (4.7 inches) inboard of the right corner and 14 centimeters (5.5 inches) inboard of the left corner. The warning on page 5-31 of the owner's manual indicated that the RSS may not detect objects close to the bumper or on the ground. Since the nonmotorist was on the ground directly behind the vehicle when the driver began to back up, it is likely that the warning did not sound as reported by the driver.

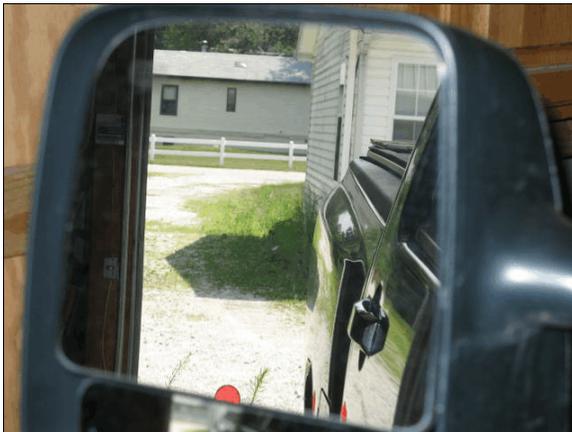
The assessments for each side view mirror were made by moving the target along the side of the vehicle until the driver could see it (**Figures 8 and 9**). The driver honked the horn when the target first came into view and the location was marked. The target was then moved laterally away from the side of the vehicle until it went out of the mirror's field of view (**Figure 10**) and this location was marked. The same procedure was used to assess the rectangular convex side view mirrors. The rearview mirror blind zone and the blind zone behind the vehicle were assessed as the driver looked through the rearview mirror (**Figures 11 and 12**) and over his right shoulder out of the backlight (**Figures 13 and 14**). The target was moved rearward along the vehicle's centerline until the driver could see it. The target was then moved to the left and right until it went out of the driver's view. Each position was located relative to the vehicle and the measurements, blind zone behind the vehicle, and the field of view of all the mirrors are depicted on the Nominal Visibility Diagram at the end of this report. The visibility study showed that the driver could not have seen the nonmotorist on the ground directly behind the vehicle because the depth of the blind zone was 16 meters (52.5 feet) and no mirror's field of view covered the area behind the vehicle where the nonmotorist had fallen.

Figure 8: Close view through left side view mirror from driver's seat; target where driver could first see it as moved rearward along left side of vehicle

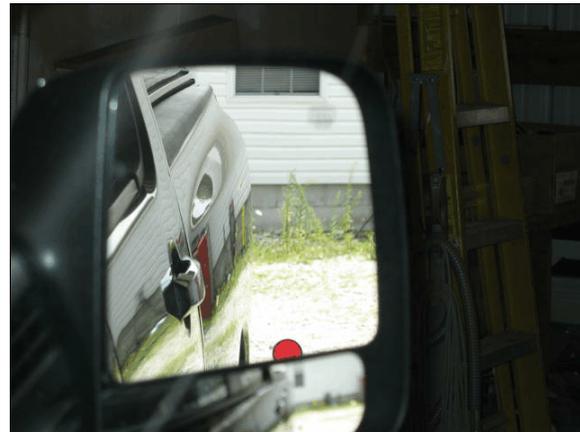
Figure 9: Close view through right side view mirror from driver's seat; target in location where driver could first see it as it was moved rearward along right side of vehicle

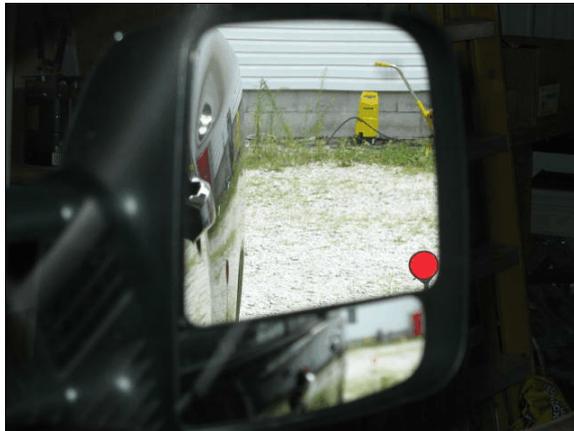
Figure 10: Close view through right side view mirror from driver's seat; target in location where it began to go out of mirror's lateral field of view

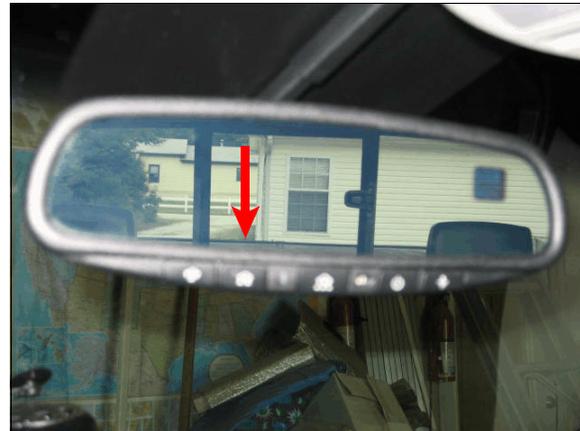
Figure 11: Close view through rearview mirror from driver's seat; arrow shows target

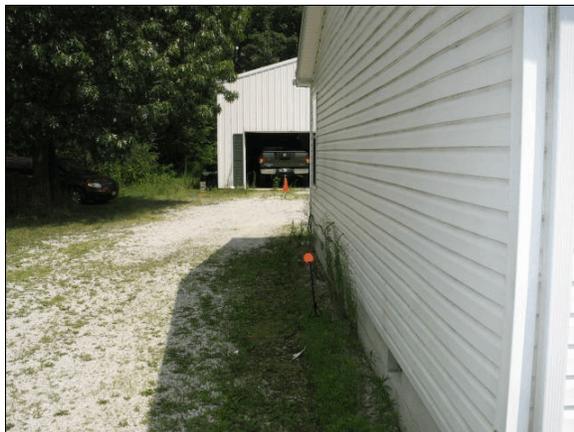
Figure 12: Location of target where driver could first see it while looking through rearview mirror; distance from back bumper to target was 17.6 meters (57.7 feet)

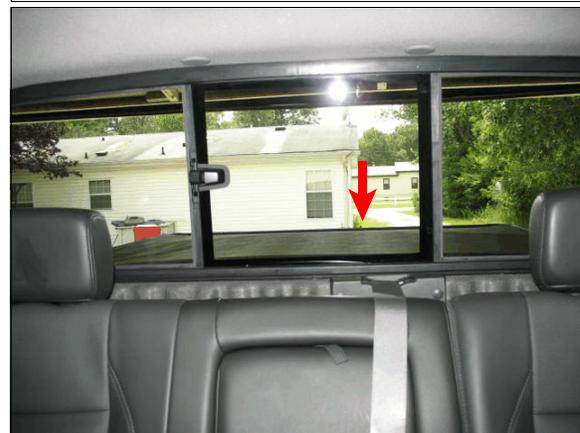
Figure 13: View through backlight from driver's seat; arrow shows target

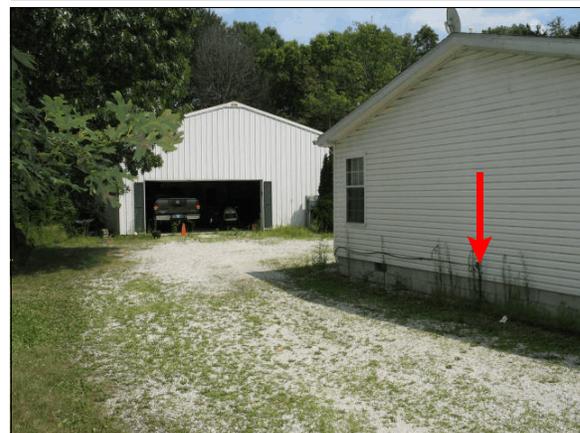
Figure 14: Arrow shows target in location where driver could first see it while looking over right shoulder out of backlight; distance from back bumper to target was 16 meters (52.5 feet)
