ON-SITE NOT IN TRAFFIC SURVEILLANCE BACK OVER INVESTIGATION

CASE NUMBER - IN08028

VEHICLE - 2000 CHRYSLER CIRRUS LX

CRASH DATE - July 2008

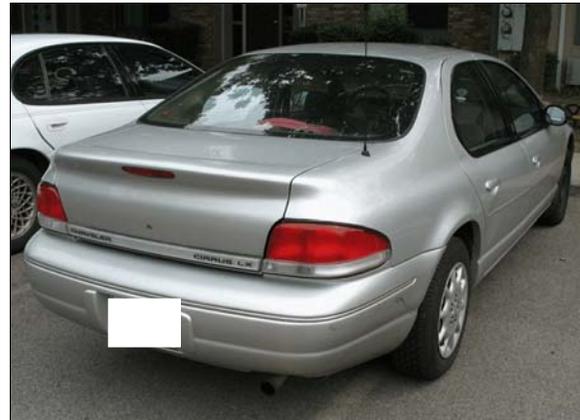
Figure 1: Back right view of Chrysler Cirrus

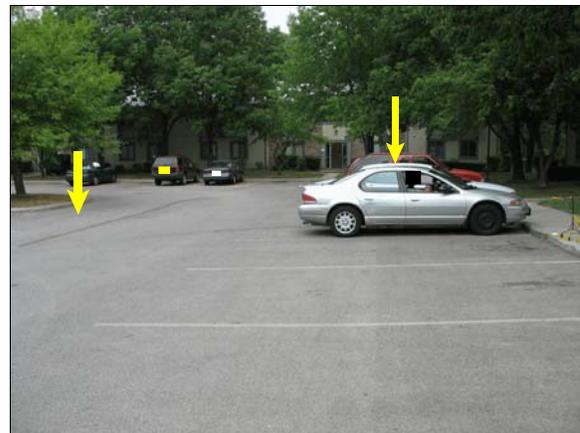
Crash Environment: The Chrysler was parked in the parking lot of an apartment complex (**Figure 2**). The grade within the parking stall was negative 7.5% in the direction of backing and became level on the parking lot roadway. A passenger car was parked on the left side of the Chrysler and no vehicle was parked on its right side. The parking lot was connected to the driver's apartment building by a concrete sidewalk and was located 6.3 meters (20.6 feet) from the front door of the building. The struck nonmotorist was located near or within a raised grassy island that was located 8.8 meters (28.9 feet) behind and 2.8 meters (9.1 feet) to the left of the Chrysler. There were also several other children playing and riding bicycles as well as a few adults in and around the parking lot. At the time of the incident, the light condition was daylight, the atmospheric condition was clear, and the parking lot was dry bituminous.

Figure 2: Right arrow shows pre-incident position of Chrysler; left arrow shows area of impact

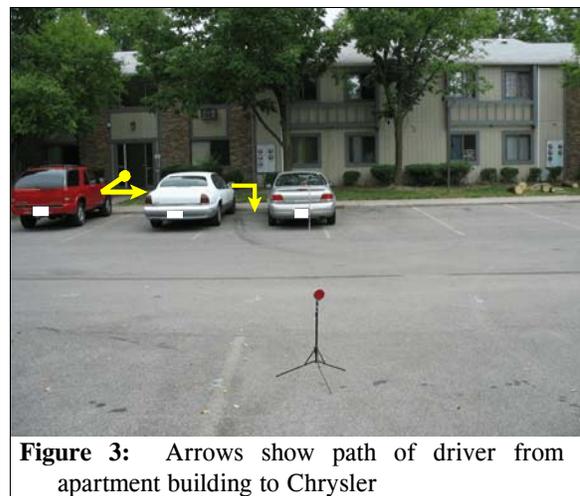
Figure 3: Arrows show path of driver from apartment building to Chrysler

11 meters (36.1 feet) on the sidewalk to the Chrysler (**Figure 3**). She approached the Chrysler from the front left and her entry was not interrupted. She entered the vehicle, put on her safety belt and looked at her right and left side view mirrors as well as her rearview mirror, but she did not remember looking over her right or left shoulder. She saw no one behind the vehicle at this time. After checking the mirrors, she started the vehicle. Meanwhile, the nonmotorist was about to start running east toward the apartment building from the raised island (**Figure 4**). The path of the nonmotorist was 8.8 meters (28.9 feet) behind and 6.4 meters (21 feet) to the left of the vehicle's centerline. The nonmotorist's mother was awaiting him by the same doorway that the driver had just exited. The doorway was located directly east from the parking lot, the raised island, and the nonmotorist.

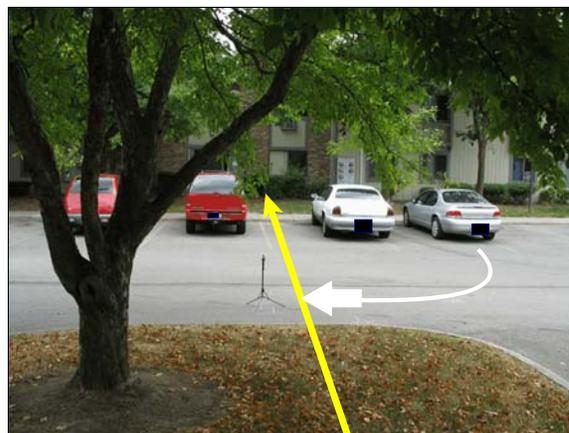
Crash: After the driver shifted into reverse, she backed clockwise out of the parking space, moving her foot on and off the brake, never pressing the accelerator. As she backed, she was looking at the right side view mirror but did not see the nonmotorist running toward the apartment building. It is possible that as the driver backed up and the vehicle's and nonmotorist's trajectories converged, the nonmotorist was continually moving away from the right side view mirror's visibility zone. The driver estimated that she had backed up 2-5 seconds when she heard other adults in the area yelling for her to stop, and she immediately stopped the vehicle. She exited and walked to the rear of the vehicle where the nonmotorist was lying just behind the right rear bumper corner (**Figure 5**). The right portion of the back bumper had struck the nonmotorist and knocked him down, but the driver did not feel the impact. At final rest, he was lying on his right side with his head toward the right side of the vehicle. Based on the information obtained from the driver and the on-site investigation, the vehicle traveled backward 11 meters (36.1 feet) to the point of impact and an additional 0.6 meters (2 feet) to the point of final rest. The impact speed was estimated at 3 km/h (2 mph.).

Figure 4: Path of nonmotorist (shown by left arrow) and Chrysler (right arrow); tripod stand shows area of impact

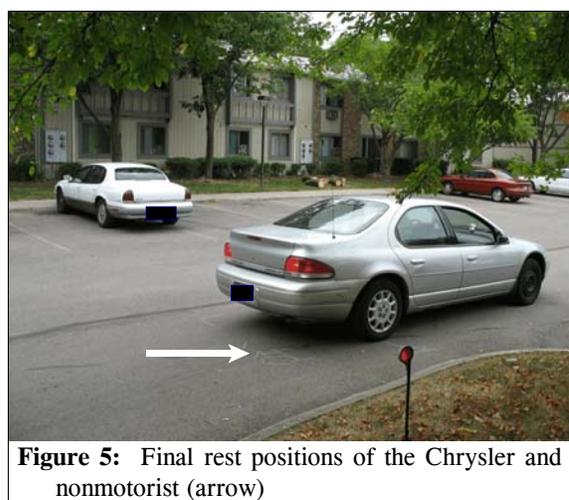
Figure 5: Final rest positions of the Chrysler and nonmotorist (arrow)

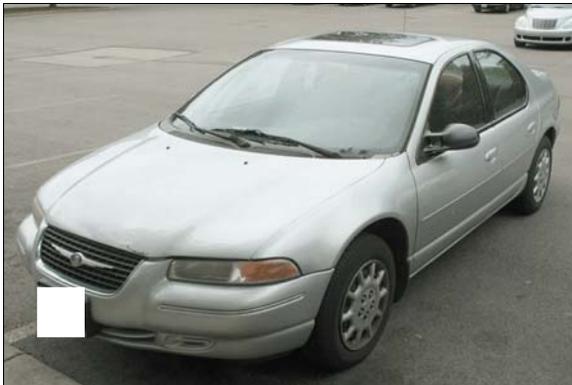
The 2000 Chrysler Cirrus LX (**Figure 6**) was a front wheel drive, 4-door, sedan (VIN: 1C3EJ46X0YN-----) equipped with a 2.4L, 4-cylinder engine and automatic transmission. All side windows and the backlight were equipped with AS-2 non-tinted glazing. At the time of the incident the left front window was partially open and the other side windows were closed. The manufacturer’s recommended tire size was P195/70R14 and the vehicle was equipped with P195/65R15 size tires. The vehicle’s specified wheelbase was 274 centimeters (108 inches), the specified rear overhang was 105 centimeters (41.3 inches), and the specified overall length was 475 centimeters (187 inches). The distance from the ground to the bottom of the back bumper (**Figure 7**) was 29 centimeters (11.4 inches) and the distance from the ground to the beltline was 88 centimeters (34.6 inches).

Figure 5: Front left view of the Chrysler Cirrus LX

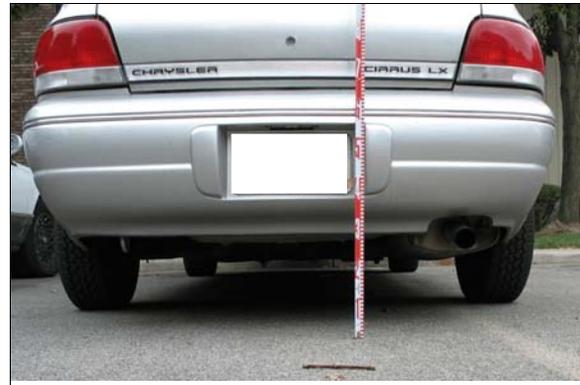
Figure 7: Chrysler’s back bumper

There was no damage and no evidence of nonmotorist contact to the Chrysler’s back bumper rear tires or rear undercarriage. Based on the driver’s description of the incident and the Collision Deformation Classification (CDC) guidelines for pedestrian impacts, a CDC of **06-BRLN-1** was assigned to describe the nonmotorist’s contact to the back bumper.
