**CALSPAN ON-SITE CERTIFIED ADVANCED 208-COMPLIANT VEHICLE
CRASH INVESTIGATION**

SCI CASE NO: CA08029

VEHICLE: 2007 SUBARU LEGACY

CRASH DATE: JULY 2008

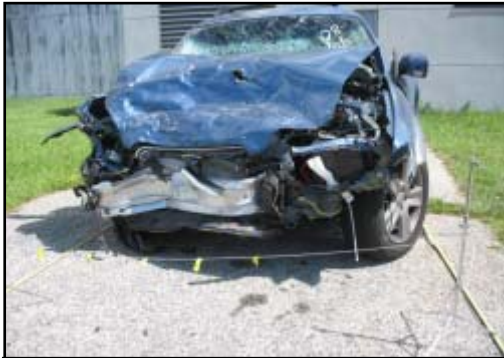
The 2007 Subaru sustained severe frontal damage as a result of the impact with the Lexus (**Figures 5 and 6**). The damaged components included but were not limited to the bumper fascia, bumper beam, hood, fenders, right front door, and the front wheels and suspension components. Additionally, the left and right wheelbases were reduced 7 cm (2.8") and 32 cm (12.6"), respectively. The impact was slightly off-set to the right; therefore, the maximum damage occurred to the right aspect of the frontal plane. The direct contact damage measured 140 cm (55") and extended from the left bumper corner to the right bumper corner. The maximum crush measured 85 cm (33.5") and was located 41 cm (16") inboard of the right bumper beam corner. A crush profile was documented along the 102 cm (40.2") bumper beam and was as follows: C1 = 51 cm (20"), C2 = 62 cm (24.4"), C3 = 68 cm (26.7"), C4 = 85 cm (33.5"), C5 = 84 cm (33"), C6 = 75 cm (29.5"). The Collision Deformation Classification (CDC) for this impact was 12-FDEW-4.

Figure 5. Overall view of the frontal damage to the Subaru.

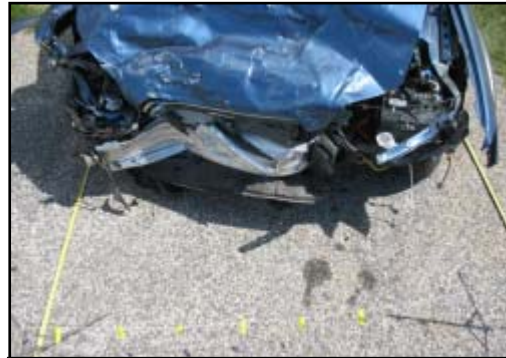
Figure 6. Overhead view of the resultant crush to the Subaru.

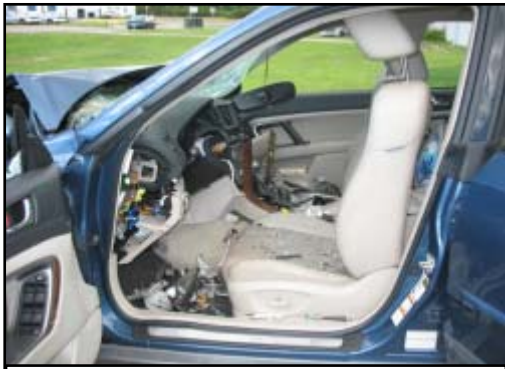
The interior of the Subaru sustained severe damage due to a combination of passenger compartment intrusion and driver contact. **Figure 7** is a view of the driver's area. The driver's contact points consisted of loading of the steering wheel, knee bolster, windshield, and sun visor. During this loading, the steering wheel flange fractured (**Figure 8**) separating the steering wheel from the column. The steering rim was displaced forward resulting in a 1 cm (0.4") gap at the 3 and 9 o'clock spokes and 3 cm (1.2") at the 6 o'clock spoke. Additionally, the steering wheel rim was deformed upward 4 cm (1.6") at the 7 o'clock location. There was 2 cm (0.8") of compression to the left and right sheer capsules. The knee bolster exhibited deformation from contact with both of the driver's knees. The left contact occurred to the left end of the knee bolster on the fuse box access door. The right knee contact was located on the right end of the bolster at the junction with the center console. A contact point was noted to the windshield forward and below the steering wheel rim. This contact was attributed to the driver's right hand and was evidenced by the fractured glass and tissue transfers. The driver's head contacted the sun visor which resulted fractured the mirror mounted within the sun visor. Also noted was that the rear view mirror was displaced from its windshield mount and the glass was fractured. This contact was attributed to the driver's right hand.

Figure 7. View of the driver's area.

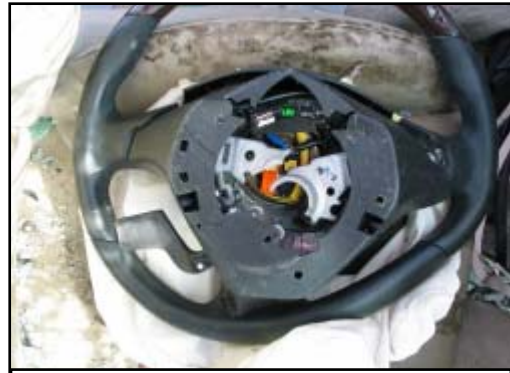
Figure 8. Fractured steering wheel flange.

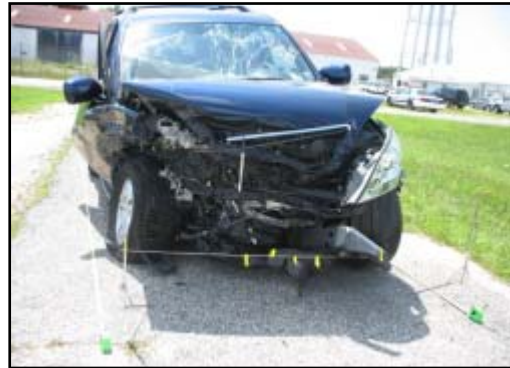
The 2006 Lexus GX 470 sustained severe damage to the front and right planes as a result of the impact with the Subaru (**Figure 9**). The damage consisted of longitudinal crush to the frontal plane. The direct contact damage from this off-set right impact began 24 cm (9.5”) left of the centerline and extended 76 cm (29.9”) to the right bumper corner. The maximum crush occurred at the right corner of the bumper beam and measured 72 cm (28.3”). A crush profile was documented along the bumper beam which was as follows: C1 = 0 cm, C2 = 0 cm, C3 = 59 cm (23.2”), C4 = 59 cm (23.2”), C5 = 56 cm (22”), C6 = 72 cm (28.3”). The CDC assigned for this impact was 12-FZEW-3.

Figure 9. Resultant frontal damage to the Lexus.

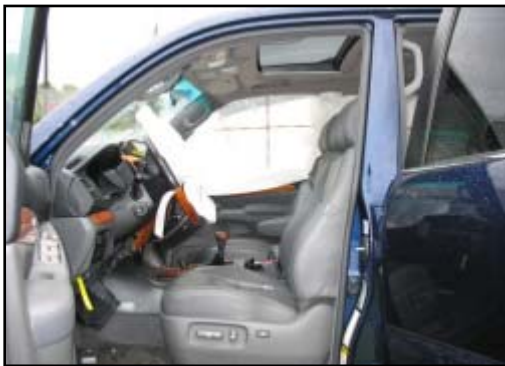
The interior of the Lexus sustained moderate severity damage from a combination of passenger compartment intrusion and occupant contact points. The occupant contact points consisted of deformation to the left knee bolster by the driver’s knees, fractured windshield from contact with the driver’s right hand, displaced rearview mirror by the driver’s right hand, and compression of the steering column. The steering column compression resulted in approximately 1 cm (0.4”) of sheer capsule displacement. Occupant contact points from the rear passengers were not evident. **Figures 10 and 11** are overall views of the first and second rows. Safety belt loading evidence was present on the belt webbings for the three occupied positions. This loading is discussed the Manual Restraints section of this report.

Figure 10. View of the front row of the Lexus.

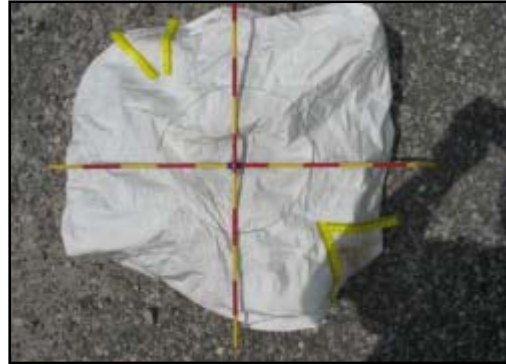
The air bag membrane contained numerous cuts and body fluid transfers. The largest area of body fluid was located on the rear panel at the 6 o'clock position and measured 31 x 22 cm (12.2 x 8.7"), height x width. Dirt was also present within this body fluid transfer. A second area of body fluid was located at the 11 o'clock sector and measured 12 cm (4.7") in height and 8 cm (3.2") in width. Body fluid was noted at the 5 o'clock position. This transfer measured 10 cm (3.9") in height and 11 cm (4.3") in width. Numerous small cuts that were approximately 0.8 cm (0.3") in size were present on the face of the membrane. These small cuts appeared to have occurred from shattered glass. Two larger cuts were noted on the membrane at the 12 and 1 o'clock positions. These cuts measured 3 cm (1.2") and 4 cm (1.6"), respectively. A 2 cm (0.8") cut was noted along the sewn perimeter seam at the 5 o'clock sector. **Figure 12** depicts the body fluid transfers and **Figure 13** shows the deployed air bag.

Figure 12. Body fluid transfers on the driver's air bag membrane.

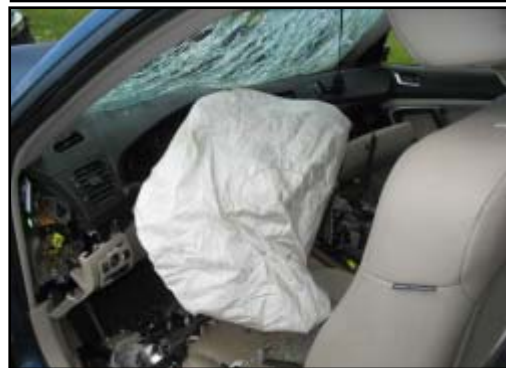
Figure 13. Deployed driver's frontal air bag.

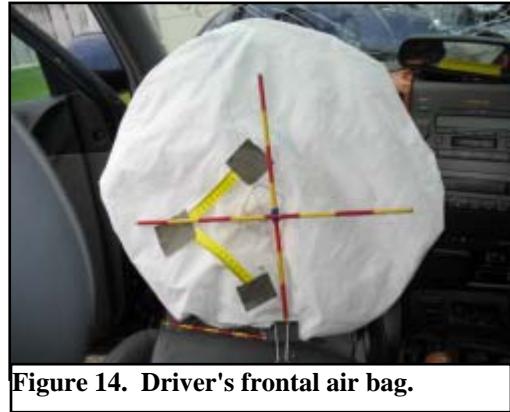
During the frontal crash, the driver's frontal air bag deployed (**Figure 14**). The driver's air bag was conventionally mounted in the center hub of the four-spoke steering wheel. The air bag module contained two symmetrical cover flaps that measured 8 cm (3.2") in height and 13 cm (5.1") in width. The air bag membrane was 57 cm (22.4") in diameter in its deflated state and was tethered internally by two straps. The air bag was vented by two ports located at the 11 and 1 o'clock positions. The maximum excursion of the air bag was 33 cm (13").

The driver's face contacted the air bag membrane, which was evidenced by a make-up transfer. The transfer was reddish colored and was located on the face of the air bag 9 cm (3.5") left of the centerline to 6 cm (2.4") right and 10 cm (3.9") above the center to 4 cm (1.6") below. Located within this transfer was a small area of body fluid. Body fluid was also present on the top rear panel and lower right rear panel of the membrane.

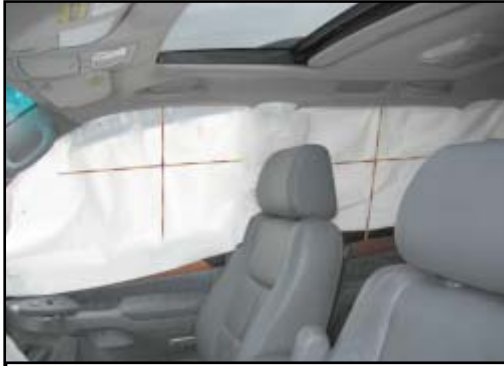
The right curtain air bag deployed from the roof side rail (**Figure 15**). The air bag membrane measured 216 cm (85") in length. At the front seating position, the membrane measured 55 cm (21.7") in height and 51 cm (20") in height at the right rear position.

Figure 15. Deployed right curtain air bag.

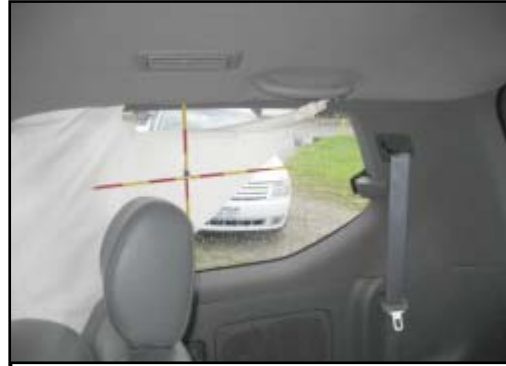
Vertically, the curtain air bag extended below the beltline at the first and second rows. At the third row, the curtain air bag did not span the complete vertical and longitudinal area of the third row glazing. A triangular shaped void was present at the third row glazing area (**Figure 16**). This void measured 37 cm (14.6") in height and 48 cm (18.9") in width. The curtain air bag was free of occupant contact points and damage.

Figure 16. Right curtain air bag at the third row position.
