Remote Not In Traffic Surveillance Power Window Entrapment Investigation  
Dynamic Science, Inc. (DSI), Case Number DS08030  
1997 GMC Jimmy  
Colorado  
July 2008

1. Report No. DS08030	2. Government Accession No.	3. Recipient Catalog No.	
4. Title and Subtitle Remote Not In Traffic Surveillance Power Window Entrapment Investigation		5. Report Date December 16, 2008

**Dynamic Science, Inc.**  
**Crash Investigation**  
**Case Number: DS08030**

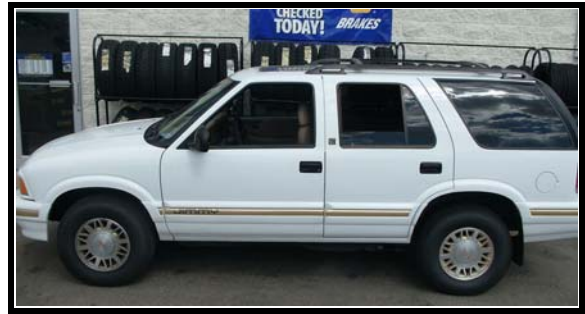
This remote Not In Traffic Surveillance (NITS) power window entrapment investigation was initiated in response to an online news article reporting the injury of a 4-year-old female child whose head became entrapped in a power window. The investigation focused on the power window switch configuration and the closing forces of the rear door windows of a 1997 GMC Jimmy sport utility vehicle (**Figure 1**).

**Figure 1.** Subject vehicle, 1997 GMC Jimmy

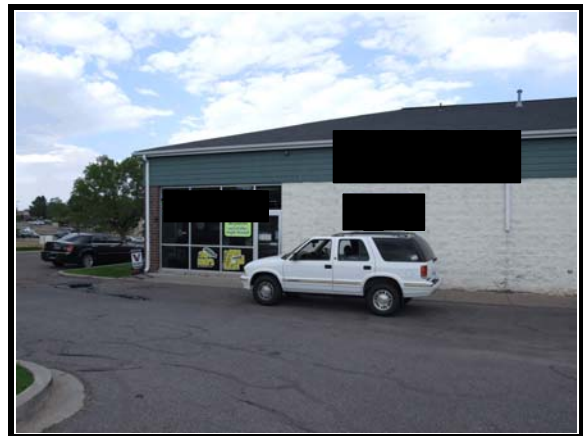
**Figure 2.** Location of subject vehicle at time of incident (looking east)

When she returned she parked the vehicle facing north in front of the front door of the business (**Figure 2**). The vehicle was left running with the air conditioner on. The doors were not locked. The driver stated that she was inside the business for approximately five minutes.

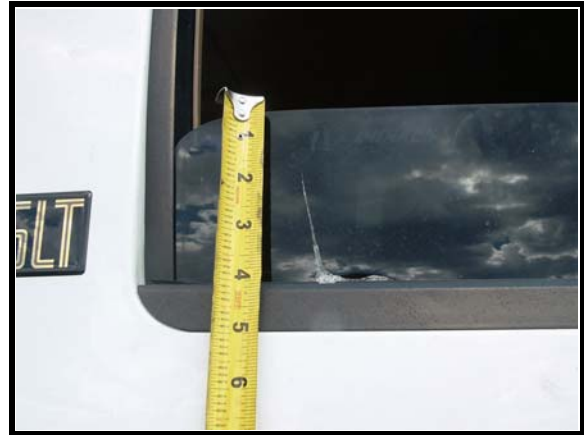
It appears that in the driver's absence the child placed her head outside the window and activated the window with one of her knees. The average difference between top of the sternum and the top of the tibia for a female child between the ages 3.5-4.5 years was 55.1 cm (21.6 in)<sup>1</sup>. With the child on her knee(s), the child's neck would have been approximately 23.1 cm (9.0 in) above the window frame.

**Figure 3.** Second row left window

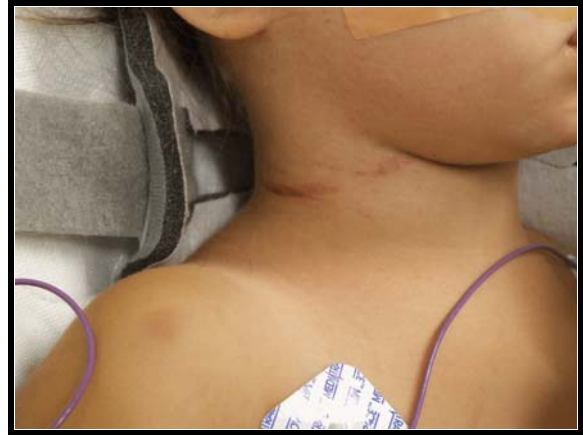
**Figure 4.** Linear abrasion to right side of child's neck

<u>Injury</u>	<u>AIS Code</u>	<u>Injury Mechanism</u>	<u>Confidence Level</u>
Linear abrasion, right side of neck	390202.1,1	Side glass	Certain
Chest contusion	490402.1,9	Unknown	Unknown
Contusion, right shoulder	790402.1,1	Door panel	Probable
Contusion, left shoulder	790402.1,2	Unknown	Unknown
Small marks to left side of neck	390099.1,2	Window frame	Probable

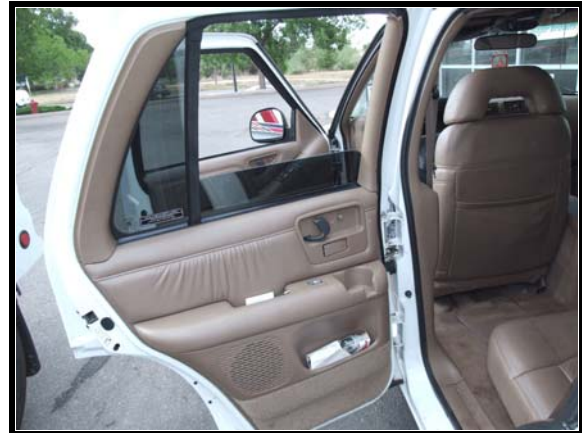
The main power window switch control panel was mounted on the forward aspect of the second row left passenger's armrest in a near horizontal position (**Figure 5**). The switch panel consisted of four rocker-style switches for the four door windows with the front window controls located forward of the rear window controls. The driver's door window switch was equipped with an auto-down feature. According to the owner's manual, the power windows will only work when the ignition has been turned to RUN. Each switch required down pressure to the leading edge to raise the windows and down pressure to the trailing edge to lower the windows. The switches were marked with up and down arrows. This vehicle was equipped with a lockout feature to prevent passengers from operating the windows. The feature is activated by pressing LOCK and is returned to normal operation by pressing NORM. The lockout feature was not actuated at the time of the incident. The left rear power window switch was positioned on top of the door armrest, just forward of the door midpoint (**Figures 6-7**). The rocker-style switch required the same motion to operate the window as the main switch panel on the driver's door rest. The rear door glazing measured 46 cm (18.1 in) wide at the base by 50 cm (19.7 in) high. The rear door panel was configured with an armrest that extended the full length of the door panel. The arm rest was approximately 32 cm (12.6 in) below the level of the side window frame. The door handle was integrated into the door panel and was forward and above the power window button in the arm rest.

**Figure 5.** Second row left interior door

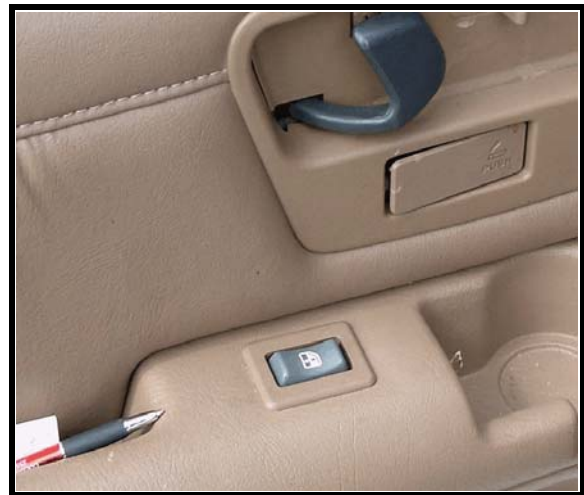
**Figure 6.** Second row left power window switch

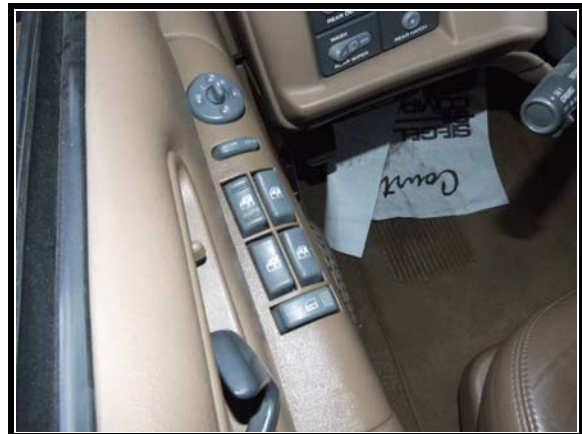
**Figure 7.** Driver's power switch control

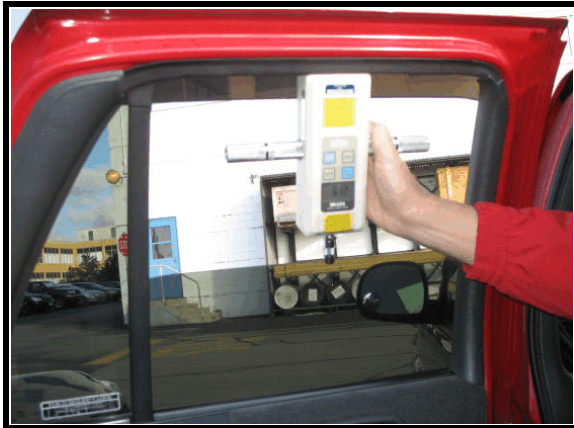
An exemplar 1998 GMC Jimmy was tested to determine the closing force of the second row left power window. The test used an Imada Model DPSH-440R Digital Force Gauge that was last calibrated on 11/29/07. The force gauge was positioned between the window and the window frame (**Figure 8**). With the engine off, a peak closing force of 208 N (46.8 lb) was recorded. With the engine on, a peak closing force of 272 N (61.2 lbs) was recorded (**Figure 9**).

**Figure 8.** Positioning of force gauge in left rear window

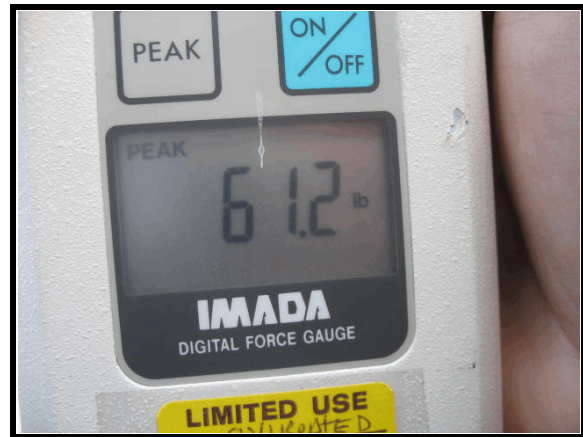
**Figure 9.** Peak closing force reading of 272 N (61.2 lbs) of the left rear power window with engine running
