Remote Not In Traffic Surveillance Back Over Investigation
Dynamic Science, Inc. (DSI), Case Number DS08031
1996 Lincoln Town Car
California
July 2008

1. Report No. DS08031	2. Government Accession No.		3. Recipient Catalog No.	
4. Title and Subtitle Remote Not In Traffic Surveillance Back Over Investigation		5. Report Date July 29, 2009

This back over incident occurred in July 2008 in California. The subject vehicle was a 1996 Lincoln Town Car that was being driven by a 19-year-old female. The incident occurred in a residential driveway that was oriented east/west. The driveway intersected a north/south oriented roadway. The Lincoln was parked in the driveway, facing east, toward the residence. The driver began backing the vehicle out of the driveway in a westbound direction. The driver was moving the vehicle away from the garage so another vehicle could enter the garage. A 1-year-old female was walking northbound across the driveway and entered the rearward path of the backing vehicle. The child was knocked down and run over by the right rear tire. The child sustained a flail chest, abrasions and contusions to the face, and a severe brain injury. She was hospitalized for two day

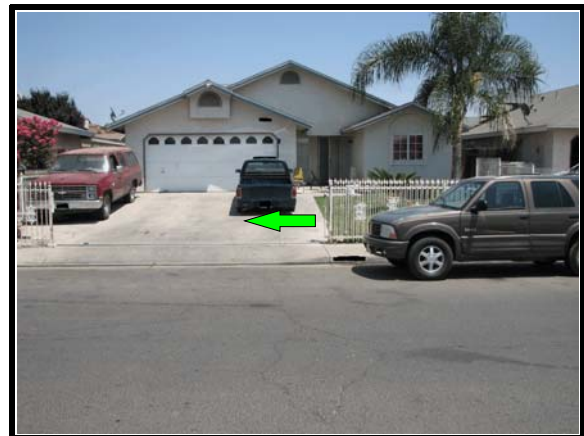
This back over incident occurred at 2108 hours. The weather was cloudy, the roadway was dry, and no unusual conditions were present. The temperature at the nearest reporting station was 26 degrees C (79 degrees F). The wind was calm and the relative humidity was 47%. The incident occurred on a private driveway (**Figure 1**). The driveway was approximately 7.6 m (25 ft) wide and was constructed of concrete. There was a slight downward grade to the west. The driveway was bordered on right by a grass lawn and on the left by a wrought iron fence. At the west end of the driveway, there was a metal gate on a track which blocked access to the driveway from the street. The gate was open at the time of the incident. The entrance to the residence was to the right of the driveway. A Chevrolet sport utility vehicle was parked on the left side of the driveway facing west. A Mazda compact pickup truck was parked on the right side of the driveway facing

Figure 1. Overview of driveway (east). Green arrow shows path of non-motorist

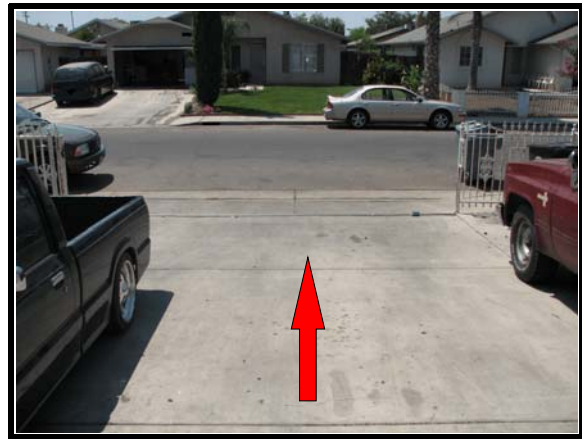
The driver of the Lincoln did not realize that her daughter was out of the house. The father reported at one point that he did not see his daughter until she was near the right rear of the Lincoln. The child was walking from south to north and was within the blind zone behind the Lincoln. As the driver backed the vehicle the child was knocked down and run over by the right rear tire (**Figure 2**).

Figure 2. Path of Lincoln to area of impact (west)

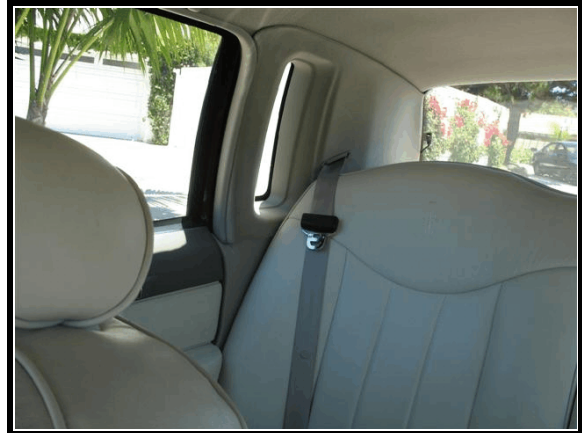
The initial set of measurements were taken with the investigator were looking over his right shoulder through the backlight (**Figures 3-4**). The target was moved rearward from the rear bumper along the Lincoln's centerline until it became visible to the investigator. The point at which the target became visible to the investigator measured 3.87 m (12.7 ft) rearward of the rear bumper. This measurement was used as the point of origin for two sets of lateral measurements which were then taken. Measurements taken laterally to the left and right would result in a visible zone that could be viewed through the backlight (View 2). The point at which the ground became visible through the backlight measured 9.2 m (30.2 ft).

Figure 3. View towards right rear of exemplar Lincoln from driver's seat

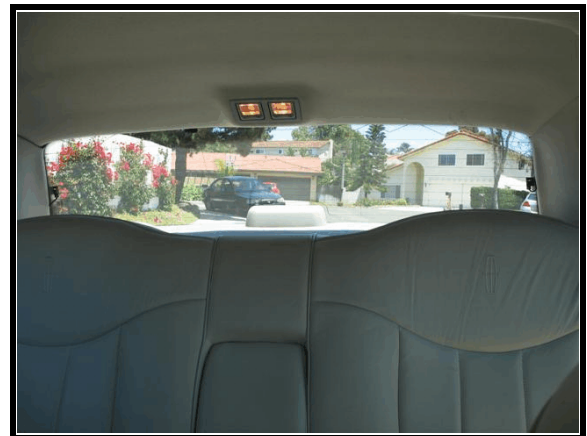
Figure 4. View out of back of exemplar Lincoln from driver's seat

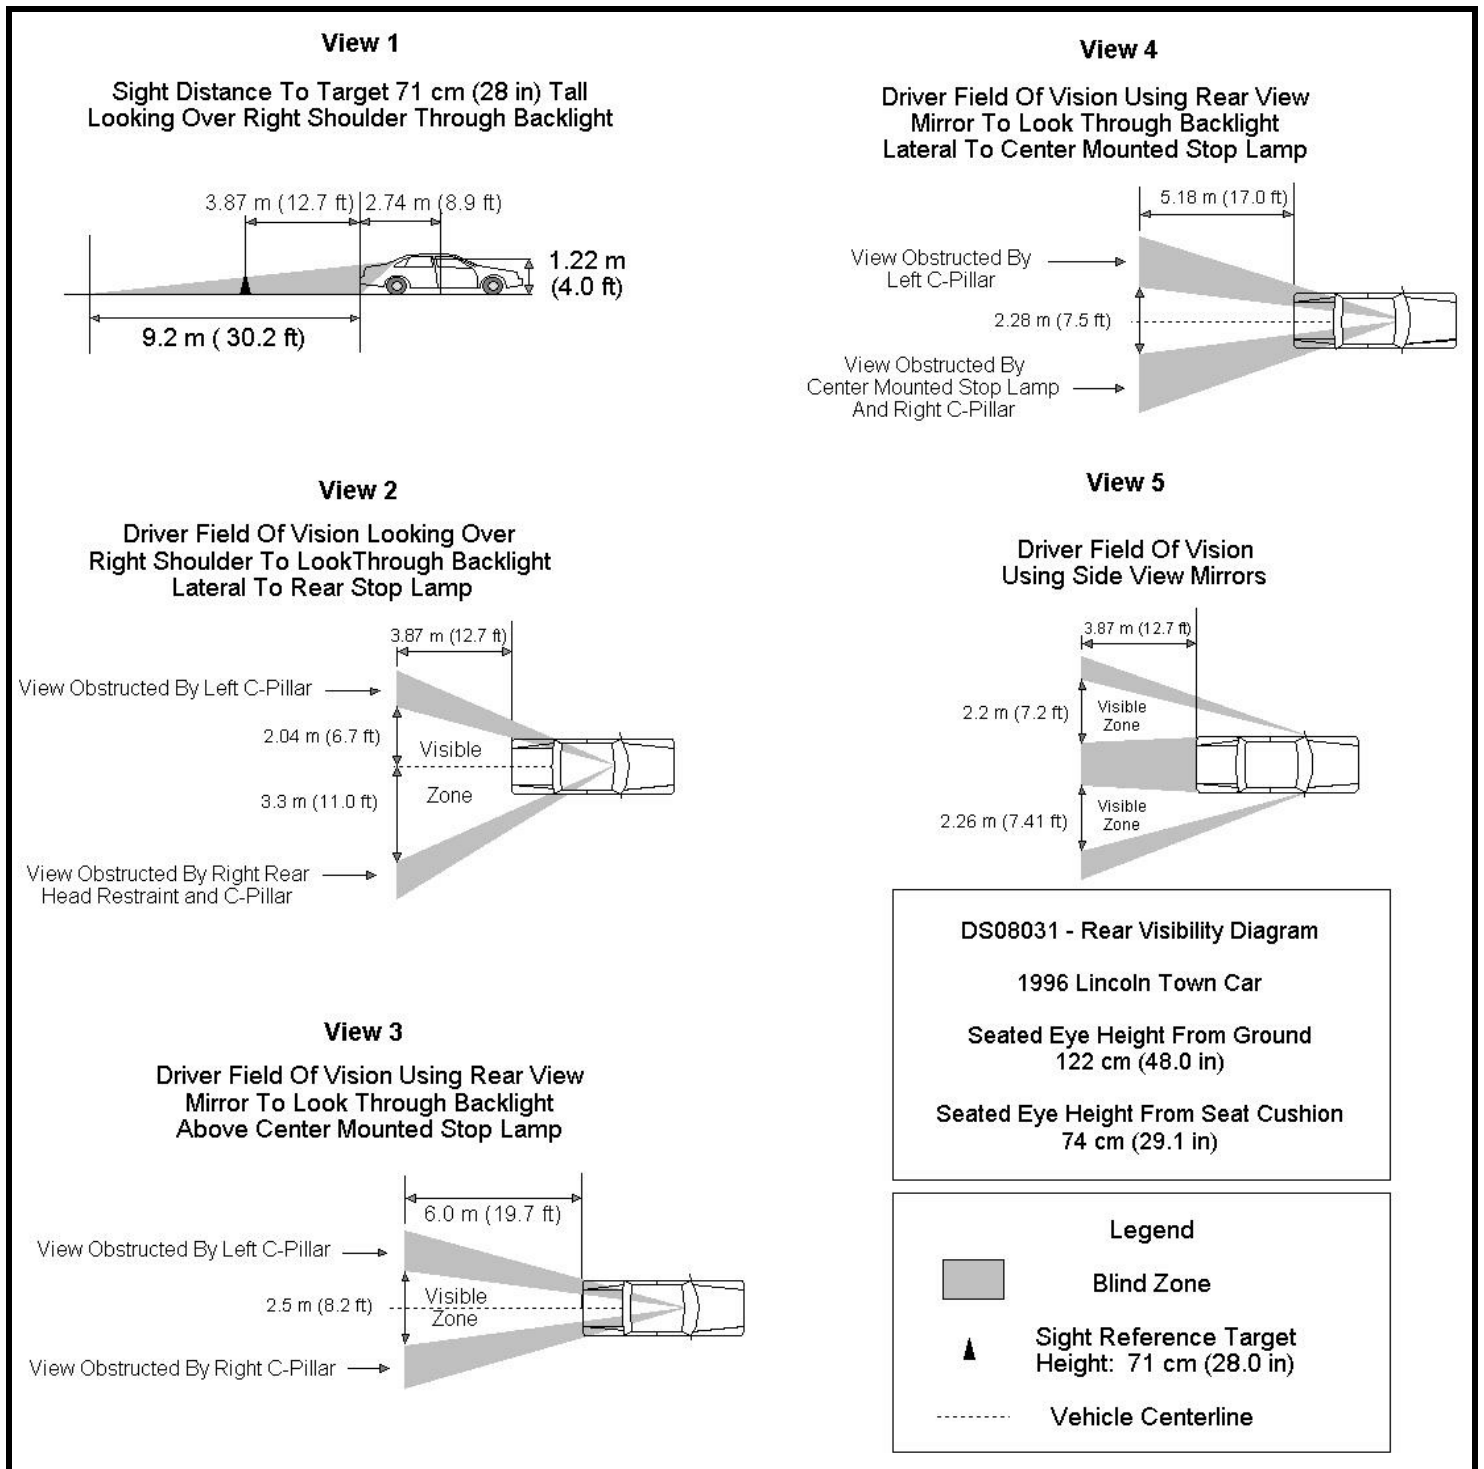
Figure 5. Nominal Sight Diagram

The driver's seated eye height when measured from the seat cushion was 74 cm (29.1 in) and when measured from the ground was 1.22 m (4.0 ft). The SCI investigator was able to duplicate the driver's seated eye height by positioning a person of similar height in the driver's seat (Nominal

At 3.87 m (12.7 ft) rearward of the rear bumper, the blind zone was approximately 1.4 m (4.6 ft) in width. The target was then moved further to the left and right until it could no longer be viewed through the rear view mirrors. The areas to the left and right in which the target could be viewed resulted in side view visible zones.
