**CRASH DATA RESEARCH CENTER**

**CALSPAN ON-SITE ROLLOVER CRASH INVESTIGATION  
CALSPAN CASE NO: CA08031**

**VEHICLE: 2007 CHEVROLET SILVERADO  
LOCATION: NORTH CAROLINA  
CRASH DATE: JUNE, 2008**

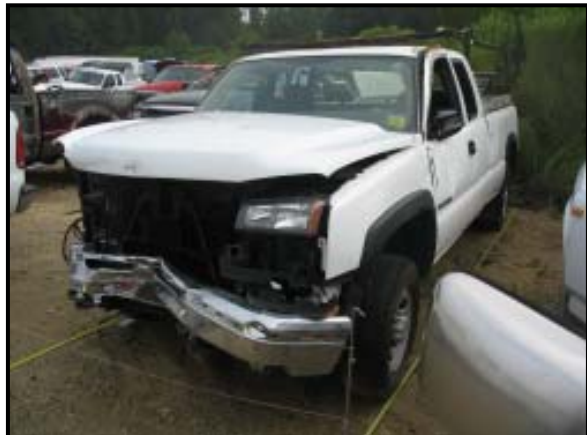
**Figure 1: Front view of the damaged 2007 Chevrolet Silverado.**

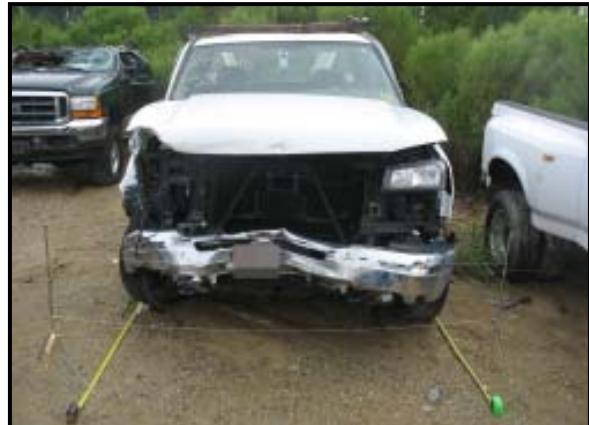
The Chevrolet Silverado sustained moderate severity frontal damage from the initial impact with the Chevrolet Cobalt (Event 1). **Figure 4** is a view of the frontal deformation. The damage was biased to the right and consisted of longitudinal deformation to the frontal structure. The width of the direct contact damage measured 112 cm (44 in) and began 46 cm (18 in) left of the centerline extending to the front right bumper corner. The maximum crush measured 34 cm (13.4 in) and was located at the right corner. The residual crush was measured along the front bumper beam and was as follows: C1 = 0 cm, C2 = 5 cm (2 in), C3 = 27 cm (10.6 in), C4 = 29 cm (11.4 in), C5 = 18 cm (7.1 in), C6 = 34 cm (13.4 in). The right wheelbase dimension was reduced 17 cm (6.7 in). The Collision Deformation Classification (CDC) of this impact was: 11-FZEW2.

**Figure 4: Residual front damage from the impact with the Chevrolet Cobalt.**

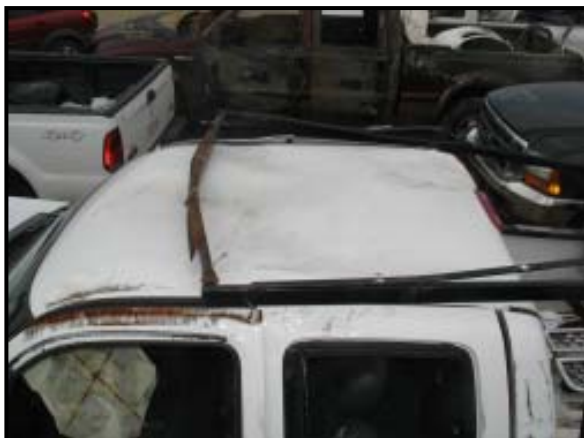
The rollover sequence (Event 2) resulted in minor severity damage to the side and top planes of the Chevrolet Silverado (**Figure 5**). The damage consisted of scattered abrasions and body panel deformation. The roof area sustained the majority of the deformation with 5 cm (4 in) of maximum vertical crush occurring in the right rear aspect of the roof area. There was no lateral deformation of the roof structure. The CDC assigned to this impact was 00-TDDO2.

**Figure 5: Rollover damage to the roof.**

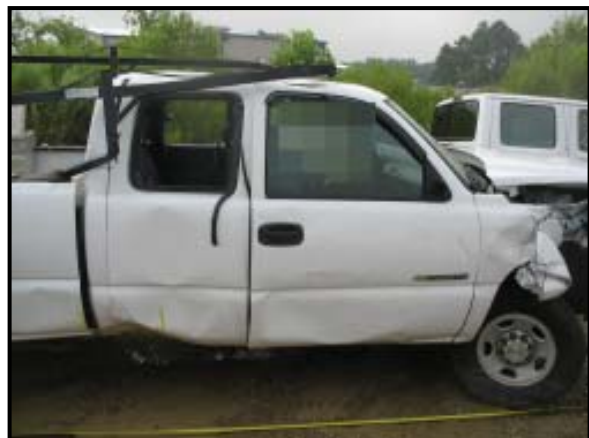
The final impact (Event 3) in this crash sequence consisted of the undercarriage of the Chevrolet Silverado impacting a utility pole as it traveled to final rest (**Figure 6**). The direct contact damage occurred on the right sill area beginning 279 cm (110 in) forward of the rear bumper. The total direct damage measured 33 cm (13 in) in length. The damage from this impact was evidenced by 15 cm (6 in) of vertical crush at the right sill, 296 cm (116.5 in) forward of the rear bumper. The CDC for this non-horizontal impact was 00-UZDN2.

**Figure 6: Right sill damage from the utility pole impact.**

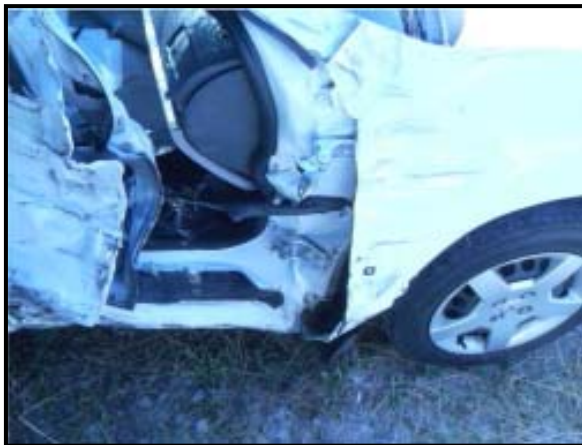
The 2007 Chevrolet Cobalt sustained severe damage to the right plane as a result of the intersection impact (Event 1). The Chevrolet had been crushed for recycling and was not inspected by the SCI investigator. The damage assessment was based on the images provided by the insurance company. The direct contact damage began immediately forward of the right A-pillar and extended to the aft aspect of the right rear door. The estimated width of the damage pattern was 215 cm (85 in). The maximum crush occurred at the B-pillar area and was estimated to be 46 cm (18 in) in depth. Based on the images, it appeared that the A-pillar mounted door hinges separated during the crash resulting in an integrity loss of the front right door. The right front door was displaced rearward creating an opening at the forward aspect that was approximately 25 cm (10 in) in length. The B-pillar hinges were not visible in the provided images; therefore, an assessment was not conducted. The right rear door appeared to have sustained damage to the latch and striker. The integrity of the right rear door did not appear to be compromised. The CDC of the Chevrolet Cobalt was 02-RPEW3.

**Figure 7: Right view of the damage at the A-pillar of the Chevrolet Cobalt. Image supplied by the vehicle's insurance company.**

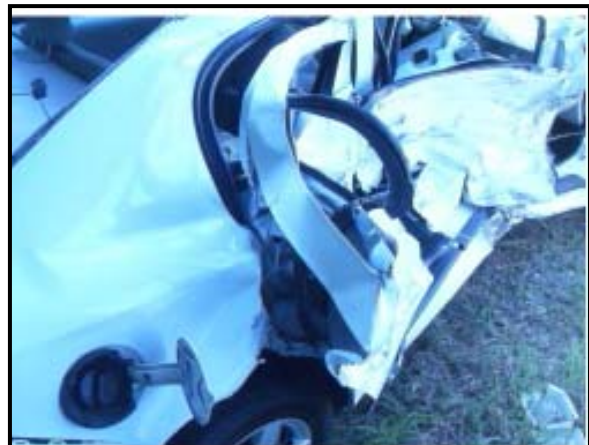
**Figure 8: View of the damage to the right plane of the Chevrolet Cobalt. Insurance company image.**

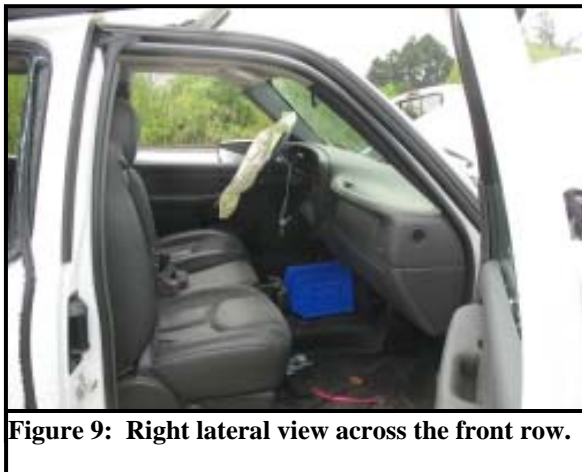
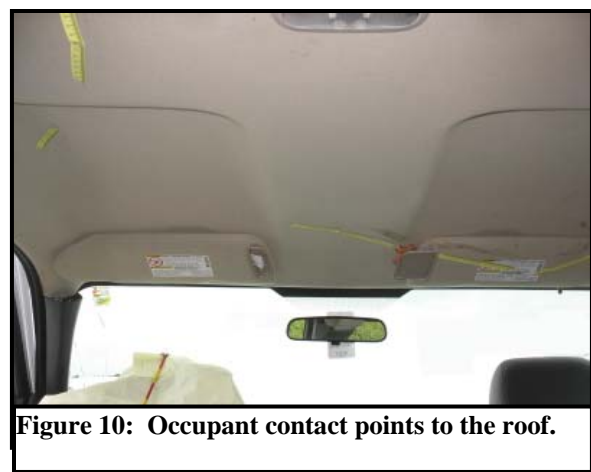
The interior of the Chevrolet sustained minor severity damage as a result the deployment of the driver air bag and minor occupant contact points. The interior contact points consisted of three scuff marks to the headliner. Two of the scuff marks were located over the driver's seat position, 22 cm (8.5 in) and 38 cm (15 in) inboard of the roof side rail, respectively. These scuff marks contained dirt and a blue-colored transfer. The third transfer was located 38 cm (15 in) rear of the windshield header and began 13 cm (5 in) left of the centerline. This scuff mark extended 53 cm (21 in) onto the right sun visor. There was no occupant compartment intrusion in the front row. The vertical intrusion of the roof measured 10 cm (4 in) in the second to right position. **Figure 8** is a right lateral view of the front row. **Figure 9** depicts the occupant contact points to the roof identified during the inspection.

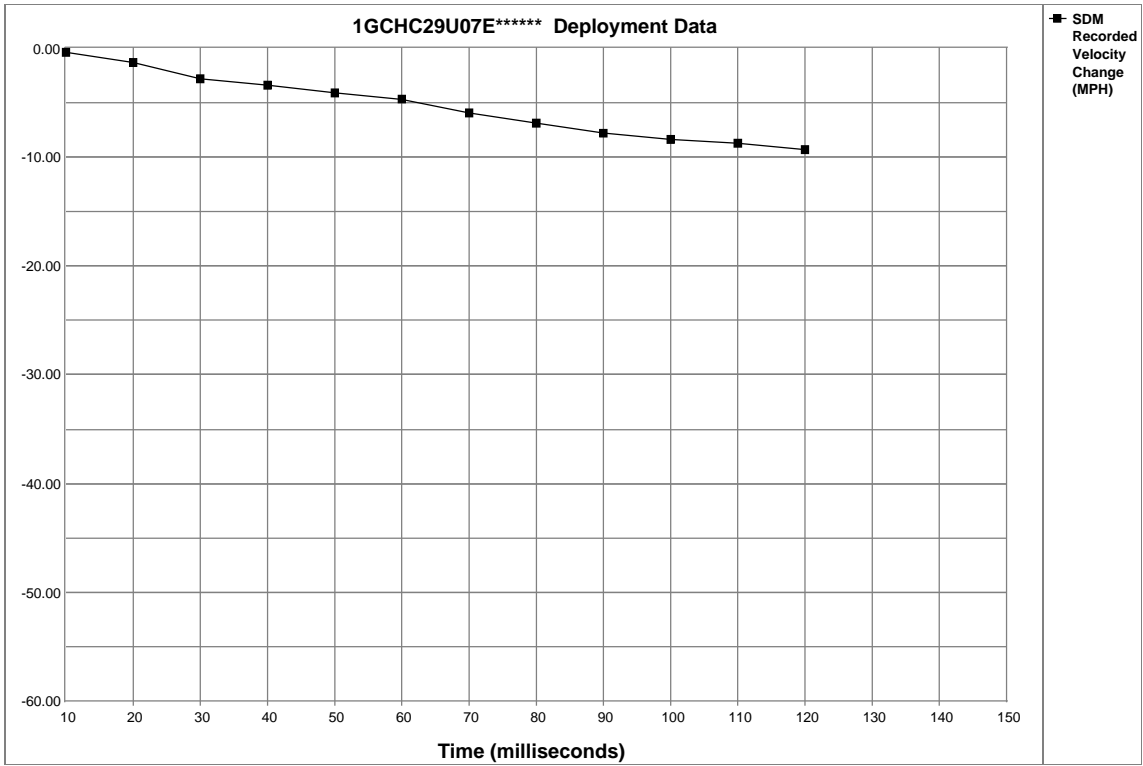
Analysis of the data indicated that the deployment event occurred first and was related to the intersection impact. The Air Bag Warning Lamp in the instrument cluster was "Off" indicating there were no faults with the air bag system. The pre-crash speed of the Chevrolet Silverado was 72 km/h (45 mph) one second prior to Algorithm Enable (AE). The brake switch circuit was "Off" throughout the pre-crash recorded time period. The driver's safety belt was unbuckled. A Stage-one driver air bag deployment was commanded 25 milliseconds after AE and the front right passenger air bag was suppressed (consistent with the vehicle inspection). The maximum recorded longitudinal delta-V was -17.2 km/h (-10.69 mph).

Time (milliseconds)	10	20	30	40	50	60	70	80	90	100	110	120	130	140	150
Recorded Velocity Change (MPH)	-0.31	-1.24	-2.79	-3.41	-4.03	-4.65	-5.89	-6.82	-7.75	-8.37	-8.68	-9.30	N/A	N/A	N/A

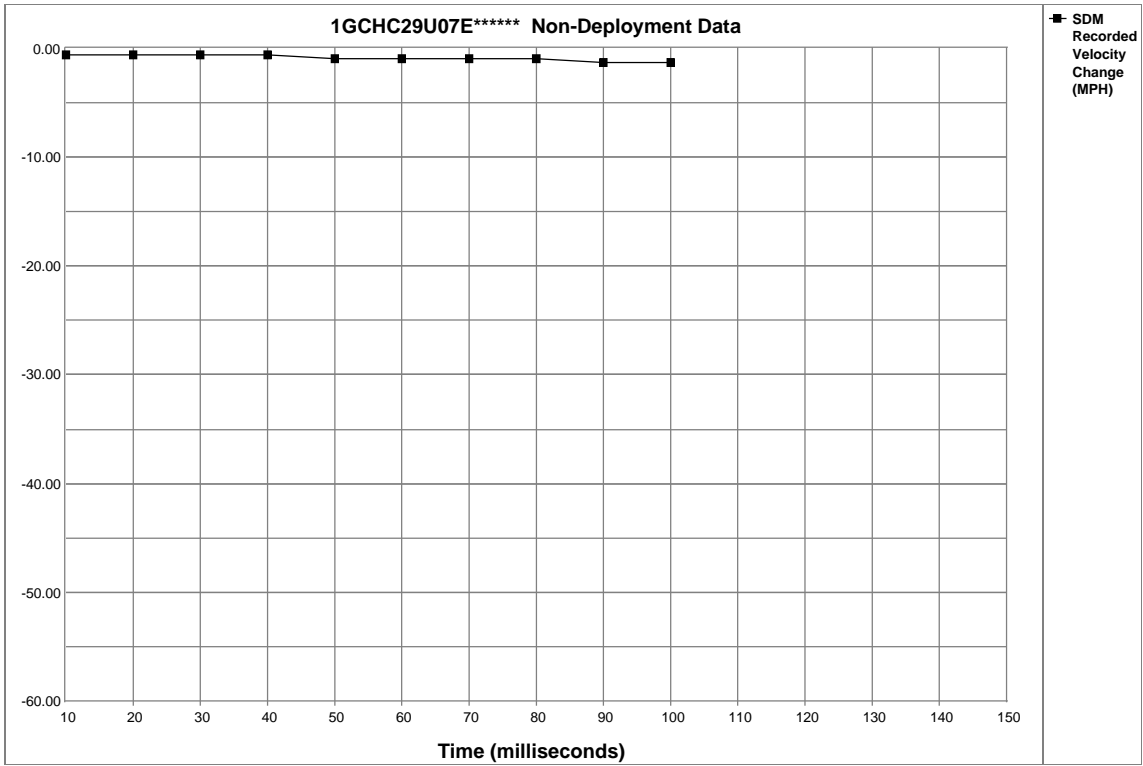
The imaged data indicated that the non-deployment event occurred at least five seconds after the deployment event. The Air Bag Warning Lamp was "On" at the time of the non-deployment event. The maximum longitudinal delta-V of the non-deployment was -2.1 km/h (-1.3 mph). The non-deployment event was most likely related to the utility pole impact (Event 3). The imaged EDR data is attached to the end of this narrative report as Attachment A.

Time (milliseconds)	10	20	30	40	50	60	70	80	90	100	110	120	130	140	150
Recorded Velocity Change (MPH)	-0.62	-0.62	-0.62	-0.62	-0.93	-0.93	-0.93	-0.93	-1.24	-1.24	N/A	N/A	N/A	N/A	N/A
