## ON-SITE SIDE IMPACT INFLATABLE OCCUPANT PROTECTION INVESTIGATION

CASE NUMBER - IN08032

VEHICLE - 2007 HONDA CIVIC LX

CRASH DATE - June 2008

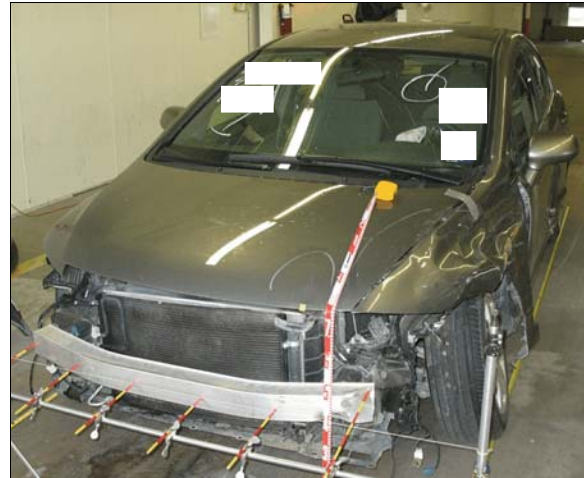
**Figure 1:** The damaged 2007 Honda Civic LX

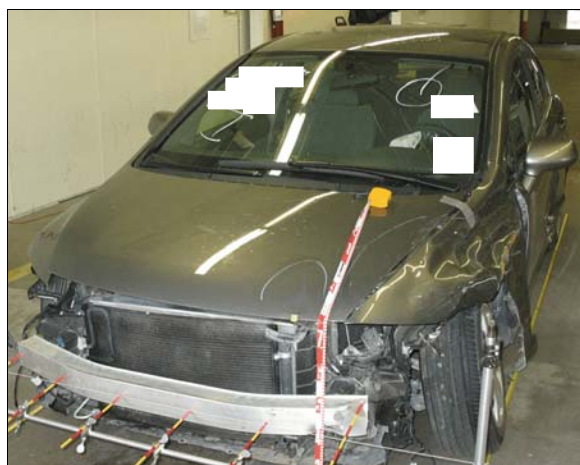
**Exterior Damage:** The Honda's initial impact with the Buick involved the front plane. The front left portion of the bumper, grille, left fender, and left headlamp/turn light assembly were directly contacted and the bumper fascia was torn off the vehicle. The direct damage also extended 135 cm (53.1 in) down the left fender and onto the front portion of the left front door. The direct damage to the front plane began at the front left bumper corner and extended 26 cm (10.2 in) across the bumper fascia. The crush measurements were taken on the front bumper bar and the residual maximum crush was 6 cm (2.4 in) occurring at C<sub>1</sub>. The table below shows the vehicle's front crush profile.

**Damage Classification:** The Honda's Collision Deformation Classifications were **11-FLEE-6** (340 degrees) for the front impact (event 1, **Figure 6**) with the Buick, and **09-LPEN-1** (280 degrees) for the left side impact (**Figure 7**) with the Buick's right rear corner (event 2). The Missing Vehicle algorithm of the WinSMASH program calculated the Honda's total Delta V for the front impact as 12 km/h (7.5 mph). The longitudinal and lateral velocity changes were -11

**Figure 6:** Front and left fender damage from the impact with the front of the Buick

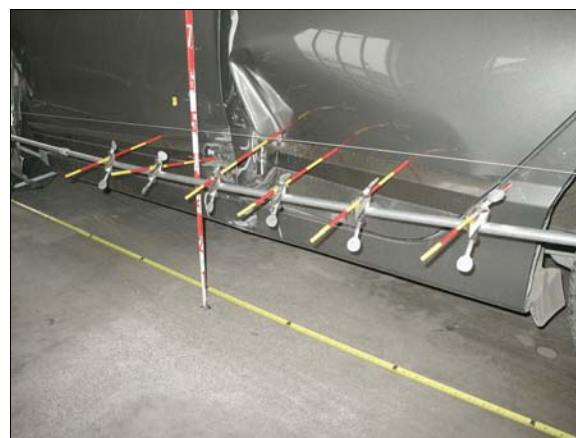
The second impact involved the Honda's left side plane. The left front door, left rear door, B-pillar, and sill sustained direct contact. The direct damage began 131 centimeters (51.6 inches) forward of the left rear axle and extended forward 98 centimeters (38.6 inches). The maximum residual crush was 5 centimeters (2 inches) occurring at C<sub>4</sub>. The Honda's left and right side wheelbase were unchanged and the induced damage involved the hood and the left front and rear doors. The table below shows the vehicle's left side crush profile.

**Figure 7:** Damage on the left side plane from the impact with the Buick's right rear corner

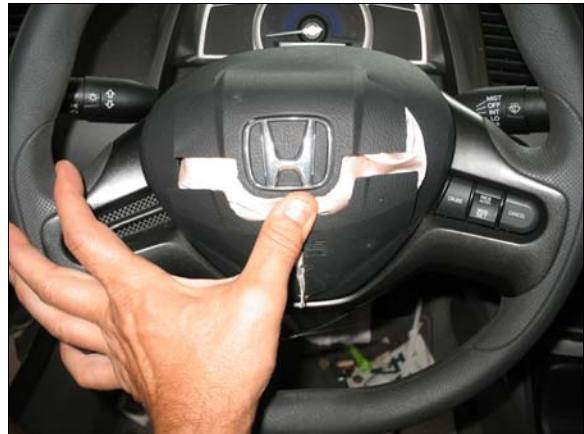
The driver's frontal air bag was located within the steering wheel hub and the module cover was a three flap configuration (**Figure 8**) constructed of pliable vinyl. The top flap was 14 cm (5.5 in) in length and 6 cm (2.4 in) in height at the Honda emblem. Each bottom flap was triangular-shaped and was 7 cm (2.8 in) in width and height as measured along the top and center tear seams. An inspection of the air bag module cover flaps revealed that they opened at the designated tear points. The deployed air bag (**Figure 9**) was round with a diameter of 60 cm (23.6 in) and was designed with two tethers and two vent ports. The vent ports were located at the 3 and 9 clock positions. Inspection of the air bag revealed no damage and no discernable evidence of occupant contact.

**Figure 8:** The driver's frontal air bag module cover flaps

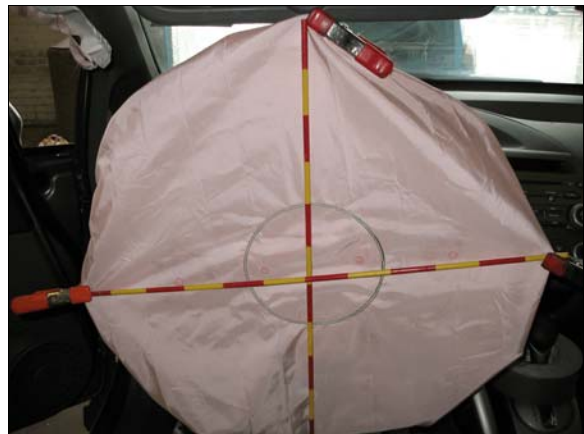
**Figure 9:** Driver's frontal air bag

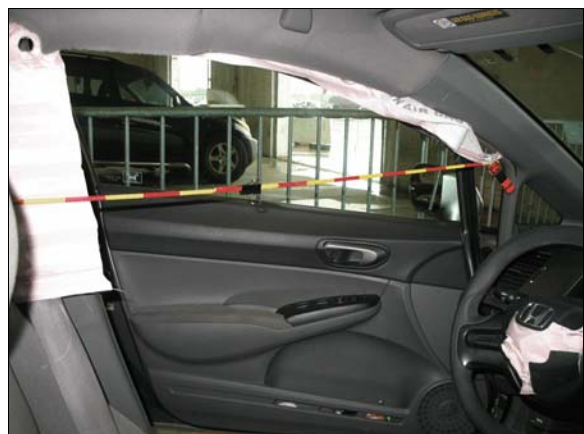
**Figure 10:** Front portion of left side curtain air bag had been cut away by emergency personnel

The left side curtain air bag was located along the left roof side rail (**Figures 10 and 11**) inside the headliner and extended from the A-pillar to the C-pillar. The deployed side curtain air bag was 175 cm (68.9 in) in length and 34 cm (13.4 in) in height. It was attached at the A-pillar by a 6 cm (2.4 in) cloth tether. There was no visible tether at the C-pillar. The fold creases on the air bag indicated that it had been folded accordion fashion within the headliner. The front portion of the air bag had been cut away (**Figure 10**), probably by rescue personnel during removal of the driver from the vehicle. Only the portion of the air bag from the B-pillar rearward was present within the vehicle.

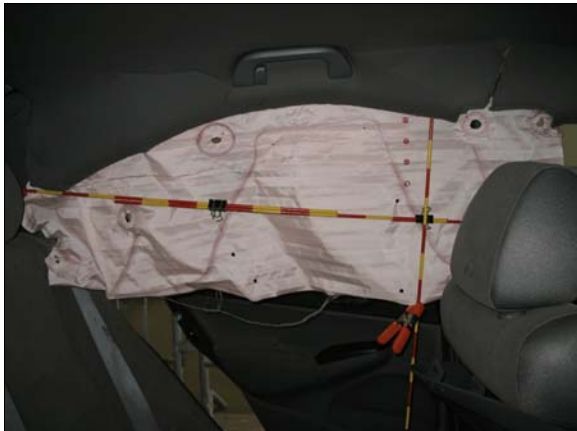
**Figure 11:** Back portion of left side curtain air bag

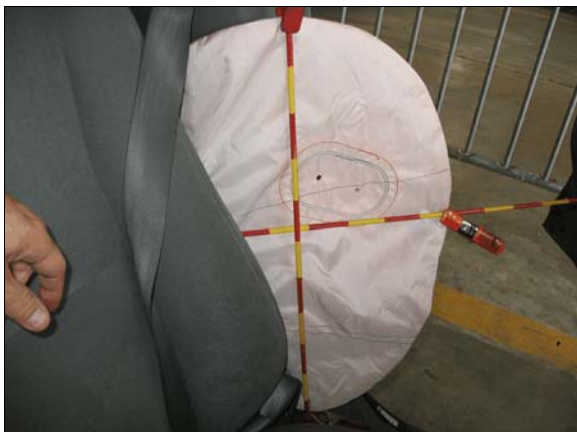
The driver's seat back-mounted side impact air bag was located in the outboard side of the seat back (**Figure 12**) and deployed through a tear-seam. The deployed air bag (**Figure 13**) was oblong and designed with one vent port located on the outboard side. The air bag had a single oval tether where both sides of the air bag were sewn together. The sewn area was 15 cm (5.9 in) in width and was located 24 cm (9.4 in) from the top and 21 cm (8.3 in) from the leading edge of the air bag. The deployed air bag was 54 cm (21.3 in) in height and 30 cm (11.8 in) in width. Inspection of the deployed air bag revealed no discernable evidence of occupant contact and no damage. There was a light abrasion on the left B-pillar (**Figure 12**) from contact with the outboard surface of the deploying air bag.

**Figure 13:** Driver's deployed seat back-mounted side impact air bag

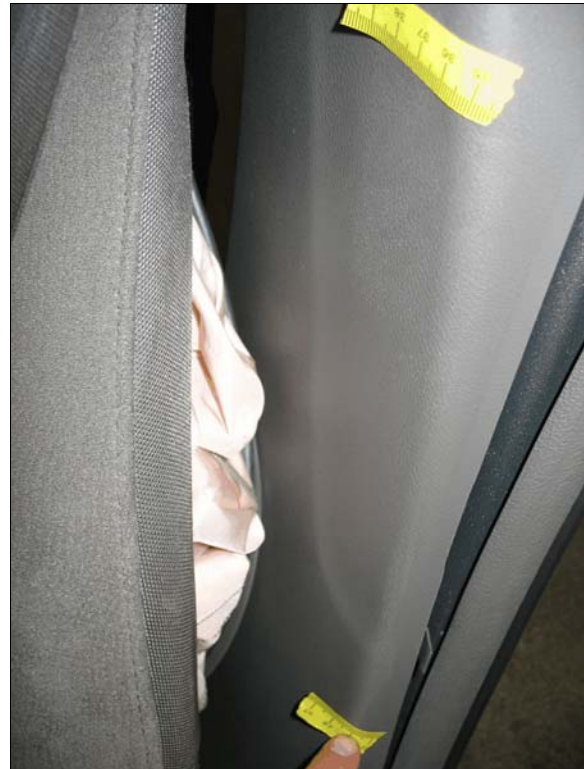
**Figure 12:** Locations of driver's seat back-mounted side impact air bag; yellow tape highlights light abrasions on B-pillar from the deployment

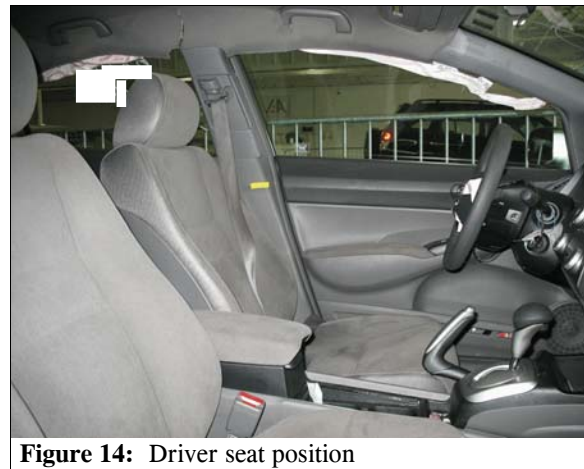
The Honda's driver [44-year-old, female; unknown height and weight] was seated in an unknown posture. At the time of the vehicle inspection, the driver's seat track was adjusted between the middle and full rear position and the seat back was slightly reclined (**Figure 14**). The adjustable head restraint was located in the full down position, and the distance from the top of the seat back to the top of the head restraint was 19 cm (7.5 in). The tilt steering column was located in the full down position and the telescoping adjustment was located between the full back and middle position.

**Figure 14:** Driver seat position
