Side Curtain Air Bag Investigation  
Dynamic Science, Inc. (DSI), Case Number DS08033  
2006 Toyota Highlander  
Oregon  
June 2008

1. Report No. DS08033		2. Government Accession No.		3. Recipient Catalog No.	
4. Title and Subtitle On-Site Rollover Investigation				5. Report Date May 29, 2009

**Dynamic Science, Inc.**  
**Crash Investigation**  
**Case Number: DS08033**

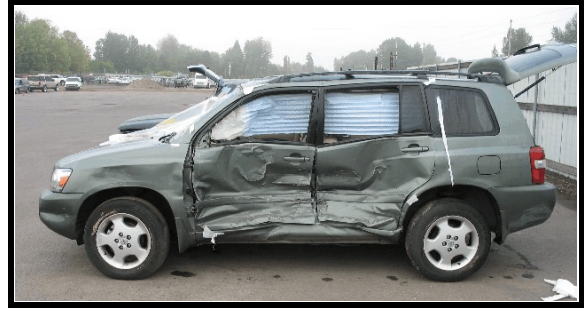
**Figure 1.** Subject vehicle, 2006 Toyota Highlander

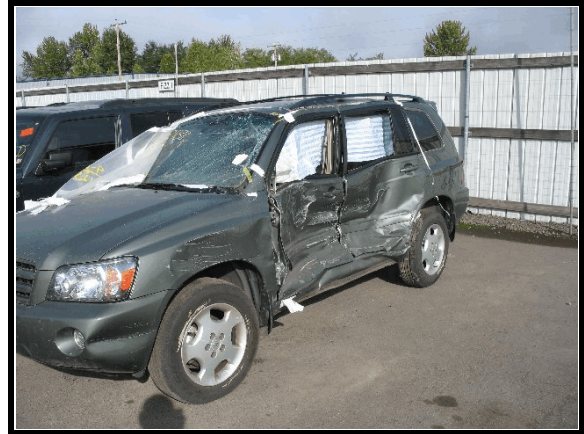
The 2006 Toyota Highlander sustained moderate left side damage as a result of the impact with the large truck (**Figure 4**). The direct damage began 19 cm (7.5 in) forward of the left rear axle, extended 325 cm (127.9 in) forward along the left side plane, and terminated at the left front bumper corner. The maximum crush was located between C2 and C3 and measured 30 cm (11.8 in) at the

mid-door level, 70 cm (27.5 in) above the ground. Both left side doors were deformed and jammed shut due to impact damage. The left side view mirror was knocked off. There was direct contact that extended vertically along the left A-pillar; the damage measured 160 cm (63.0 in) from the ground to the top of the damage. The side glass for both left side doors was disintegrated. There was 57 cm (22.4 in) abrasion damage along the edge of the right front rim due to lateral loading across the road surface (**Figure 5**). The right front tire was flat and de-beaded. The windshield sustained fracture damage from the movement of the A-pillar. Six crush measurements were documented at the mid-door level as follows: C1 = 0 cm, C2 = 29 cm (11.4 in), C3 = 29 cm (11.4 in), C4 = 0 cm, C5 = 0 cm, C6 = 4 cm (1.6 in). The Collision Deformation Classification for the impact with the truck was 09LYAW3.

**Figure 4.** Left side damage

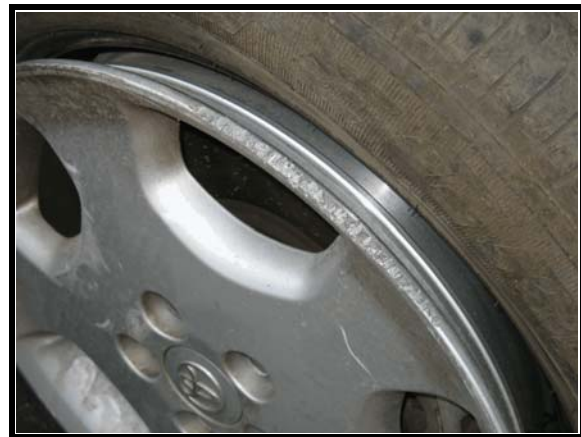
**Figure 5.** Damage to right front rim

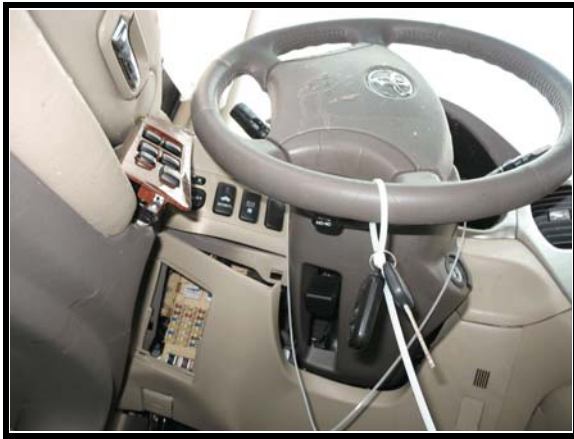
The 2006 Toyota Highlander sustained moderate interior damage as a result of passenger compartment intrusion (**Figures 6-7**). The left side doors and B-pillar sustained lateral intrusion. As a result of the lateral intrusion, the left front seat back and seat cushion, the center console, and the second row seat cushions were displaced laterally to the right. There were scuffs along the forward edge of the first row left door that may have been caused by the driver's left leg. The window control panel was dislodged due to the door movement.

**Figure 6.** Left door intrusion and instrument panel damage

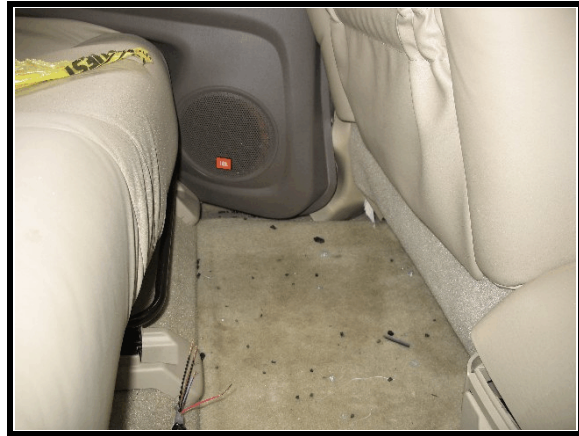
**Figure 7.** Second row door intrusion

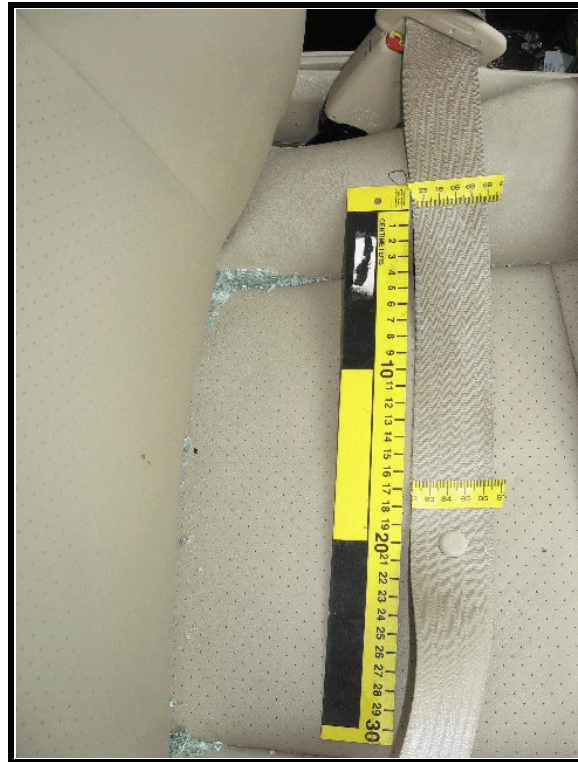
The 2008 Toyota Highlander was equipped with 3-point manual lap and shoulder belts for each seating position. Both front seat safety belts were equipped with retractor pretensioners. The driver's safety belt was configured with a sliding latch plate, an Emergency Locking Retractor (ELR), and an adjustable D-ring. At the time of the vehicle inspection, the driver's belt was restricted in the used position as a result of the pretensioner actuation. The driver's latch plate exhibited signs of historical usage. The front right safety belt was located in the stowed position and the pretensioner did not actuate. The belt webbing exhibited a 17 cm (6.7 in) long area of possible loading that was located 3 cm (1.2 in) from the stop button and 60 cm (23.6 in) from the anchor (**Figure 8**).

**Figure 8.** Possible loading to front right safety belt

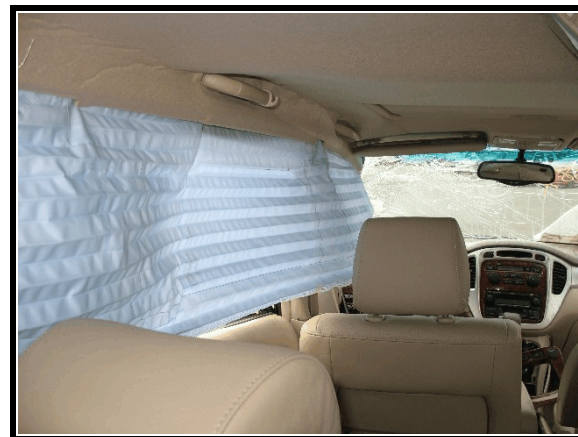
The left side curtain air bag deployed from the roof side rail (**Figure 9**). The air bag was rectangular in shape and extended from the A-pillar to 14 cm (5.5 in) rearward of the center of the C-pillar. The air bag was attached to the A-pillar by a 2 cm (0.8 in) long tether. There was a 30 cm (11.8 in) sail at the forward aspect of the air bag. The air bag measured 200 cm (78.7 in) in length and 40 cm (15.7 in) in height. An irregularly shaped abrasion that measured 5 cm (1.9 in) in width by 14 cm (5.5 in) in height was present on the outboard aspect of the air bag (**Figure 10**). The abrasion was located 9 cm (3.5 in) rearward of the sail and 8 cm (3.1 in) from the bottom of the air bag. There were no indications of damage or occupant loading to the inboard aspect of the air bag.

**Figure 9.** Side curtain air bag

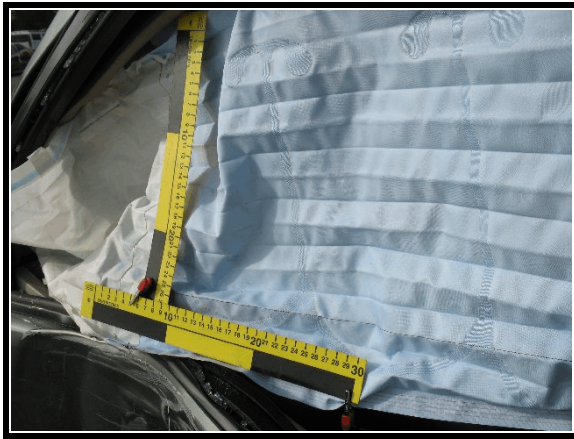
**Figure 10.** Scuff located on outboard side of left side curtain air bag

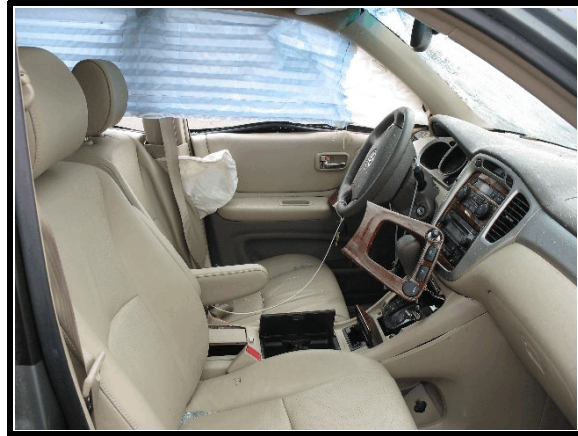
The left seat-mounted side air bag deployed from the front left seat back (**Figure 11**). The air bag was D-shaped and measured 26 cm (10.2 in) in height and extended 20 cm (7.9 in) forward. There were no indications of contact or damage.

**Figure 11.** Side curtain air bag and seat-mounted side air bag
