**NOT-IN-TRAFFIC SURVEILLANCE  
CALSPAN REMOTE BACK OVER INCIDENT INVESTIGATION**

**SCI CASE NO.: CA08035**

**VEHICLE: 1999 HONDA ODYSSEY MINIVAN**

**INCIDENT DATE: JUNE 2008**

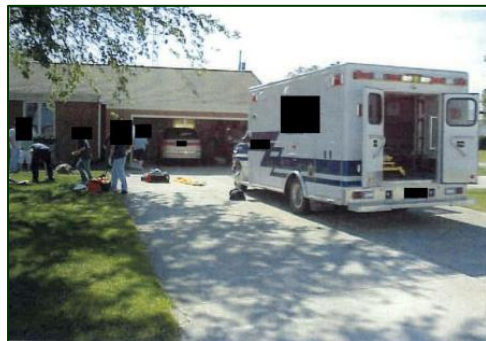
**Figure 2. Overall view of the incident site.**

estimated at 0.5-1 percent. There were no visual obstructions along the edges of the driveway or adjacent to the garage. **Figure 2** is an overall view of the incident site. A schematic of the incident scene is attached as **Figure 13**.

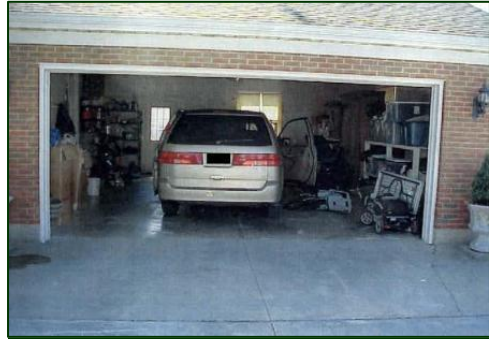
**Figure 5. Backing trajectory of the Honda Odyssey onto the driveway.**

The driver placed the automatic transmission in reverse and backed the vehicle from the garage onto the concrete driveway (**Figure 5**).

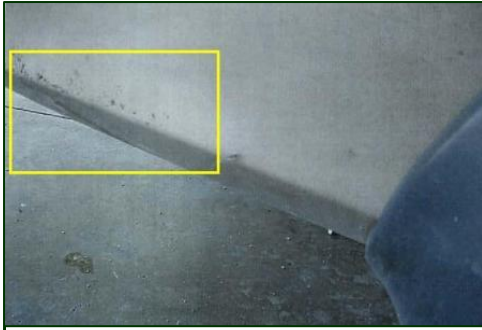
Based on the evidence noted on the PAR, the driver apparently backed the vehicle on a slight angle towards the vehicle's left as she exited the garage. The right aspect of the rear bumper fascia struck the non-motorist and knocked the child to the concrete driveway surface. The lower aspect of the right rear quarter panel aft of the wheel opening and possibly the right rear tire (**Figure 6**) contacted the non-motorist's head resulting in the reported laceration of the ear. A right rear tire mark was noted on the concrete driveway surface (**Figure 7**) that was 0.8 m (2'9") in length. Based on the police documentation of this tire mark, the driver backed approximately 7.2 m (23'6") from the parked position in the garage. Body fluid from the non-motorist was present within this tire mark. The non-motorist came to rest under the minivan with his head in close proximity to the right rear tire of the Honda.

**Figure 6. Possible police reported scuff mark on the lower rear aspect of the quarter panel.**

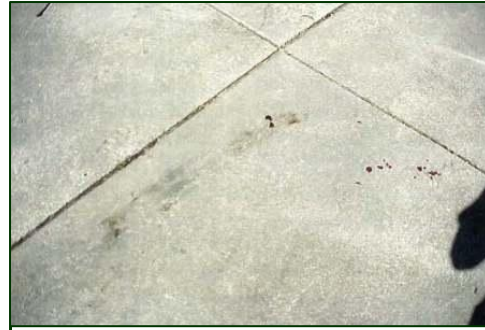
**Figure 7. Tire mark with body fluid on driveway.**

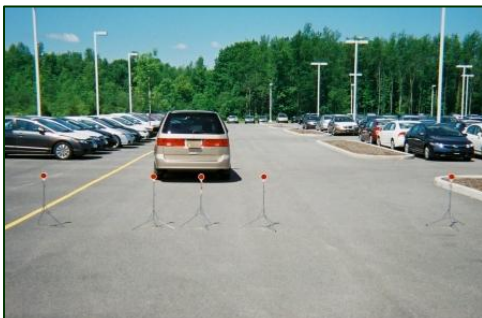
An exemplar 2001 Honda Odyssey minivan (same body style as the 1999) was located by the SCI team for this visibility study (**Figure 8**). An exemplar driver with a height of 173 cm (68") was used to identify the field of view through the mirrors and a direct line of sight through the backlight. The exemplar driver's eye height was 140 cm (55") above the paved surface of the level parking lot. A (3") diameter reflective marker was placed in a tripod stand and set to a height of 71 cm (28") above the pavement.

**Figure 8. Rear visibility of the exemplar vehicle.**

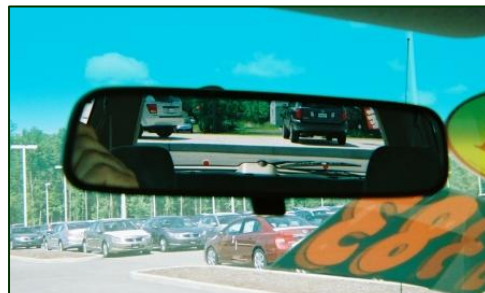
The exemplar driver was positioned in the vehicle and the mirrors were adjusted to his line of sight. The reflective marker was positioned behind the Honda Odyssey. The exemplar driver detected the full diameter of the marker 4.5 m (14'10") rearward of the bumper when looking over his right shoulder through the backlight of the minivan. The marker was fully visible to the exemplar driver at a distance of 5.6 m (18'3") when viewed through the interior rear view mirror (**Figure 9**).

**Figure 9. Reflective markers visible through the rear view mirror.**

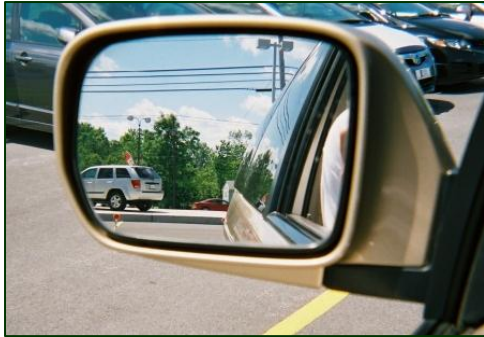
Lateral cones of visibility were established using the outside mirrors with the reflective marker positioned at the 5.6 m (18'3") distance from the back of the vehicle. The left mirror provided the exemplar driver with a cone of visibility that began 0.7 m (2'3") left of the vehicle's centerline to a point that was 2.2 m (7'4") outboard of the centerline (**Figure 10**). The right outside mirror yielded a cone of visibility that ranged from 0.9 m (3') right of the vehicle centerline to a point that extended 3.7 m (12') right of the centerline (**Figure 11**). The rear visibility diagram is attached as **Figure 12**.

**Figure 10. Left outside mirror visibility.**

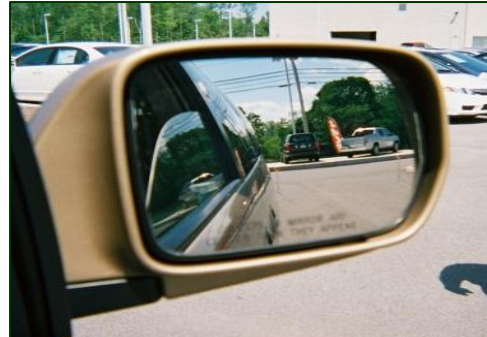
**Figure 11. Right outside mirror visibility.**
