ON-SITE ROLLOVER INVESTIGATION

CASE NUMBER - IN08036

VEHICLE - 2007 SATURN VUE

CRASH DATE - August 2008

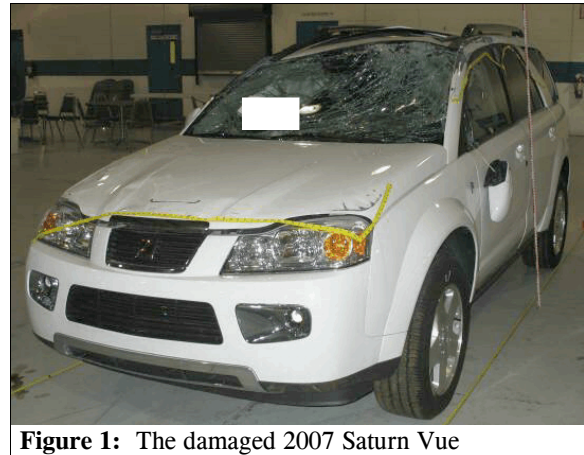
Figure 1: The damaged 2007 Saturn Vue

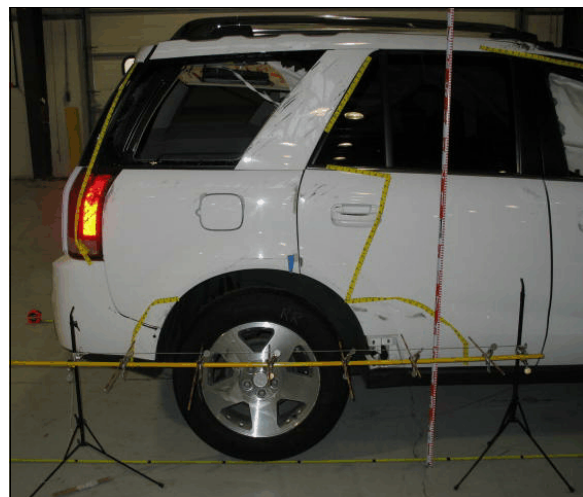
Crash: The front of the Ford impacted the right rear side of the Saturn (**Figure 4**, event 1). The impact engaged the rear portion of the right rear door as well as the right rear wheel and quarter panel. The impact caused the Saturn to rotate clockwise and as it traveled into the east leg of the intersection, it rolled over (**Figure 1**, event 2), left side leading, 4 quarter turns. The Saturn's EDR data indicated that the deployment of both side curtain rollover air bags was commanded due to the rollover event. The vehicle came to final rest on its wheels, on the sidewalk, on the south side of the roadway heading southwest (**Figure 5**). The Ford's driver did not stop and fled the scene.

Figure 4: Yellow tape on lower portion of right rear door and quarter panel shows location of impact by the front of the Ford

Exterior Damage: The Saturn's impact with the Ford involved the right rear portion of the vehicle. The right rear door, right rear wheel, and the right quarter panel were all directly damaged (**Figure 4**). The direct damage began 82 cm (32.3 in) forward of the right rear axle and extended 132 cm (52 in) rearward on the right side. The front of the Ford engaged primarily the vehicle's right rear wheel. The contact to this stiff structure resulted in a high pulse, short duration event that produced no residual crush to the side of the vehicle. There were only scuffs

on the sheet metal of the door and quarter panel, and the right rear wheel was negatively cambered approximately 10 degrees. The right side wheelbase was extended 1 cm (0.4 in), and there was no change to the left side wheelbase. Induced damage from this impact involved the back bumper fascia.

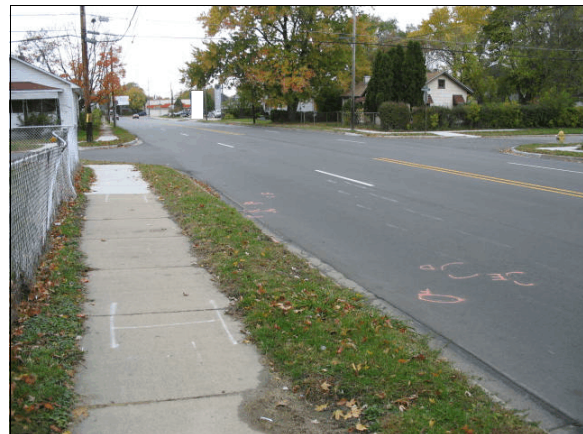
Figure 5: View northwest at Saturn's area of final rest on the sidewalk; orange marks show evidence in roadway from the rollover

In this crash, the Saturn's initial right side plane impact with the Ford induced a clockwise rotation. The vehicle rotated clockwise approximately 110 degrees across a distance of 11.7 m (38.4 ft), and the opposing force on the left side wheels continued to build as it rotated. The force on the left side wheels was sufficient to induce a roll moment and the vehicle rolled over on the roadway, left side leading, four quarter turns across a distance of approximately 11 m (36.0 ft). The vehicle came to final rest on its wheels on a side walk on the south side of the roadway.

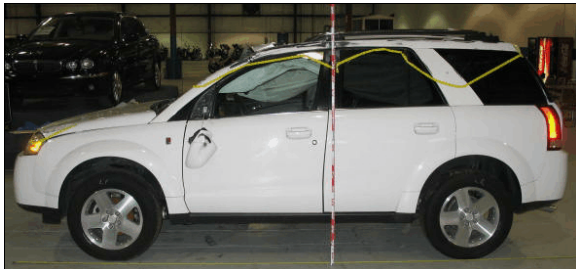
The damage from the rollover involved the vehicle's left and right side planes and the top plane (**Figures 6-10**). The left fender, left side view mirror, left roof side rail, left A, B, and C-pillars, right roof side rail, right side view mirror, right rear door, right A, C, and D-pillars, hood, windshield, roof and both luggage racks were directly damaged. The direct damage on the left side plane began 65 cm (25.6 in) rear of the left front axle and extended 241 cm (98.9 in) rearward on the left side. The direct damage on the right side plane began 72 cm (28.3 in) rear of the right rear axle and extended 293 cm (115.3 in) forward on the right side. The direct damage on the top plane began 68 cm (26.8 in) forward of the right front axle and extended 365 cm (143.7 in) rearward on the top and involved the full width of the front portion of the roof and hood. The maximum vertical crush was 7 cm (2.8 in) and occurred on the right A-pillar (**Figure 11**). There was no lateral displacement of either roof side rail or A-pillar. Induced damage involved the front bumper fascia, roof and windshield.

Figure 6: Left side of Saturn; yellow tape outlines damage from the rollover

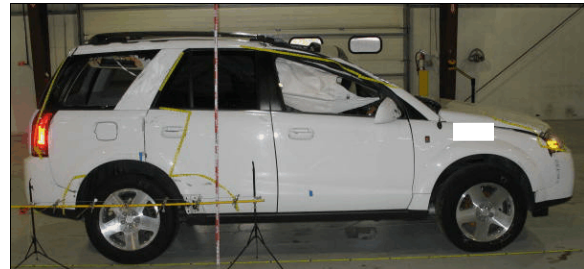
Figure 7: Yellow tape above the level of the right rear wheel outlines the damage from the rollover

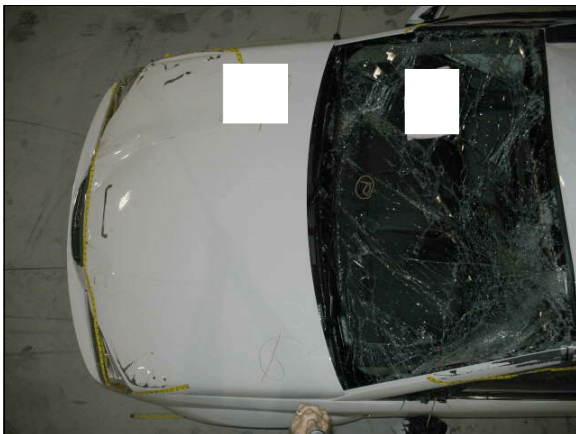
Figure 8: Damage from the rollover on the hood, windshield and A-pillars

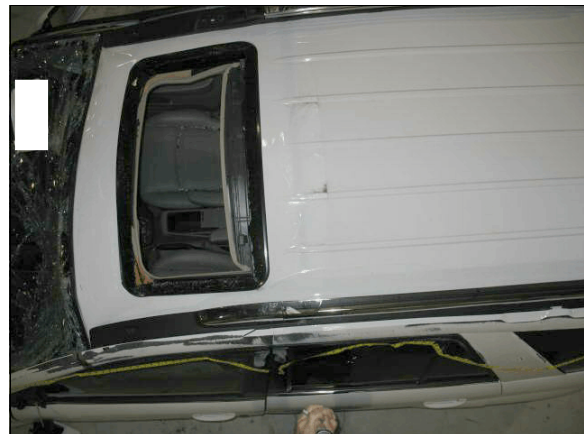
Figure 9: Damage on the roof from the rollover

Damage Classification: The Collision Deformation Classifications for the Saturn were **01-RZEW-1** (30 degrees) for the impact with the Ford (event 1) and **00-TDDO-2** for the rollover (event 2). The WinSMASH program could not be used to calculate the Saturn’s Delta V for the right side impact because the Ford was not inspected and the Saturn sustained no residual crush as a result of the impact. The severity of this impact was minor and the extent of the roof crush due to the rollover was minor.

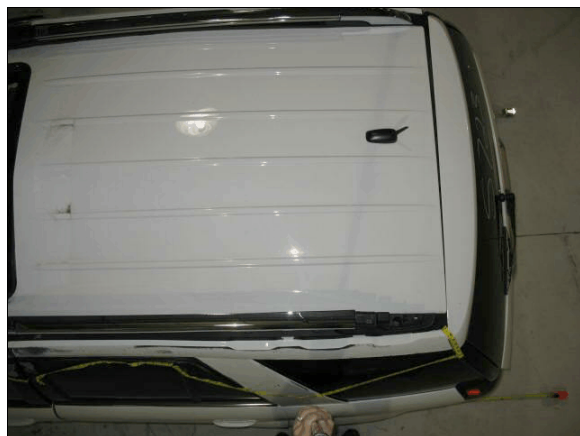
Figure 10: Damage on left roof side rail and luggage rack from the rollover

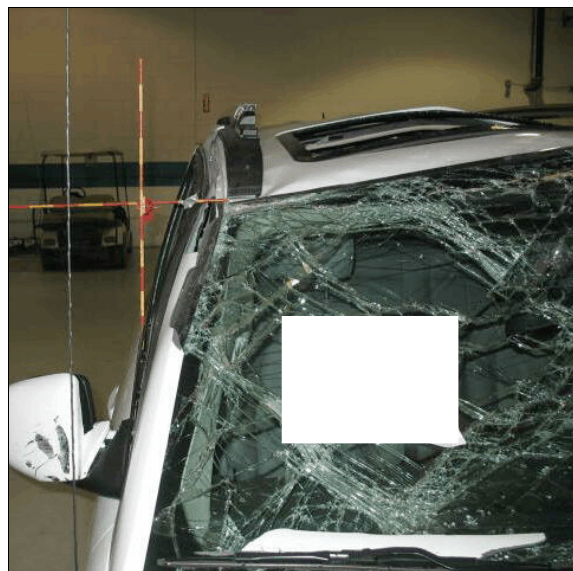
Figure 11: Crush to the right A-pillar

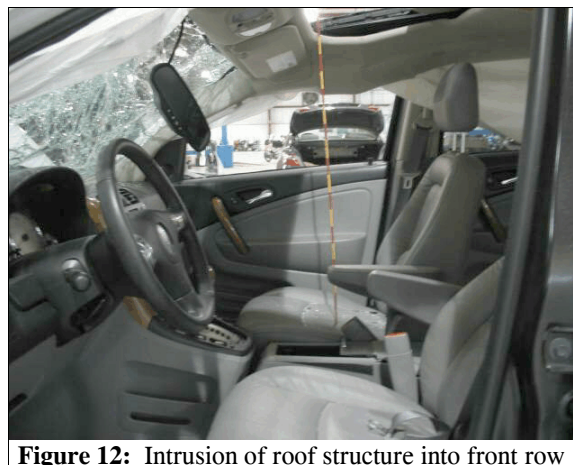
The Saturn sustained 7 intrusions into the center and right front row areas, all of which occurred on the vertical axis (**Figure 12**). The intrusions involved the roof, windshield header, windshield, right roof side rail, right A-pillar and the roof console. The most severe intrusions occurred in the front right passenger's occupant space. The right A-pillar and right roof side rail intruded 7 and 6 cm (2.8 and 2.4 in), respectively while the windshield header and roof both intruded 5 cm (2 in).

Figure 12: Intrusion of roof structure into front row

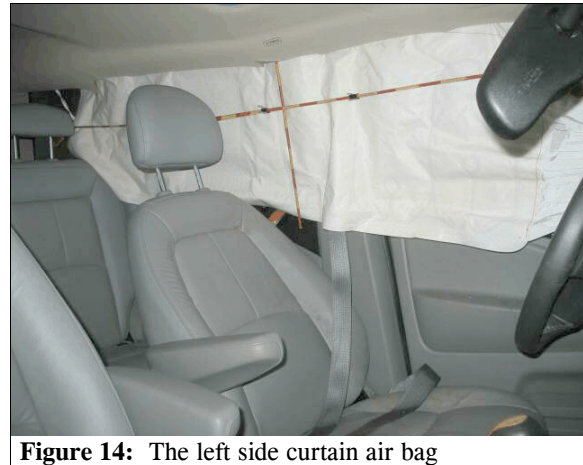
Figure 14: The left side curtain air bag

The deployed left side curtain air bag (**Figures 14**) was 171 cm (67.3 in) in width and 46 cm (18.1 in) in height. It extended 10 cm (4 in) below the belt line and was not equipped with any visible vent ports. A triangular shaped fabric, 42 cm (16.5 in) in length, tethered the side curtain air bag to the A-pillar. The side curtain air bag was also tethered to the D-pillar by a nylon rope that was 32 cm (12.6 in) long and 1 cm (0.4 in) wide. There was no damage or discernable occupant contacts located on the side curtain air bag. The right side curtain air bag was of the same dimensions and features as the left.
