On-Site Side Air Bag Investigation
Dynamic Science, Inc. (DSI), Case Number DS08036
2007 Honda Civic LX
Washington
August 2008

1. Report No. DS08036	2. Government Accession No.		3. Recipient Catalog No.	
4. Title and Subtitle On-Site Side Air Bag Investigation			5. Report Date August 6, 2009

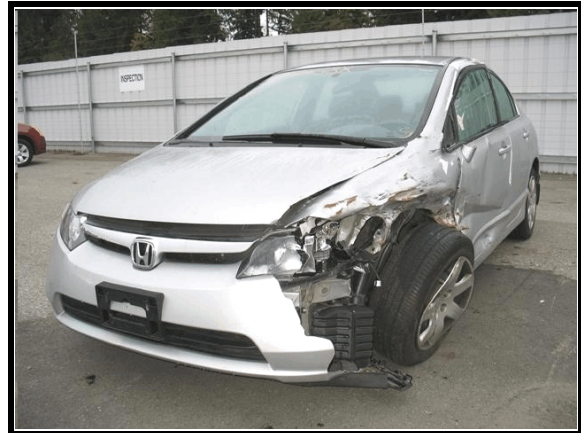
This on-site Side Air Bag Investigation focused on the air bags that deployed in a 2007 Honda Civic LX sedan (**Figure 1**) that was involved in a three-vehicle crash. The Honda was equipped with advanced, dual-stage frontal air bags, seat-mounted side air bags, and side curtain air bags. The driver's frontal air bag, seat-mounted side air bag, and side curtain air bag deployed in the crash.

Figure 1. Subject vehicle, 2007 Honda Civic LX

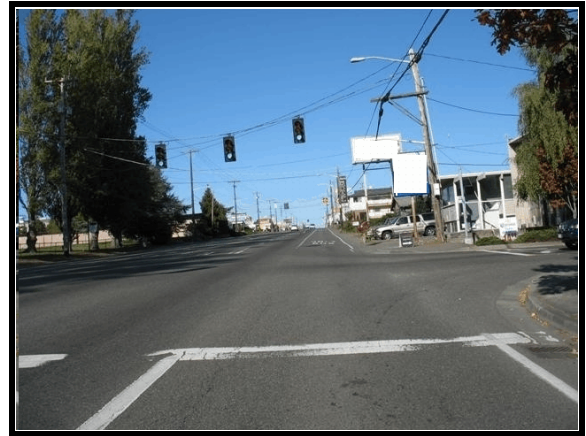
The crash occurred within the three-leg intersection of a north/south roadway and an east/west roadway (**Figure 2**). The north/south roadway was divided by a raised median. There were three

Figure 2. Northbound approach of subject vehicle to area of impact

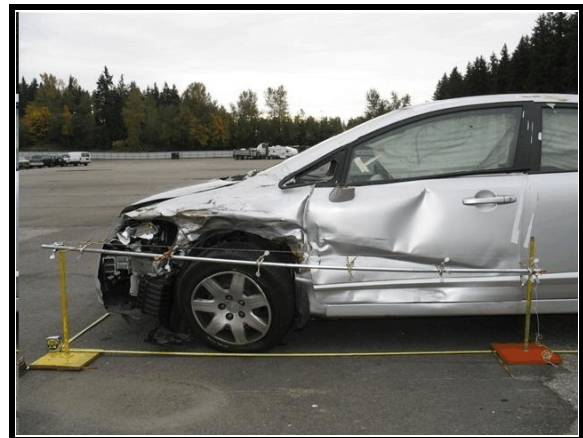
The Honda sustained moderate left side damage as a result of the impact with the Chevrolet (Event 1). The front bumper fascia was cracked and the left bumper corner was missing from the vehicle. The left front fender and door were crushed. The left front axle was bent and the tire was canted outboard approximately 10 degrees. The left side view mirror was fractured and missing, and there was direct contact to the lower A-pillar. The hood was slightly deformed and shifted to the right. The left headlamp assembly was fractured and part of it was missing. The direct damage to the left side began at the front left bumper corner, extended 225 cm (88.6 in) down the left side, and ended at the left B-pillar (**Figure 3**). Six crush measurements were taken at the mid-door level as follows: C1 = 0 cm, C2 = 6 cm (2.4 in), C3 = 7 cm (2.8 in), C4 = 7 cm (2.8 in), C5 = 14 cm (5.5 in), C6 = 11 cm (4.3 in). The maximum crush measured 14 cm (5.5 in) and was located at C5. The Collision Deformation Classification (CDC) for the first impact was 11LYAW2.

Figure 3. Left side damage

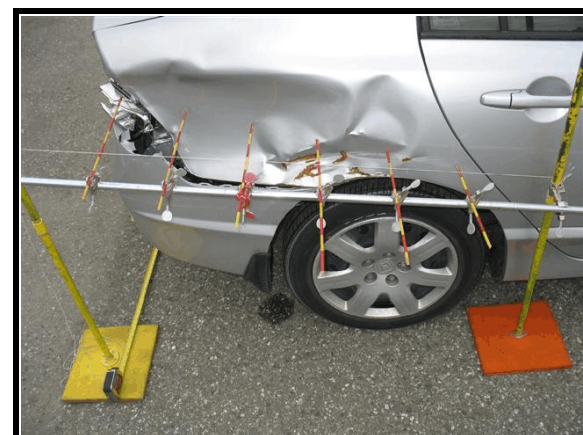
Figure 4. Right side damage

The Honda sustained minor right side damage as a result of the impact with the Dodge (Event 2). The rear quarter panel was deformed laterally and the right rear tail light was fractured. The direct damage to the right side began at the back right bumper corner and extended 97 cm (38.2 in) up the right side (**Figure 4**). Six crush measurements were taken at the mid-door level as follows: C1 = 10 cm (3.9 in), C2 = 11 cm (4.3 in), C3 = 12 cm (4.7 in), C4 = 8 cm (3.2 in), C5 = 3 cm (1.2 in), C6 = 0 cm. The maximum crush measured 14 cm (5.5 in) and was located at C3. The CDC for the second impact was 01RBEW2.

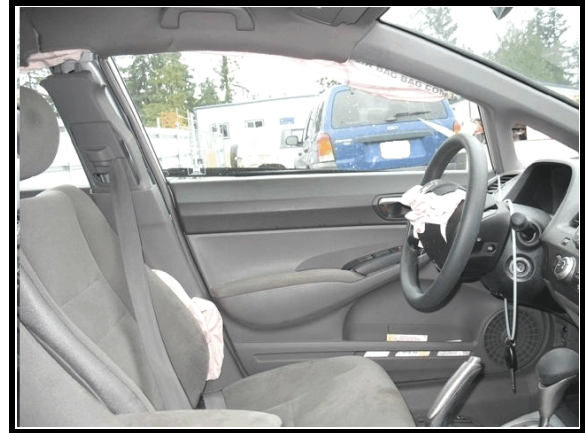
Figure 5. View showing driver compartment and left side interior

The B-pillars were configured with upper and lower interior covers. The covers on the left B-pillar came loose during the crash (**Figure 5**). The resulting gap measured 3 cm (1.2 in) and revealed the safety belt retractor mechanism and the stored length of belt within the pillar. Their displacement did not affect the deployment of the side curtain air bag, the seat mounted air bag, or the safety belt pretensioner. No suspected occupant contacts were observed on the covers, and the driver was shielded from these components by the deployed side curtain and seat mounted air bags. Other than the displacement of the covers, there was no damage observed.

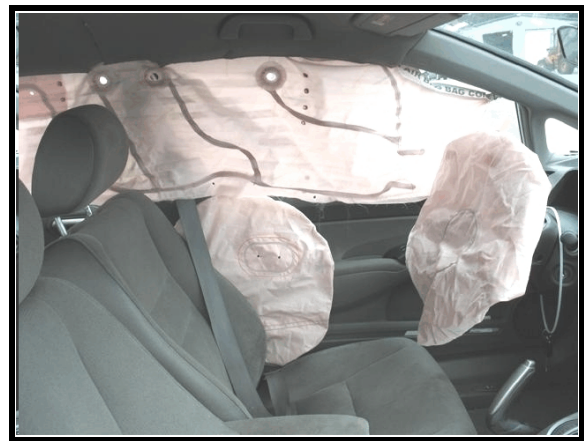
Figure 6. View showing deployed air bags

The driver's frontal air bag deployed from the steering wheel hub through one upper and two lower cover flaps (**Figure 6**). The flaps opened at their tear points and there was no damage to the flaps or to the bag. The module cover was displaced forward of its original position relative to the steering column by 2 cm (0.8 in). The frontal air bag was circular in shape and the face measured 56 cm (22 in) in diameter. There was a circular stitching pattern in the bag's front center which measured 16 cm (6.3 in) in diameter. The bag had one internal tether and two circular vent ports on the bag's upper back that were located at the 11 and 1 o'clock positions.
