On-Site 15-Passenger Van Investigation  
Dynamic Science, Inc. (DSI), Case Number DS08037  
1982 Dodge B350 Maxi Van  
Arizona  
October 2008

1. Report No. DS08037	2. Government Accession No.		3. Recipient Catalog No.	
4. Title and Subtitle On-Site 15-Passenger Van Rollover Investigation		5. Report Date September 4, 2009

14. Sponsoring Agency Code		
15. Supplemental Notes				
16. Abstract  This on-site investigation focused on a 1982 Dodge B350 15-passenger van that was involved in a rollover. The single vehicle crash occurred in October 2008 at 1430 hours. The Dodge was occupied by a male driver and 17 additional passengers. The driver and passengers were members of a church group and were returning from a church service in a nearby town. The van was traveling eastbound when the right rear tire experienced a tread separation. The driver lost control of the vehicle, traveled off the right side of the roadway, returned to the roadway and traveled off the left side of the roadway, returned to the roadway once again and initiated a left side leading rollover. The Dodge rolled two quarter turns and came to rest on its roof. Prior to the arrival of emergency personnel, all of the van'

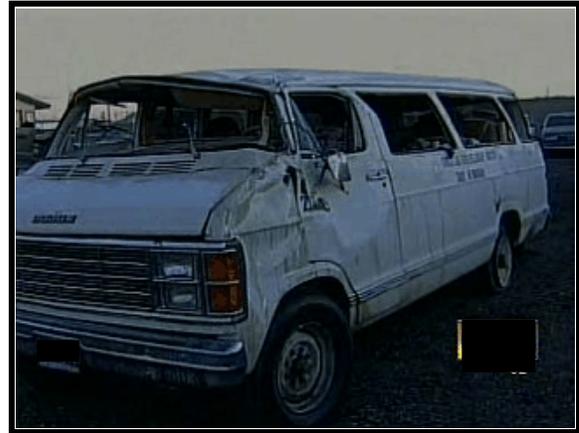
This on-site investigation focused on a 1982 Dodge B350 15-passenger van that was involved in a rollover (**Figure 1**). The single vehicle crash occurred in October 2008 at 1430 hours. The Dodge was occupied by a male driver and 17 additional passengers. The driver and passengers were members of a church group and were returning from a church service in a nearby town. The van was traveling eastbound when the right rear tire blew out. The driver lost control of the vehicle, traveled off the right side of the roadway, returned to the roadway and traveled off the left side of the roadway, returned to the roadway once again and initiated a left side leading rollover. The Dodge rolled two quarter turns and came to rest on its roof. Prior to the arrival of emergency personnel, all of the van's occupants exited the vehicle either on their own or with the assistance of other passengers. A total of six ambulances and one helicopter responded to the crash.

**Figure 1.** Subject vehicle, 1982 Dodge B350 Maxi Van

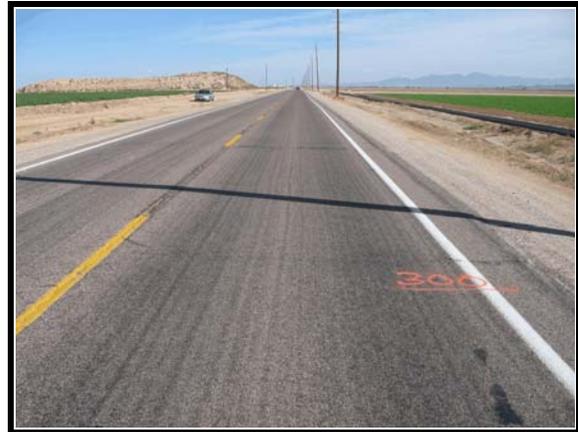
As the Dodge traveled eastbound, the right rear tire lost air and began marking the roadway (**Figure 2**). There were no indications that it contacted any foreign objects. The vehicle traveled 36.2 m (119 ft) before there was a change in the tread pattern (**Figure 3**). The marking indicated that a portion of the tread had separated from the tire at that point. The vehicle traveled a total of 83.5 m (274 ft) from the point where the tire initially began marking as the vehicle partially departed the south side of the roadway. The driver steered to the left and the vehicle returned to the roadway. The vehicle crossed the center line and the driver steered to the right. As the vehicle reentered the eastbound travel lane the driver steered back to the left. The vehicle departed the north side of the roadway and the driver steered back the right. The distance from the south side road departure to the north side departure was 101.1 m (331 ft).

**Figure 2.** Eastbound approach to area of tread separation

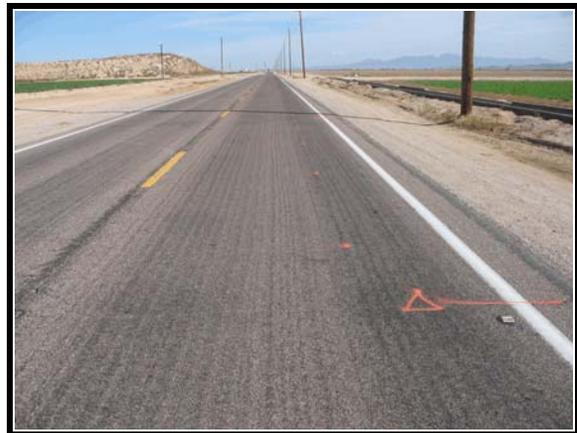
**Figure 3.** Area of tread pattern change

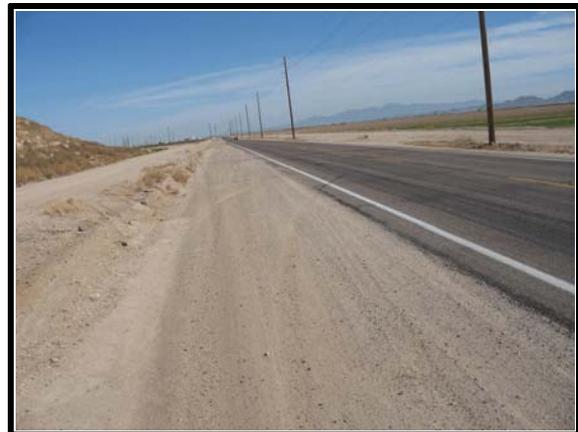
The Dodge began a clockwise rotation and traveled 21.6 m (71 ft) before the left side tires engaged the shoulder surface and road edge (**Figure 4**). The vehicle tripped and initiated a left side leading rollover. The vehicle rolled two quarter turns and came to rest on its roof facing southeast (**Figure 5**). The total distance from the point where the right rear tire began marking to final rest measured 234.3 m (769 ft).

**Figure 4.** North side road departure and rollover

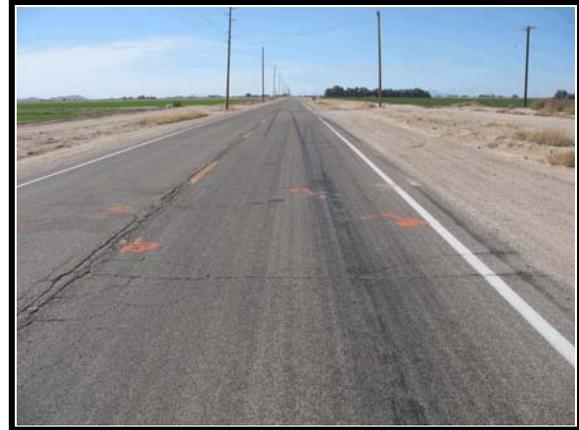
**Figure 5.** Look back view from final rest (west)

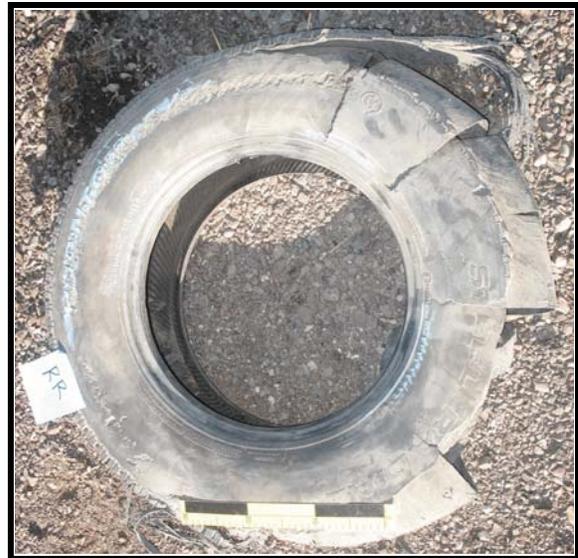
**Figure 6.** Right rear tire (outboard aspect)

Phantom A/T 9.50R16.5 tire<sup>1</sup> with a maximum pressure of 448 kPa (65 psi). The tire was made for Discount Tires but has been discontinued. The Tire Identification Number (TIN) for the tire was BFXL AEDD 3100, indicating that it was manufactured during the 31<sup>st</sup> week of 2000. The tire was located in the rear seat of the vehicle and was badly damaged. Approximately 92 cm (36.2 in) of the tread had separated and was missing. The tire specifications indicated a circumference of 233 cm (91.7 in), so the missing section represented approximately 39% of the total tread. On the outboard aspect of the tire, within the area of the missing tread, there were four 22 cm (8.7 in) long tears that ran from the tread to the rim (**Figure 6**). On the inboard aspect of the tire, there was chunking and abrading along the entire sidewall (**Figure 7**). The shoulder of the tread was damaged along the entire circumference. There were at least 16 tears from tread to bead. The interior surface of the tire was examined and there no indications of punctures or tears other than those related to the tread separation and air-out. All the tires were mounted on steel rims. The valve stems for each tire were examined and there were no indications of damage. The driver reported that the front tires had been recently replaced, but the rears were not. He did not know when the rear tires had last been replaced. The driver's door was jammed so the tire label was not visible. According to a 1982 Dodge B350 shop manual, the vehicle manufacturer's recommended tire pressure was 552 kPa (80 psi).

<b>Position</b>	<b>Measured Pressure</b>	<b>Measured Tread Depth</b>	<b>Restricted</b>	<b>Damage</b>
LF	310 kPa (45 psi)	10 mm (12/32 in)	No	None
LR	Tire flat	9 mm (11/32 in)	No	Debeaded.
RR	Tire flat	9 mm (11/32 in)	No	Debeaded, cut, abraded.
RF	345 kPa (50 psi)	10 mm (12/32 in)	No	None

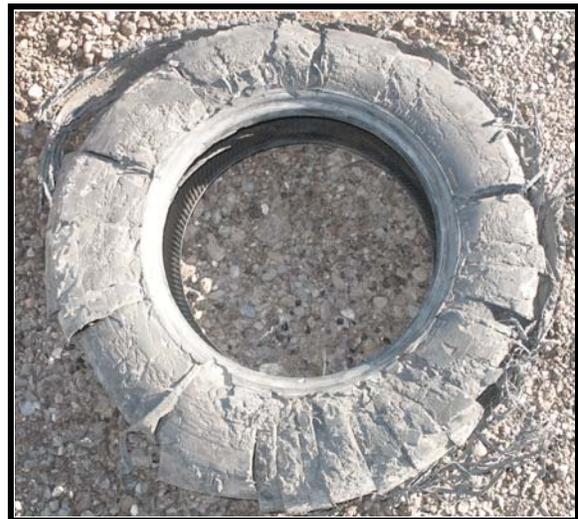
**Figure 7.** Right rear tire (inboard aspect)

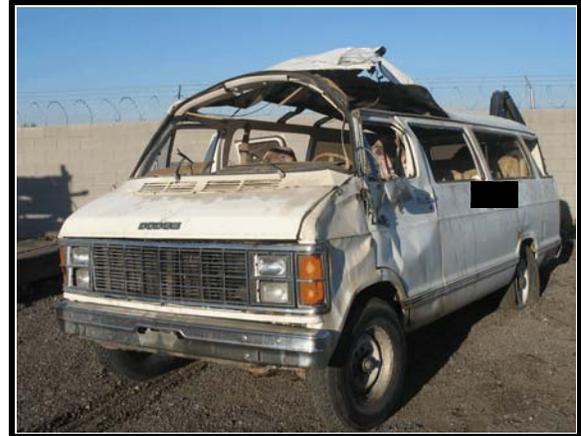
The Dodge van sustained moderate left side and roof damage due to the rollover (**Figure 8**). The direct damage began along the top of the windshield and extended rearward along the entire roof. The damage width measured 150 cm (59) laterally. The maximum crush sustained during the rollover was measured at the left B-pillar and measured 10 cm (3.9 in) laterally and 9 cm (3.5 in) vertically. The Collision Deformation Classification (CDC) for the rollover was 00TZDO2.

**Figure 8.** Rollover damage, subject vehicle

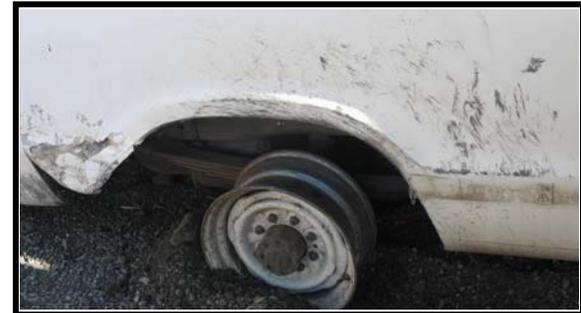
**Figure 9.** Tire-related right rear damage

The Dodge also sustained damage as a result of the tire blowout (**Figure 9**). There was 156 cm (61.4 in) of direct contact to the rear fender area that began 63 cm (24.8 in) rearward of the right rear axle. The wheel well was bowed outward 9 cm (3.5 in). At the top of the wheel well there were tears in the metal that measured 40 cm (15.7 in) long by 29 cm (11.4 in) wide. The interior of the vehicle was visible through the tears. The damage was located to the right of row 4 (**Figure 10**).

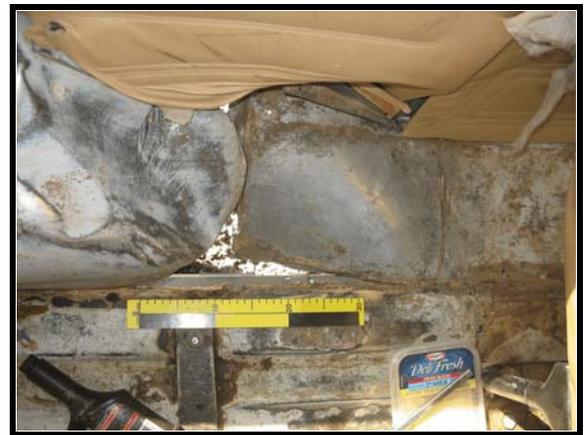
**Figure 10.** Torn area of wheel well (right of row 4)

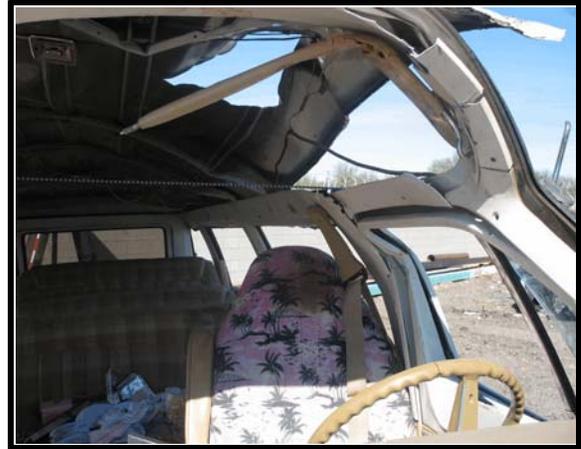
The Dodge van sustained moderate interior damage as a result of passenger compartment intrusion. The left roof side rail, window frame, B-pillar and left door sustained lateral intrusion (**Figure 11**). There was vertical intrusion to the left B-pillar and left side rail. There was probably roof intrusion, but damage was masked by the post-crash deformation of the roof (forklift).

**Figure 11.** Left side intrusion
