**CALSPAN ON-SITE ALTERNATIVE FUEL VEHICLE CRASH INVESTIGATION**

**SCI CASE NUMBER: CA08038**

**VEHICLE: 2007 TOYOTA PRIUS**

**CRASH DATE: JULY 2008**

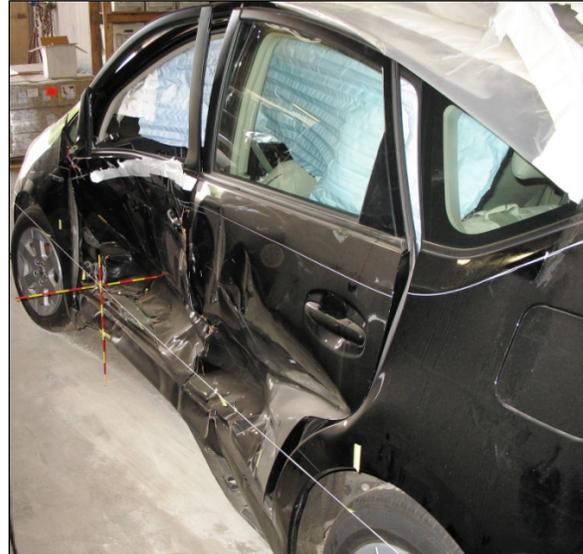
The Toyota sustained moderate left side damage from the collision. Damage on this plane included all components from the roof to the wheels forward of the aft edge of the rear passenger door.

Both the driver and rear passenger doors had damage to the exterior skins consisting of abrasions and lateral crush. The left front door was jammed closed and was not operational as a result of the crash. The left rear door was also jammed shut, and although the latch remained operational, door sill deformation prevented its opening. The B-pillar was deformed and displaced right laterally. The windshield was cracked on its left aspect, and the left front glazing was disintegrated.

**Figure 5:** Damage plane of the Toyota.

The direct damage began 62 cm (24.5 in) forward of the left rear axle and extended 175 cm (69 in) forward. The direct and induced damage (Field L) began 15 cm (6 in) forward of the left rear axle and extended 272 cm (107 in) forward. The accompanying crush profile was measured at six equidistant points at the lower door level with the following results: C1 = 0 cm (0 in), C2 = 13 cm (5 in), C3 = 19 cm (7.5 in), C4 = 32 cm (12.5 in), C5 = 10 cm (4 in), C6 = 0 cm (0 in). Maximum crush was 37 cm (14.5 in), located 198 cm (78 in) forward of the left rear axle. The Door/Sill Differential (DSD) measured 23 cm (9 in), located 191 cm (75 in) forward of the left rear axle. The Collision Deformation Classification (CDC) for this damage pattern was 09LPEW3.

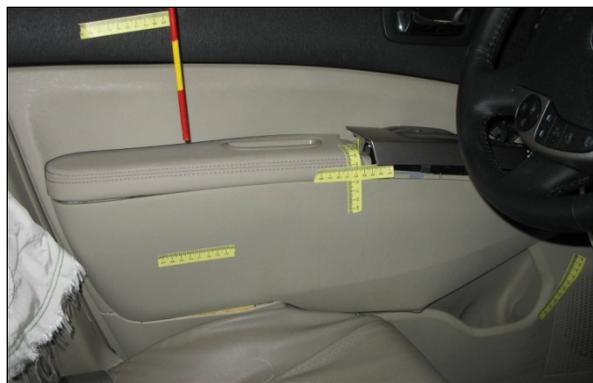
Interior intrusion associated with the crash was limited to the left side of the passenger compartment. The left front and left rear door panels were intruded laterally and engaged against the outboard sides of the seat cushions of the corresponding seating positions. The left front polymer door panel was also buckled, with isolated stress loading discoloration. This is depicted in **Figure 6** (note the engagement of the door against the seat).

**Figure 6:** Interior intrusions of the left front door.

The B-pillar was intruded laterally and in contact with the side of the seatback at the front left occupant position. The left rear polymer door panel had buckled in the middle and yielded along the crease surrounding the door-mounted speaker. No direct occupant contact was found. Measurements of interior left side intrusions were as follows:

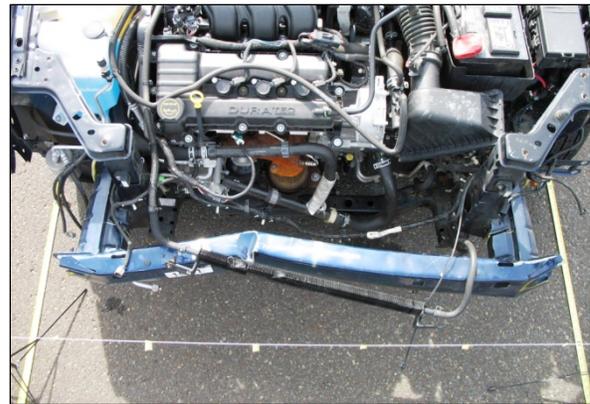
The Mercury sustained minor severity frontal damage from the collision. At the time of the SCI inspection, the front bumper fascia, grille, hood, left fender, headlight assemblies, radiator, and other components had been removed as the vehicle was already in the process of repaired. Therefore, exact damage sustained by the Mercury from the frontal was unknown and a direct contact length could not be obtained.

**Figure 7:** Damage plane of the Mercury.

The induced damage extended the full width of the bumper beam and measured 133 cm (52 in) in width (**Figure 7**). The crush profile was as follows: C1 = 7 cm (3 in), C2 = 9 cm (3.5 in), C3 = 17 cm (7 cm), C4 = 22 cm (9 in), C5 = 12 cm (5 in) and C6 = 7 cm (3 in). Maximum crush was 22 cm (9 in), located at C4. The CDC associated with this damage pattern was 12FDEW1.

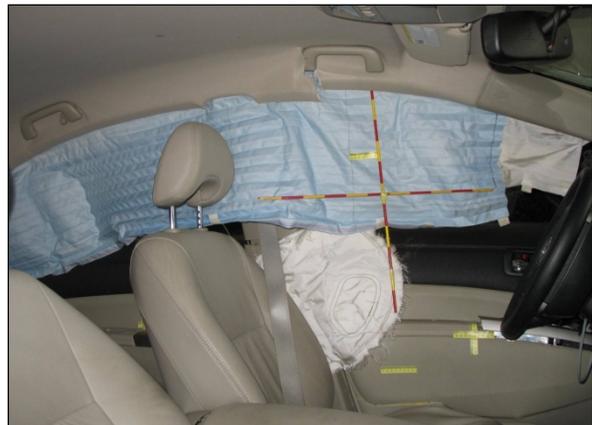
The Toyota was equipped with a side impact air bag system that consisted of seatback-mounted and IC air bags. The IC air bag was stowed along the length of the roof side rail in an accordion fold, and it had deployed downward through the edge of the headliner. Forces from the collision triggered the deployment of this side air bag system on the left side, as depicted in **Figure 8**.

**Figure 8:** Side impact air bag system deployed on the left side of the Toyota.

The left IC air bag was rectangular in shape and measured 38 cm (15 in) tall by 155 cm (61 in) long. This bag was available for the front left and rear left seating positions. There was no rear tether. The forward aspect of the air bag was attached to a trapezoidal-shaped sail panel that was 22 cm (8.5 in) tall and 19 cm (7.5 in) wide and covered the forward aspect of the front left seating position at the A-pillar. There was no direct occupant contact evidence found on the IC air bag.

The seatback-mounted side impact air bag was half-oval in shape. It was 29 cm (11.5 in) wide by 38 cm (15 in) tall. It had deployed during the crash sequence through a 27 cm (10.5 in) split in the stitching on the outboard seam edge of the seatback, at thoracic to lumbar level. No direct occupant contact evidence was found on the seatback-mounted air bag.

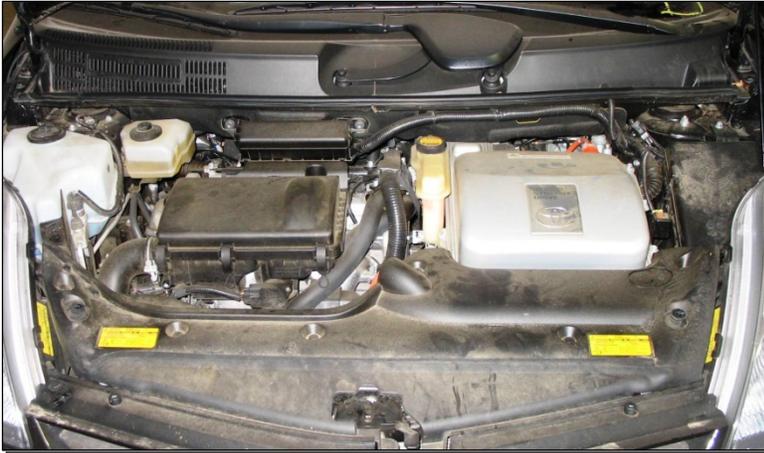
The Toyota was visually inspected for compliance with FMVSS No. 305. The left side impact damage did not involve the area of the propulsion battery. There was no intrusion into the battery compartment, nor was there any damage to the battery or battery cover. No leakage was detected during the SCI vehicle inspection. The battery propulsion system components were not displaced or damaged by this impact event.

A view of the powertrain in the engine compartment of the Toyota is depicted in **Figure 9**. The battery cell is depicted in **Figure 10**. The integrity of this alternative fuel powertrain was not compromised by the crash.

**Figure 9:** Alternative fuel powertrain of the Toyota.

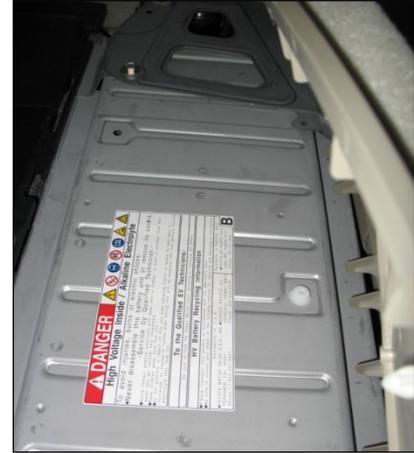
**Figure 10:** Battery cell of the Toyota's hybrid system.
