ON-SITE SIDE IMPACT INFLATABLE OCCUPANT PROTECTION INVESTIGATION

CASE NUMBER - IN08043
LOCATION - TEXAS
VEHICLE - 2003 HONDA ACCORD EX
CRASH DATE - September 2008

Technical Report Documentation Page

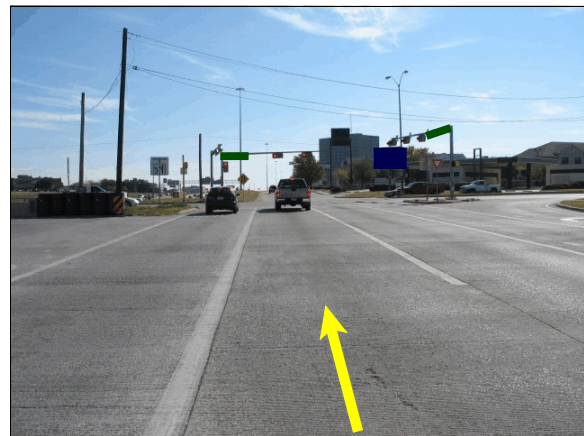
Crash Environment: The trafficway on which the Honda was traveling was a 6-lane, undivided, one-way service road of an Interstate highway, traversing in a southeasterly direction, and the Honda was approaching a 4-leg intersection (**Figure 1**). On the northwest leg of the intersection, the southeastbound roadway had 3 through lanes, one channelized right turn lane, a left turn lane, and a channelized U-turn lane. The trafficway on which the Chevrolet was traveling was a 7-lane, divided, city street, traversing in a north-northeasterly and south-southwesterly direction, and the Chevrolet was approaching the same 4-leg intersection (**Figure 2**). On the northern leg of the intersection, both the roadways had 3 through lanes while the southern leg had one left-hand turn lane.

Figure 1: Honda's southeast travel path in inside through lane

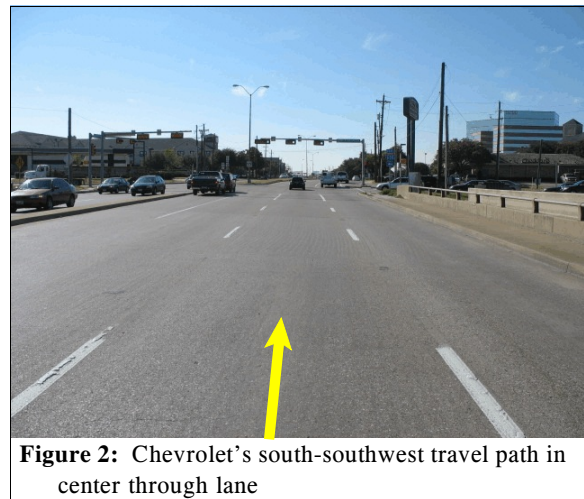
Figure 2: Chevrolet's south-southwest travel path in center through lane

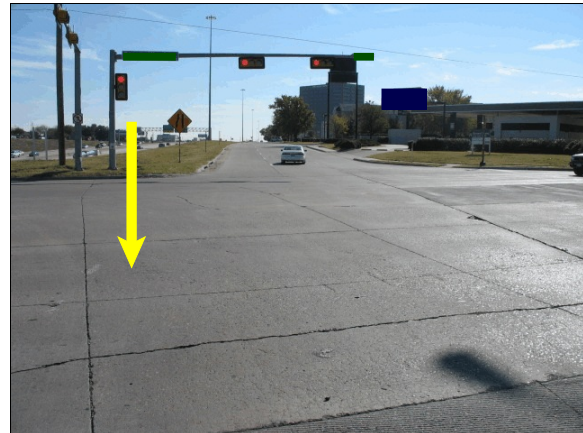
Pre-Crash: The Honda was traveling southeast in the inside through lane and the driver intended to proceed straight through the intersection (**Figures 1 and 3**). The Chevrolet was traveling south-southwest in the center through lane and the driver intended to continue straight through the intersection (**Figures 2 and 4**). It is unknown if the Honda's driver made any avoidance maneuvers prior to the crash. The crash occurred in the 4-leg intersection of the 2 trafficways (**Figures 3, 4, and 5**).

Figure 3: Honda's southeast travel path into impact with Chevrolet; arrow indicates approximate collision location

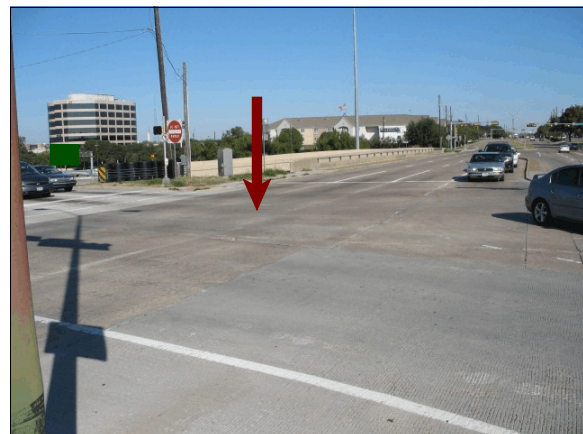
Figure 4: North view of impact location (arrow) between Honda and Chevrolet

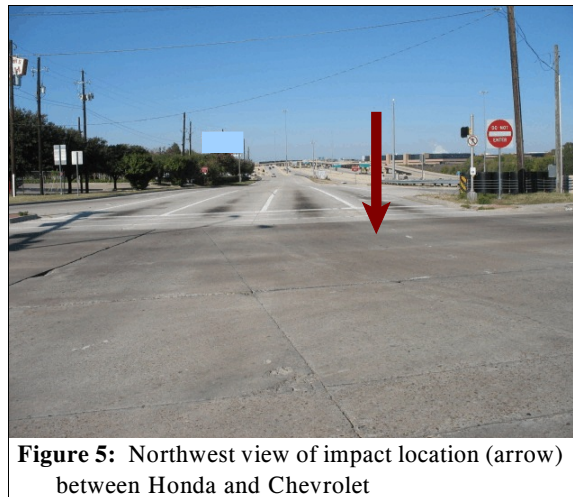
Figure 5: Northwest view of impact location (arrow) between Honda and Chevrolet

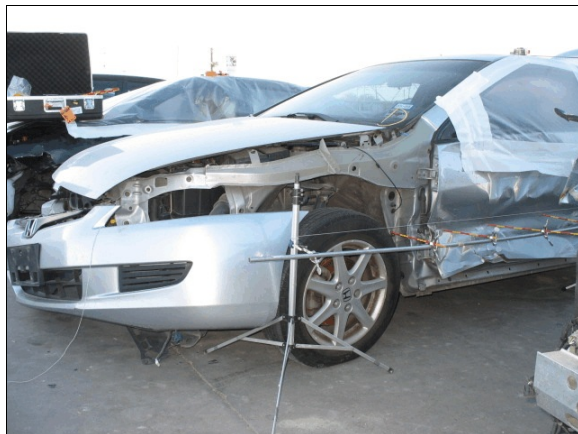
Exterior Damage: The Honda's contact with the Chevrolet involved the left side with the damage distributed on approximately the center portion (**Figures 6 and 7**). Direct damage began 63.0 cm (24.8 in) in front of the left rear axle (**Figure 8**) and extended 178 cm (70.1 in) forward along the left side. Residual maximum crush was measured as 15 cm (5.9 in) at C₄ (**Figure 9**). The table below shows the case vehicle's crush profile.

Figure 6: Honda's left side crush from impact by Chevrolet; C₆ was located just behind left front wheel assembly

The wheelbase on the Honda's left side was extended 1 cm (0.4 in) while the right side was also extended 1 cm (0.4 in). The Honda's left fender, left door, left exterior rearview mirror, and left quarter panel were directly damaged and crushed inward. There was induced damage to the front bumper fascia (Figures 6 and 10), left head-

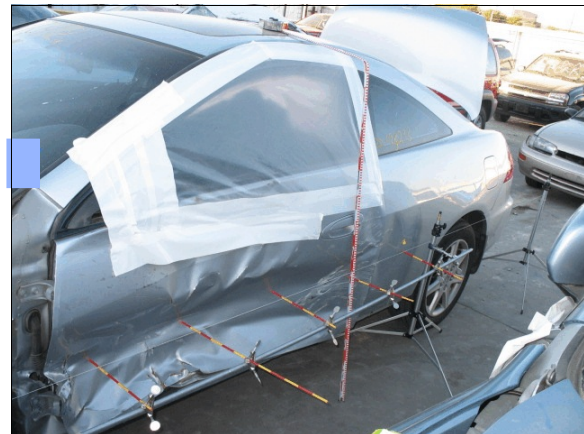
Figure 7: Elevated view from front of Honda's left side crush showing C₁ through C₅

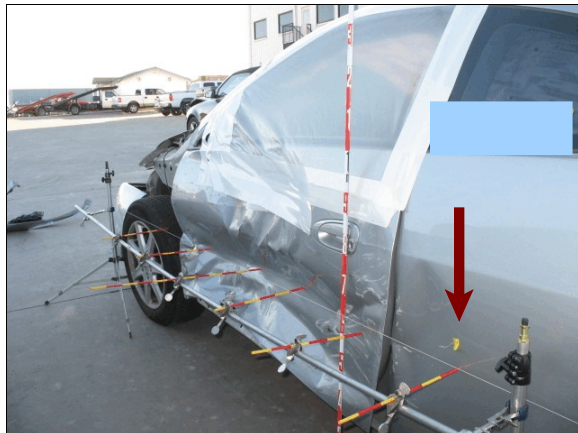
Figure 8: Honda's left side crush viewed from rear; arrow points to yellow dot representing C₁, indicating beginning of Field L

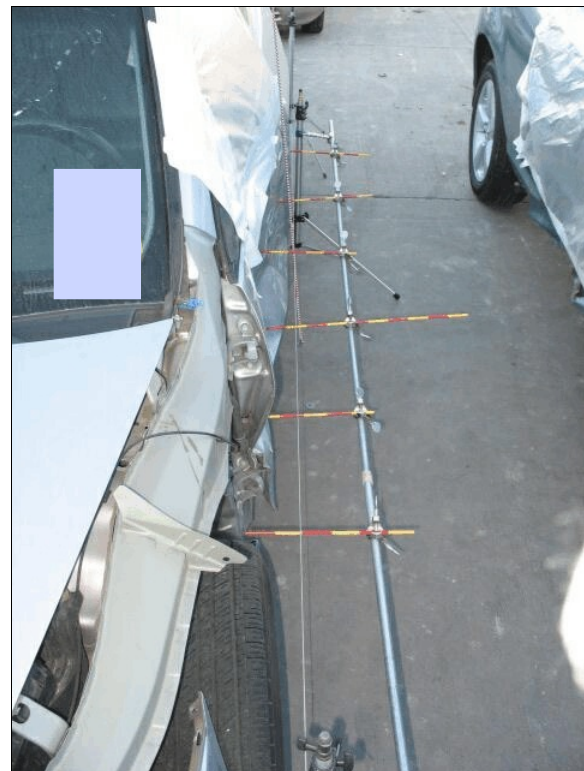
Figure 9: Elevated view of Honda's crush profile; C₆ was located just behind left front tire; maximum crush occurred at C₄

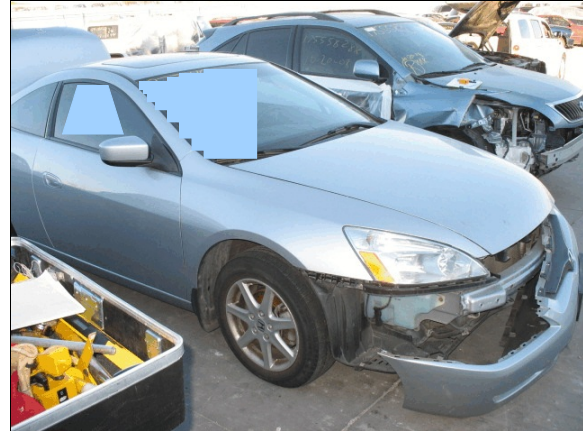
light and turn signal assemblies, and the left door's glazing. No obvious induced damage or remote buckling was noted to the remainder of the Honda's exterior.

Figure 10: Induced damage to Honda's front bumper fascia from left side impact by Chevrolet

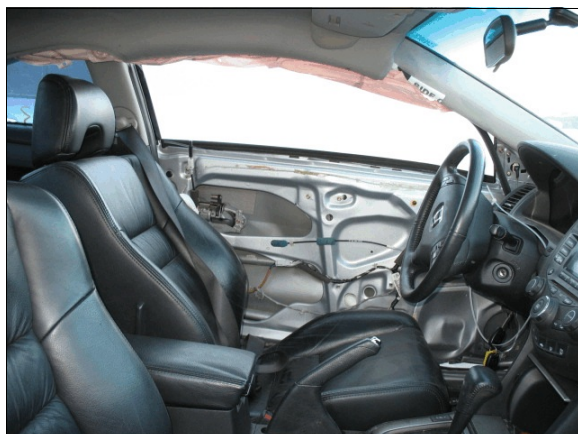
Figure 11: Honda's front seating area showing removed interior surface of driver's door and undeformed steering wheel rim

Interior Damage: Inspection of the Honda’s interior revealed that the interior surface of the driver’s door had been removed prior to this contractor’s inspection (**Figure 11**). As a result, there was no direct evidence of occupant contact on this interior surface of the vehicle. The driver’s door was jammed shut as a result of the crash, and there was evidence of lateral intrusion to the upper [i.e., 6 cm (2.4 in)] and lower [7 cm (2.8 in)] portions of the driver’s door. There was no evidence of compression to the energy absorbing shear capsules in the steering column, and no deformation to the steering wheel rim (**Figure 12**).

The Honda's left IC air bag was housed within the left roof side rail (**Figure 11**). The IC air bag extended along the front and second seat rows. It was designed to provide protection for an occupant's head during a side impact. The IC air bag was anchored to the left A-pillar and left C-pillar. There was no tether cord at either the front or back of the air bag. The whole left IC air bag was designed with a length of 140 cm (55.1 in) but the inflatable chamber was 115 cm (45.3 in) in length, and the air bag's height was 30 cm (11.8 in). The air bag was designed with irregularly shaped inflatable chambers adjacent to the driver and second row left seat positions (**Figures 16 and 17**). The IC was designed without any tethers or vent ports; however, there were three areas of circular stitching that are designed to enable the air bag to maintain its designed shape. Inspection of the IC revealed no evidence of damage due to deployment on either the outboard or inboard surfaces. An inspection of the IC's fabric revealed no contact evidence on the interior surfaces of the fabric.

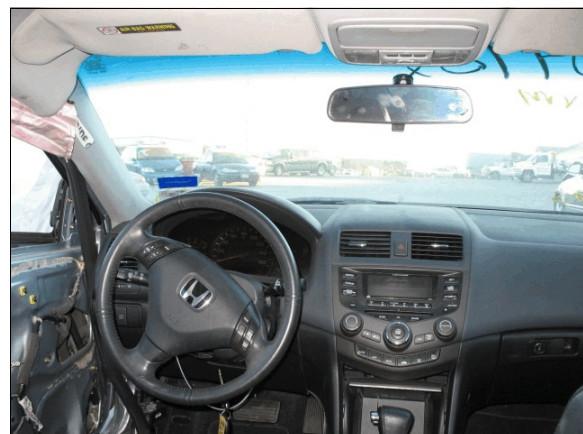
Figure 12: Honda's driver seating area showing no apparent occupant contact evidence or loading on steering wheel

The Honda was equipped with AOPS features that consisted of dual stage frontal air bags at the driver and front right passenger positions. The Honda’s driver air bag was located in the steering wheel hub (**Figure 12**) and the front right passenger’s air bag was located in the top of the instrument panel. Neither of these air bags deployed in this side impact crash.

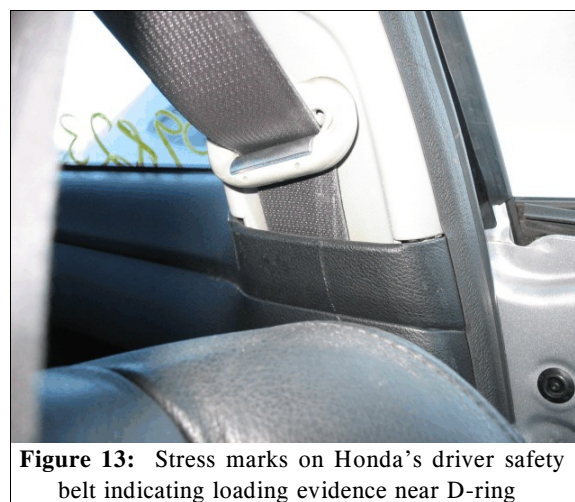
The driver’s seat belt exhibited indications of historical usage. The driver was the only occupant in the vehicle. The inspection of the driver’s safety belt webbing, D-ring, and latch plate revealed that the safety belt would not retract because the pretensioner actuated. Stress marks were present on the safety belt near the D-ring (**Figure 13**) indicating loading evidence.

Figure 13: Stress marks on Honda’s driver safety belt indicating loading evidence near D-ring

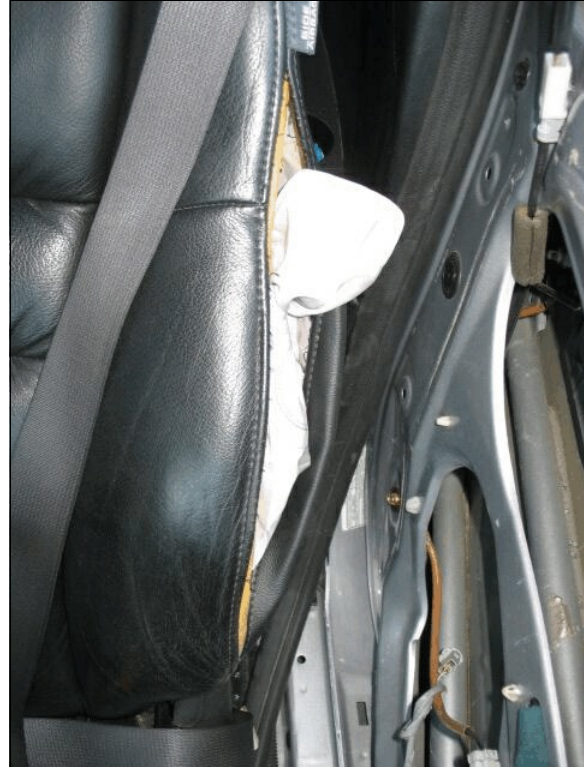
The case vehicle's driver and right front side impact inflatable occupant protection systems (air bags) were located near the middle of the driver's and front right passenger's seat backs, respectively. The bags were attached on the outboard surface of the seat back and deployed through a seam (**Figure 14**). An inspection of the driver side impact air bag module's deployment area and the air bag's fabric revealed that the module opened along the seam at the designated tear points, and there appeared to be scuff on the front inboard surface near the 3 o'clock position—when viewed from the inboard side of the vehicle, that probably occurred during the deployment of the air bag (**Figure 15**). The driver's side air bag was designed without any tethers or vent ports; although, there was a circular stitched area near the center of the air bag that was designed to act like a tether (i.e., the stitching help the air bag maintained its designed shape). The deployed side impact air bag was elliptical with a height of approximately 34 cm (13.4 in) and a width (i.e., forward excursion) of approximately 22 cm (8.7 in). An inspection of the driver's air bag fabric revealed no contact evidence on either the outboard or inboard surfaces of the driver side air bag's fabric.

Figure 14: Honda's driver side seat back-mounted side impact air bag positioned on outboard side of driver's seat

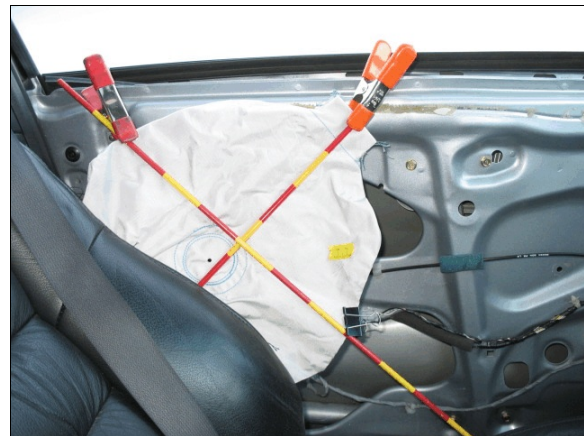
Figure 15: Inboard surface of Honda's deployed driver side air bag showing center circular stitching and deployment scuff toward front of bag

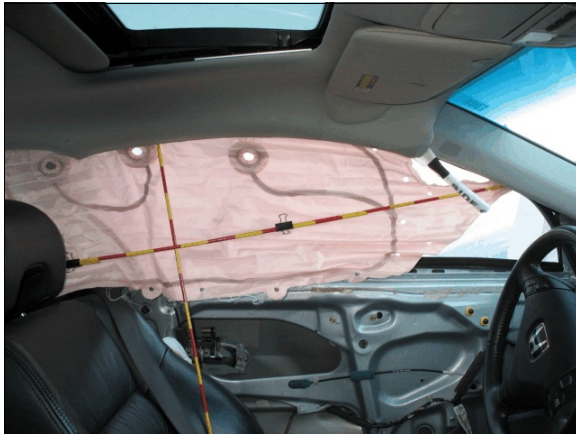
Figure 16: Front portion of Honda's deployed left IC air bag

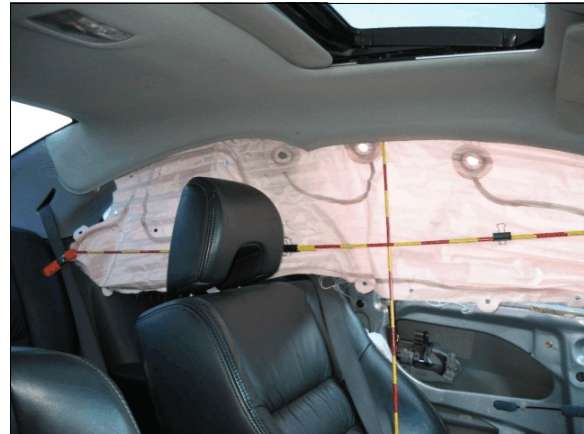
Figure 17: Rear and middle portions of Honda's deployed left IC air bag
