ON-SITE ROLLOVER INVESTIGATION

CASE NUMBER - IN08045

VEHICLE - 2008 FORD ESCAPE XLT

CRASH DATE - September 2008

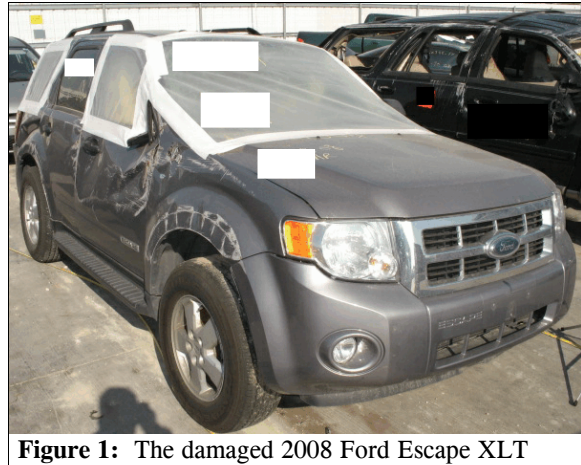
Figure 1: The damaged 2008 Ford Escape XLT

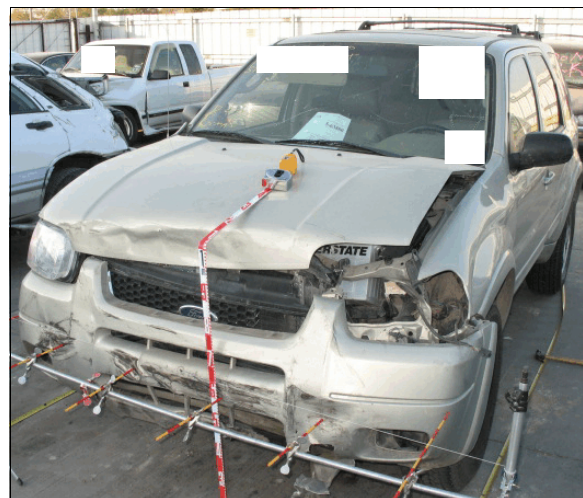
Figure 4: Damage to front of 2003 Ford from impact with the left side plane and left rear wheel of the 2008 Ford

Exterior Damage: The 2003 Ford's impact with the 2008 Ford involved the entire front plane. The direct damage involved the front bumper, grille, hood, and the left headlamp/turn lamp assembly. The direct damage began at the right front bumper corner and extended 156 cm (61.4 in) across the bumper. The maximum residual crush was 18 cm (7.1 in) occurring at C₁. The left and right side wheelbase were reduced 1 cm (0.4 in) and the induced damage involved the hood and left fender. The table below shows the vehicle's front crush profile.

The 2003 Ford's CDC for the front impact with the left side plane of the 2008 Ford was **01-FDEW-01 (30 degrees)**. The Damage algorithm of the WinSMASH program calculated the vehicle's total Delta V as 11 km/h (6.8 mph). The longitudinal and lateral velocity changes were -10 km/h (-6.2 mph) and -6 km/h (-3.7 mph), respectively. The results of the WinSMASH program appeared reasonable.

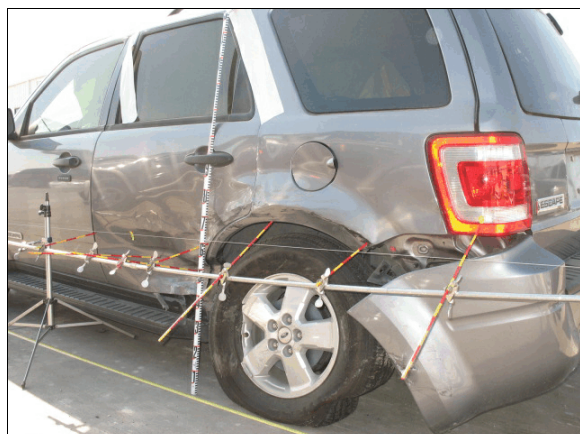
Figure 5: Damage to the left rear side of 2008 Ford from impact with the front of the 2003 Ford

Exterior Damage: The 2008 Ford's impact with the 2003 Ford involved the rear portion of the left side plane. The left rear door, left quarter panel, left rear wheel, and rear bumper cover were directly contacted (**Figure 5**). The direct damage started 174 cm (68.5 in) rear of the left front axle and extended 154 cm (60.6 in) rearward on the left rear door and quarter panel. The crush measurements were taken at the lower door level and the residual maximum crush was 17 cm (6.7 in) occurring 20 cm (7.9 in) rear of C₅. The height of the vehicle's sill was 31 cm (12.2 in) and height of the maximum crush was 50 cm (19.7 in). The door sill differential was 11 cm (4.3 in). The table below shows the vehicle's left side crush profile.

Damage Classification: The 2008 Ford's Collision Deformation Classifications (CDC) were **10-LZEW-2 (300 degrees)** for the left side plane impact with the front of the 2003 Ford, and **00-RDAO-2** for the rollover. The Damage algorithm of the WinSMASH program calculated the vehicle's total Delta V for the side impact as 10 km/h (6.2 mph). The longitudinal and lateral velocity changes were -5 km/h (-3.1 mph) and 9 km/h (5.6 mph), respectively. The results of the WinSMASH program appeared reasonable. The severity of the rollover damage was based on the extent of damage to the vehicle's right side.

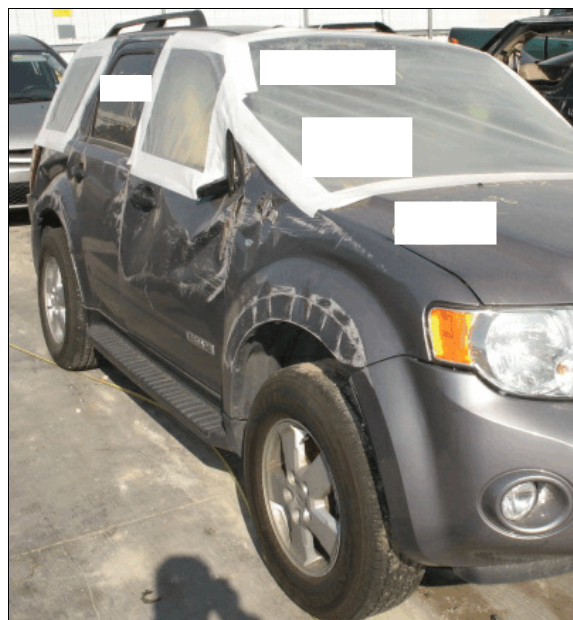
Figure 6: Damage to the 2008 Ford's right side plane from the rollover

The rollover involved the right side plane, with the direct damage involving the vehicle's entire right side (**Figure 6**). The extent of the damage was primarily scratching, denting and abrading of the sheet metal. There was no lateral crush to vehicle's roof structure. The right side wheelbase was unchanged and the left side wheelbase was extended 1 cm. (0.4 in.). Induced damage involved the windshield, left rear door, left quarter panel, and rear bumper cover.

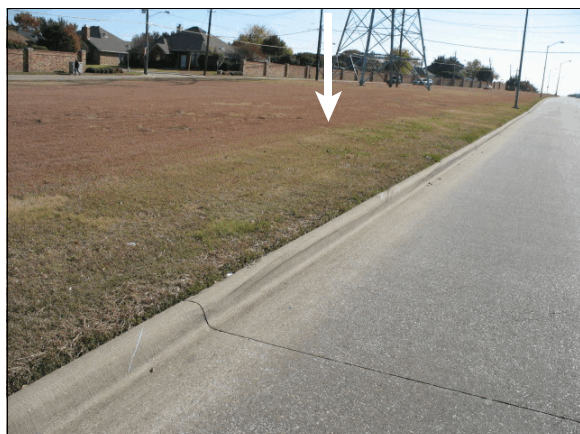
Figure 7: Tire marks on median curb; arrow shows estimated area of 2008 Ford's final rest position

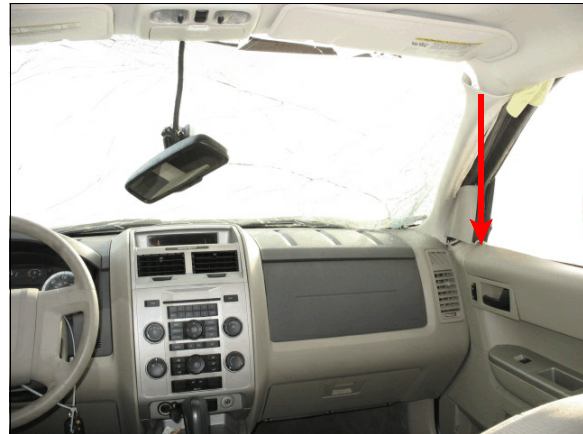
windshield intruded vertically 16 cm (6.3 in) into the front right occupant space and 4 cm (1.6 in) into the middle of the front row. The right front door's forward upper quadrant intruded 6 cm (2.4 in) laterally into the front right occupant space (Figure 9).

Figure 9: Arrow shows intrusion of right front door

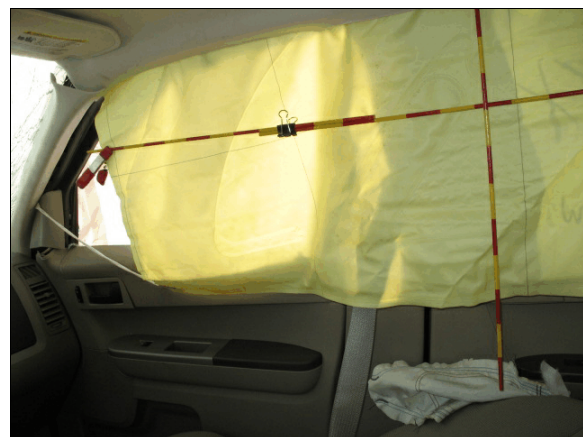
Both side curtain air bags were located along the roof side rails (Figures 10 and 11) inside the headliner and extended from the A- to C-pillar. They were designed with inflation chambers adjacent to each outboard seat position and did not have external vent ports. Each deployed side curtain air bag was 145 cm (57.1 in) in width, 48 cm (18.9 in) in height, and extended 10 cm (4 in) below the beltline. Each air bag was attached at the respective A-pillar by a 40 cm (15.7 in) cloth tether and attached to the C-pillar by a 6 cm (2.4 in) cloth tether. There was a 30 cm (11.8 in) wide gap between the center leading edge of each air bag and the A-pillar. The fold creases on the air bags indicated that they had been folded in an accordion fashion within the headliner.

Figure 10: Front portion of right side curtain air bag

The inspection of each air bag revealed no discernable evidence of occupant contact and no damage.

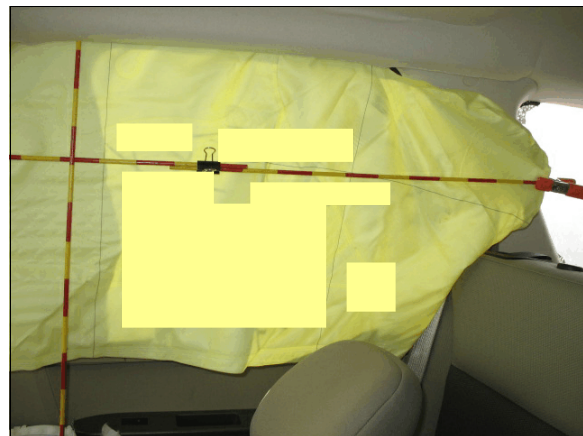
Figure 11: Rear portion of right side curtain air bag

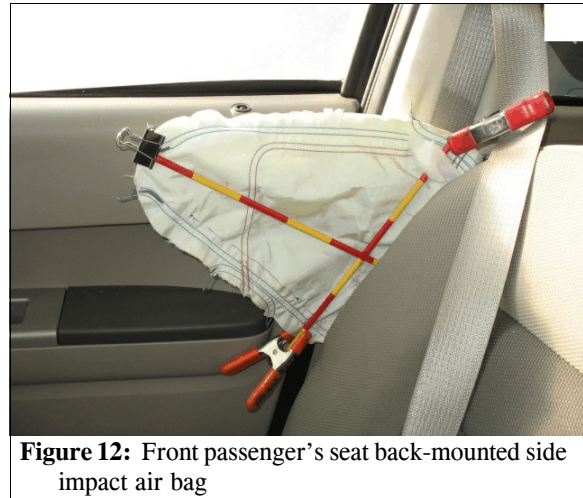
The driver's and front passenger's seat back-mounted side impact air bags were located in the outboard sides of the seat backs and deployed through a tear-seam. Each deployed air bag was oblong (**Figure 12**) and designed with what appeared to be a vent port located on the leading edge of the air bag. Each air bag was 30 cm (11.8 in) in width and 29 cm (11.4 in) in height. The inspection of the air bags revealed no discernable evidence of occupant contact and no damage.
