**CALSPAN ON-SITE CERTIFIED ADVANCED 208-COMPLIANT
VEHICLE CRASH INVESTIGATION
SCI CASE NUMBER: CA08045**

VEHICLE: 2007 TOYOTA SOLARA

LOCATION: TEXAS

CRASH DATE: JULY 2008

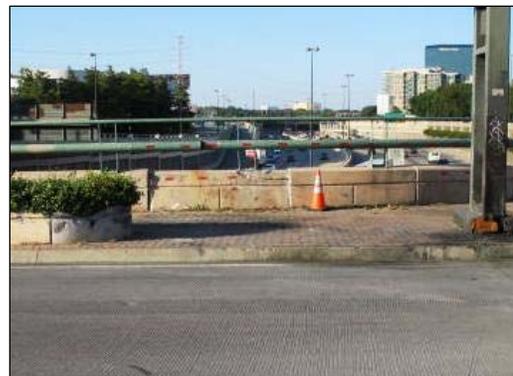
As the Toyota departed the roadway, the front tires and associated undercarriage impacted the curb. Both front wheel rims were damaged by these impacts. The vehicle continued on its travel path, and the left bumper corner impacted the raised concrete landscaping island. As the Toyota contacted the end radius of the concrete island, it was deflected approximately 20 degrees clockwise (CW). This impact engagement caused front left corner and left side damage to the Toyota, and was evidence by gouge

Figure 4: Location of impacts.

marks, abrasions, and rubber transfer on the end radius of the concrete island. The Toyota continued on its forward trajectory and impacted the concrete retaining wall and bridge rail with the full frontal structure. **Figure 4** is an overall view of the crash site.

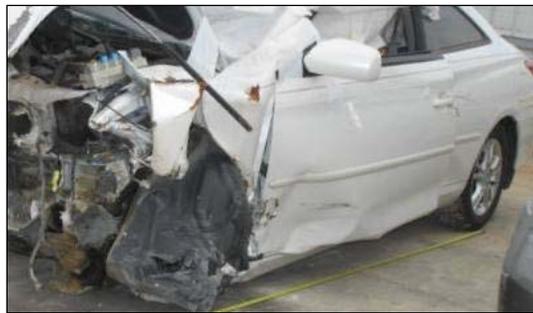
The Toyota sustained disabling frontal damage as a result of the crash sequence. The initial events fractured the left front wheel and dented the right front wheel. Both tires were punctured and aired out. The Collision Deformation Classification (CDC) associated with these events was 12FLWN3 and 12FRWN3. Damage from the third impact with the raised concrete landscaping island was overlapped by damage from the final impact event. However, crush, scuffing, and abrasion damage was present on the forward lower aspect of the left front door. The CDC associated with this event was estimated at 12FLEE6.

Figure 5: Left side damage to the Toyota.

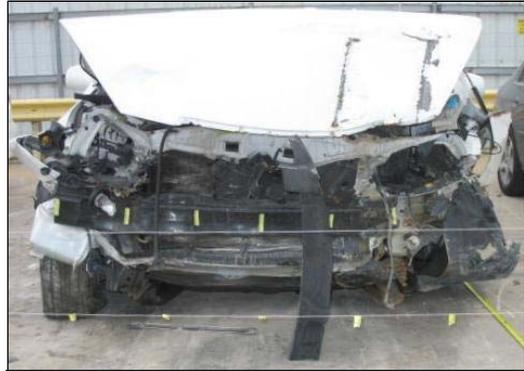
The impact with the concrete wall caused damage resembling a barrier-type crash crush profile. The bumper fascia and grille were separated. The head, marker, and fog lighting assemblies were disintegrated. The hood was buckled, and there were two distinct areas of contact from the bridge rail post during maximum engagement, as seen in **Figure 5**. These contact areas extended diagonally from 24 cm (9 in) to 36 cm (14 in) and 52 cm (20 in) to 62 cm (24 in) left of center. Under hood components including the radiator, fluid reservoirs, battery, and engine were all damaged and crushed rearward. The battery was destroyed by the crush, and acid leakage was found inside the vehicle. The left front suspension was separated and the wheel was rotated with its outboard side facing rearward, crushed into the firewall aft of its pre-crash axle location. The left front fender was crushed and displaced right laterally and rearward. The driver's door had been jammed shut as a result of induced crush, and had been pried open by emergency services personnel. Damage to the vehicle glazing included the disintegration of the driver's door glazing and complete fracturing of the windshield.

The induced and direct contact damage extended 123 cm (48 in) from bumper corner to bumper corner. The accompanying crush profile was measured at mid-bumper level, minus free space, with the following results: C1 = 55 cm (22 in), C2 = 61 cm (24 in), C3 = 65 cm (26 in), C4 = 64 cm (25 in), C5 = 53 cm (21 in), C6 = 37 cm (15 in). Maximum crush was located at C3. The Collision Deformation Classification (CDC) for the damage pattern (**Figure 6**) was 12FDEW3.

Figure 6: Frontal damage from barrier-type crash.

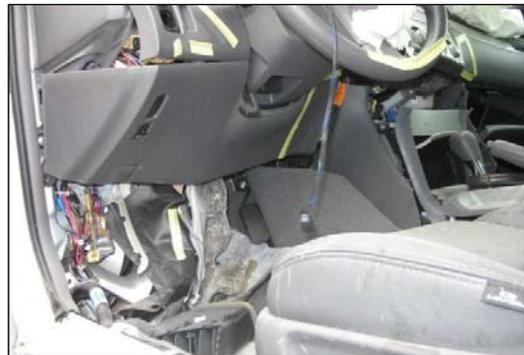
Interior damage included passenger compartment intrusion and occupant contact. On the left side, the knee bolster and mid-instrument panel were bowed outward and intruded. As seen in **Figure 7**, this intrusion was the result of the displacement of the left front wheel. On the right side, rearward crush resulted in the intrusion of the toe pan and components within the instrument panel. Accordingly, the glove box that was located below the instrument panel forward of the right front seating position had popped open and could not be closed.

Figure 7: Left side interior toe pan intrusion.

POSITION	COMPONENT	MAGNITUDE	DIRECTION
LF	Toe pan	28 cm (11 in)	Longitudinal
LF	Left side of center console	8 cm (3 in)	Lateral
LF	Mid-instrument panel	5 cm (2 in)	Longitudinal
RF	Toe pan	3 cm (1 in)	Longitudinal

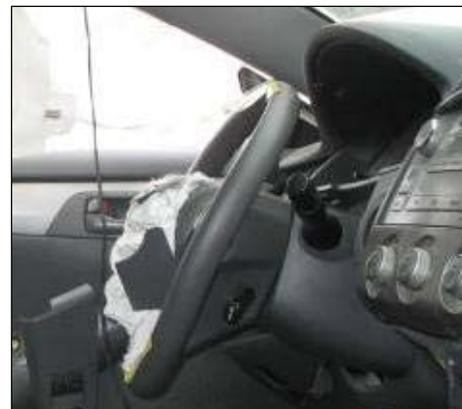
The steering wheel consisted of 3-spokes, positioned at 3, 6, and 9 o'clock. There was forward deformation of the upper half of the wheel rim from the 3 to 9 o'clock positions, measuring 4 cm (2 in). Both of the lateral spokes were also bent forward, as seen in **Figure 8**. The lower half of the steering wheel was deformed forward 1 cm (0.5 in). The steering column had 0.5 cm (0.25 in) of displacement of left sheer capsule, but the right could not be seen.

Figure 8: Steering wheel deformation.

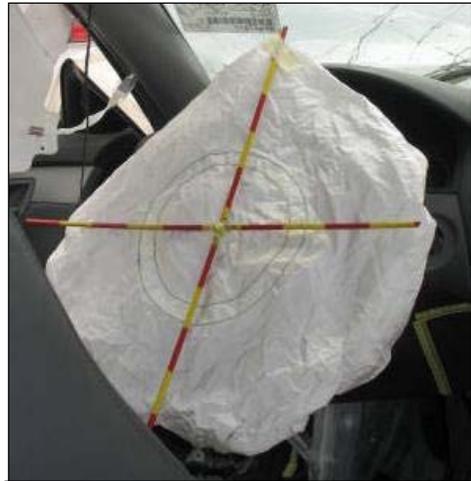
The driver air bag was identified by the manufacturer's code GA120-15110 15116026159. The air bag had properly deployed through its designated flaps in the face of the steering wheel without damage. The 61 cm (24 in) diameter air bag had two center circles of green tether stitching measuring 18 cm (7 in) and 22 cm (9 in) in diameter, as seen in **Figure 9**. The associated tethers were at the 3 and 9 o'clock positions. There were two 4 cm (2 in) vertical vent slits in the back of the bag. A small 2 cm (1 in) diameter area of occupant contact was located 13 cm (5 in) above the horizontal centerline on the vertical centerline.

Figure 9: Driver air bag.

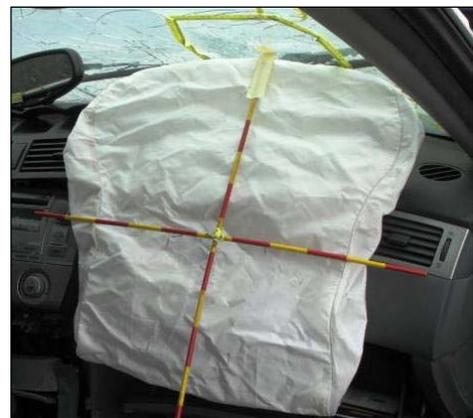
The front right passenger air bag was mounted in the top of the instrument panel. Two vertical trapezoidal and two horizontal triangular flaps formed the rectangular cover. The upper and lower trapezoidal shaped flaps measured 22 cm (9 in) long outboard and 10 cm (4 in) long inboard. The right and left triangular flaps had 13 cm (5 in) vertical bases and extended 5 cm (2 in) inward. The 61 cm (24 in) tall air bag was trapezoidal in shape, measuring 46 cm (18 in) and 38 cm (15 in) wide at its upper and lower aspects, respectively. There were two 5 cm (2 in) diameter vents, centered 19 cm (8 in) aft of the hinge point of the lower flaps on either side. Two black vertical expansion marks were on the face of the air bag. Abrasions and damage were found above the front right passenger air bag to the inside of the windshield glazing, attributed to the bag's deployment during the crash. There was no direct occupant contact evidence found on the air bag, as seen in **Figure 10**.

Figure 10: Front right passenger air bag.

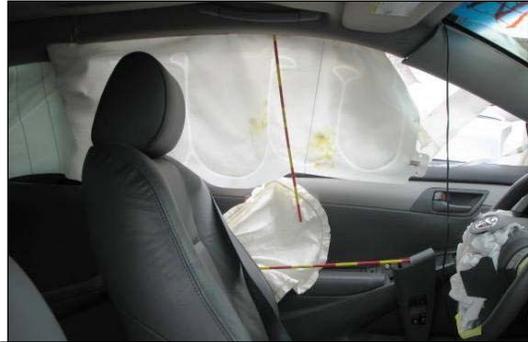
The Toyota was equipped with seatback-mounted side impact air bags and roof side rail-mounted IC air bags. Forces from the collision triggered the deployment of this side air bag system only on the left side (**Figure 11**). The left IC air bag was identified by the manufacturer's bar code TE2TYUSAAFD. Labeling at the B-pillar declared that this air bag was constructed of Automotive Safety Components International (ASCI) recognized PA 6.6 nylon material. Vertical dimensions of this air bag included 34 cm (13.5 in) tall at its forward aspect, 33 cm (13 in) tall at the B-pillar, and 28 cm (11 in) tall at its rear aspect. Coverage of the air bag extended 72 cm (28 in) forward of the B-pillar, and 83 cm (33 in) rearward. There was no contact evidence found on this air bag.

Figure 11: Deployed left side impact air bag system.

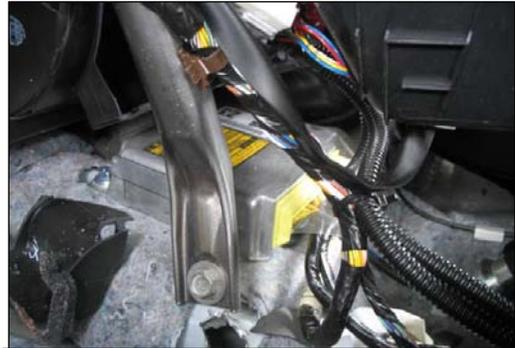
The air bag systems were controlled by an Air bag Control Module (ACM) located under the center console (**Figure 12**). The ACM had EDR capabilities. The EDR data was removed from the vehicle by the SCI team and sent to NHTSA for imaging by Toyota. The EDR in the 2007 Toyota Solara had the capability and capacity to record and store two longitudinal and two lateral crash events. The events were designated "Latest" and "Next Most-Recent", and two 5 second pre-crash memory buffers stored data elements related to each individual event. The imaged EDR had one stored event, termed the "Latest" event, which appeared to be related to the subject crash. The "Latest" event data reported that both the driver and passenger belts were buckled, with the driver's seat in a rearward track position. This data was consistent with the SCI inspection. The deployment time was reported to be 26 milliseconds for both frontal air bags. They were deployed in the "Hi" stage. All times were reported with respect to the initial crash recognition.

Figure 12: EDR mounted in the Toyota.

The EDR had the capacity to record 150 milliseconds of delta-V data. The maximum reported longitudinal delta-V was 23.7 km/h (14.7 mph) at 150 milliseconds. The graph of the respective

crash pulse had a positive slope at the end of the recording. The delta-V was still increasing, indicating that the entire crash pulse was not recorded. This EDR did not have the capability to record pre-crash data per Toyota. The pre-crash fields in the imaged data were all zero.
