ON-SITE CERTIFIED ADVANCED 208-COMPLIANT VEHICLE INVESTIGATION

CASE NUMBER - IN08048

VEHICLE - 2006 CHEVROLET COBALT LEVEL 1

CRASH DATE - November 2008

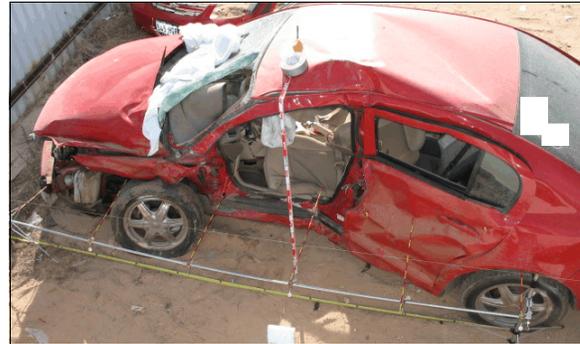
Figure 1: The damaged 2006 Chevrolet Cobalt LS

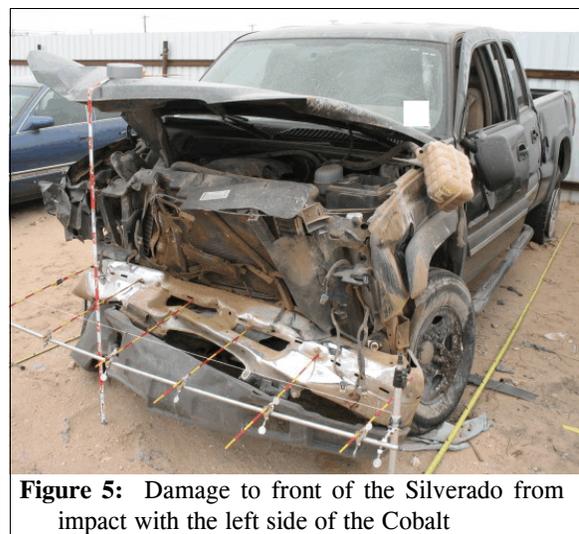
Figure 5: Damage to front of the Silverado from impact with the left side of the Cobalt

Exterior Damage: The Silverado's initial impact with the Cobalt (event 1) involved the Silverado's front plane. The front bumper, grille, both headlamp/turn signal assemblies, and the hood were directly damaged. The direct damage began at the front left bumper corner and extended 163 cm (64 in) across the bumper. The crush measurements were taken at the bumper level and the maximum residual crush was 39 cm (15.4 in) occurring at C₅. The vehicle's left side wheelbase was reduced 8 cm (3.1 in) and the right side wheelbase was reduced 11 cm (4.3 in). The table below shows the vehicle's front crush profile.

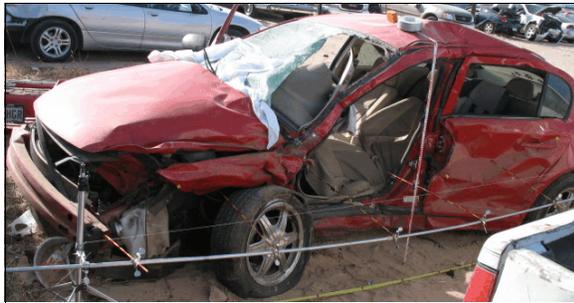
Figure 6: Damage to the left side plane of the Cobalt from impact with the front of the Silverado

Exterior Damage: The Cobalt’s initial impact (event 1) with the Silverado involved the Cobalt’s left side plane. The left side of the bumper fascia, left fender, hood, left front door, left A- and B-pillars, roof side rail, and the left rear door were directly damaged. The direct damage began 96 cm (37.8 in) forward of the left rear axle and extended forward 222 cm (87.4 in). The crush measurements were taken at the mid-door level and the maximum residual crush was 63 cm (24.8 in) occurring at C₄ (**Figure 12**). It was necessary to estimate the crush at C₃ and C₄ based on the crush occurring at the A- and B- pillars because the damage to the left front door had been altered when it was removed from the vehicle during extraction of the driver. The vehicle’s sill height was 31 cm (12.2 in) and the height of the maximum crush was 53 cm (20.9 in). The Door Sill Differential was 5 cm (2 in). The table below shows the vehicle’s left side crush profile.

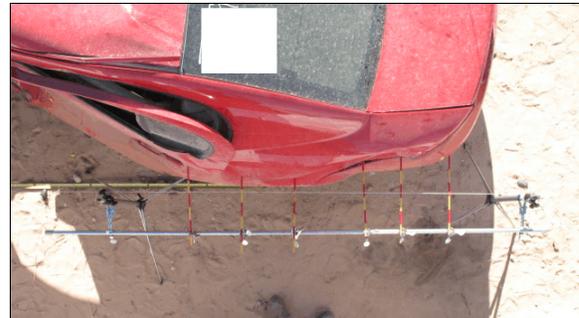
Figure 7: Top view of damage on the rear portion of the Cobalt's left rear door and the quarter panel from impact with the Silverado's right front door and fender

The Cobalt's second impact (event 2) with the Silverado also involved the vehicle's left side plane. The rear portion of the left rear door and the quarter panel were directly damaged. The direct damage began 26 cm (10.2 in) forward of the left rear axle and extended 99 cm (39 in) rearward. The crush measurements were taken at the upper quarter panel level and the maximum residual crush was 3 cm (1.2 in) occurring at C₃. Due to the partial overlap of the crush pocket from the initial left side impact, the crush values at C₅ and C₆ were estimated to zero. The table below shows the vehicle's crush profile for this impact.

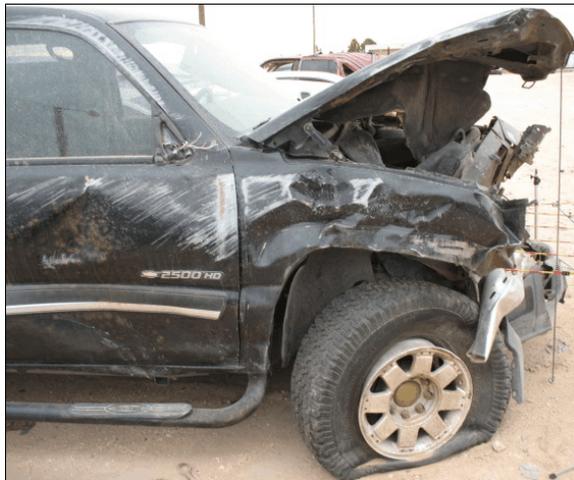
Figure 8: Damage to Silverado's door and fender from impact with the Cobalt's left quarter panel and left rear door; tire debanded from curb impact

The Silverado's second impact with the Cobalt involved the right side plane. The direct damage involved the right front door and the right fender. It began 227 cm (89.4 in) forward of the right rear axle and extended onto the right fender. There was overlapping damage to the fender from the front impact and the rollover and the total length of direct damage could not be determined.

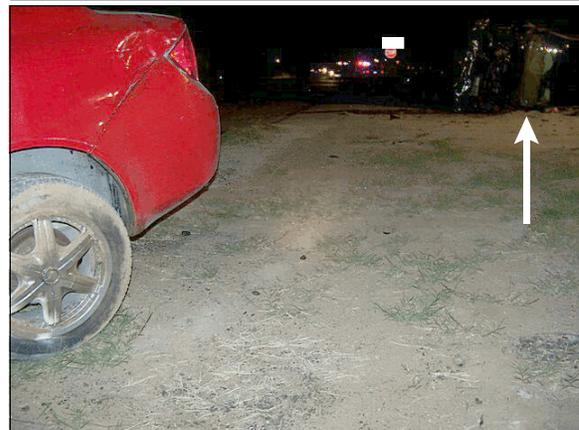
Figure 9: Police photo of Cobalt's left rear wheel showing abrasions to tire sidewall and rim scratches from curb impact; arrow shows final rest position of the Silverado

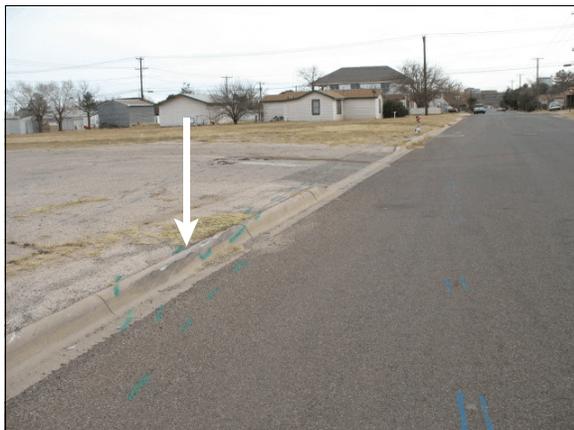
Figure 10: Arrow shows tire mark and scrapes on the curb from impact by the Cobalt's left rear wheel

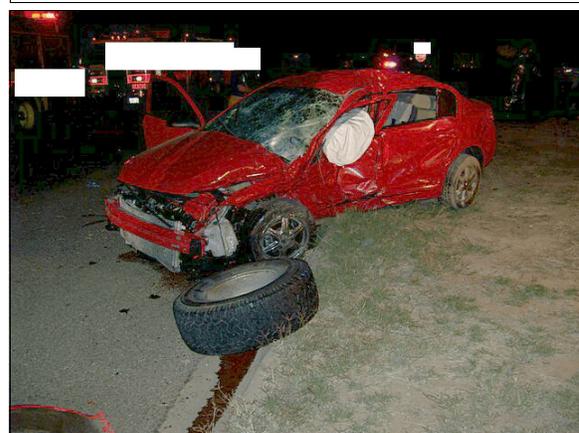
Figure 11: Police photo of final rest position of the Cobalt

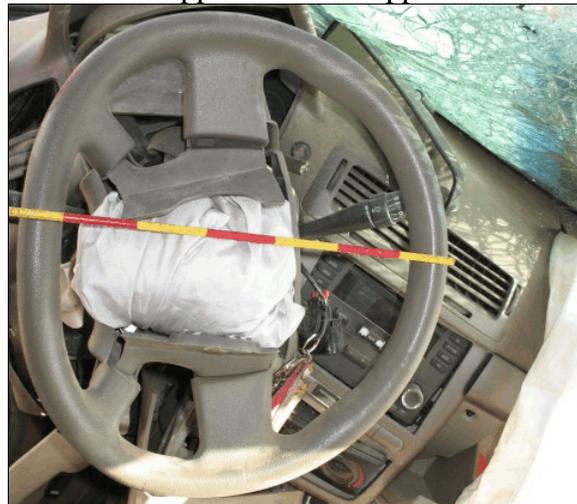
The driver's frontal air bag was located within the steering wheel hub and the module cover was a two flap configuration constructed of pliable vinyl (**Figure 13**). The cover flaps were undamaged and opened at the designated tear points. Each flap was 11.5 cm (4.5 in) in height, 7 cm (2.8 in) in width at the top, and 6 cm (2.4 in) in width at the bottom. The deployed air bag (**Figure 14**) was round with a diameter of 62 cm (24.4 in) and was designed with two tethers and two vent ports. The vent ports were located on the back of the air bag at the 11 and 1 o'clock positions. There was no discernable occupant contact evidence on the air bag. Several blood transfers were present on the left half of the air bag, which were probably related to blood spatter from the driver. There also were numerous small punctures dispersed over the air bag, which were probably the result of flying tempered glass fragments from the disintegrated left front window glazing.

Figure 13: The steering wheel and air bag module cover flaps; steering wheel rotated 90 degrees clockwise

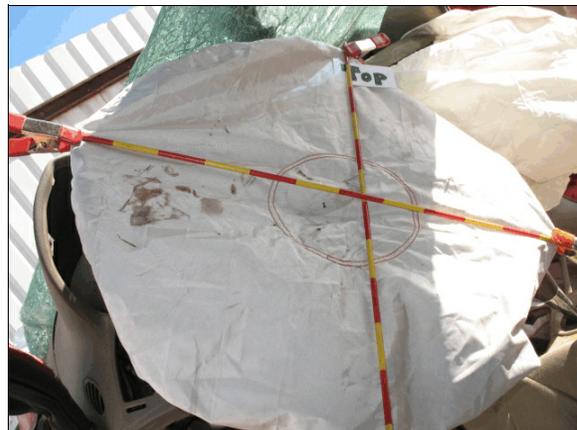
Figure 14: The Cobalt driver's frontal air bag

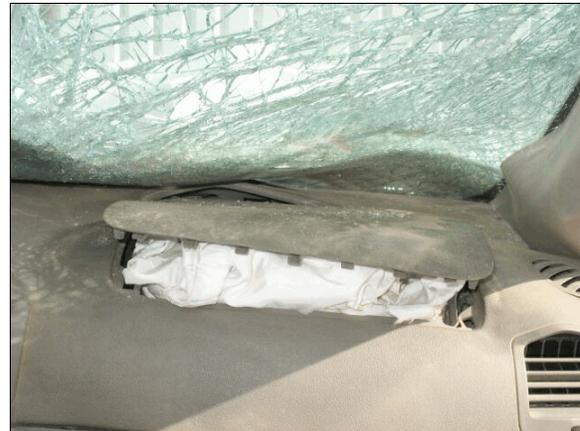
The front right passenger's air bag was located within the top of the instrument panel and deployed through a single module cover flap (**Figure 15**), which was undamaged and opened at the designated tear points. The deployed air bag

Figure 15: The front right passenger's frontal air bag cover flap and air bag module)

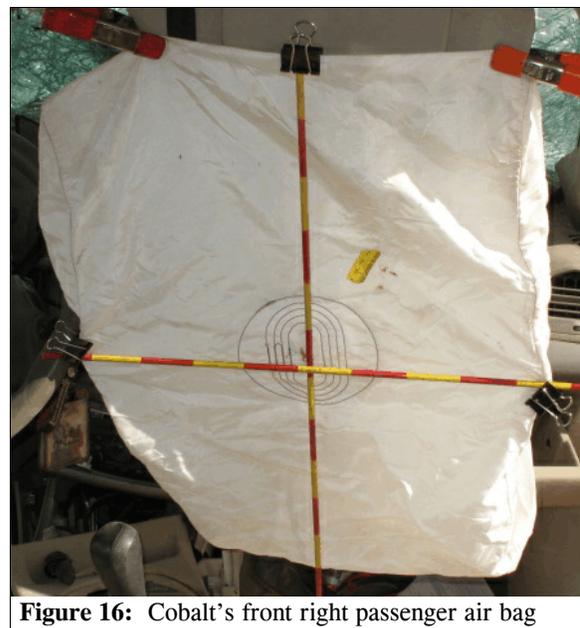
(Figure 16) was 45 cm (17.8 in) in length and 60 cm (23.6 in) in height and was designed with two tethers and two vent ports. The vent ports were located at the 10 and 2 o'clock positions. There was no discernable evidence of occupant contact on the air bag. Two small blood transfers were present on the air bag's upper right quadrant, but they appeared to be related to blood spatter.

Figure 16: Cobalt's front right passenger air bag

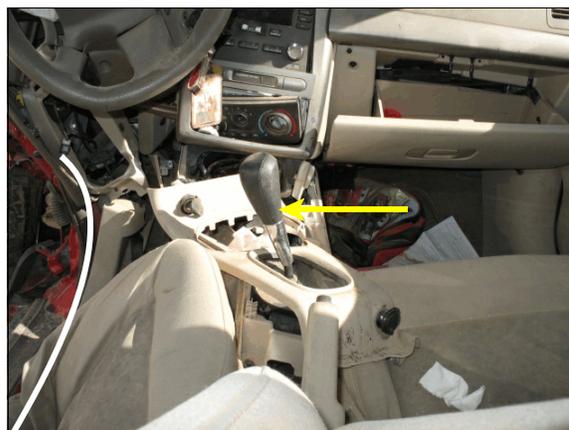
Figure 17: Gear shift lever bent to left due to contact by the front left passenger; curved line on left illustrates approximate extent of left front door intrusion
