ON-SITE SIDE IMPACT INFLATABLE OCCUPANT PROTECTION INVESTIGATION

CASE NUMBER - IN08049

VEHICLE - 2004 HYUNDAI TIBURON GL

CRASH DATE - November 2008

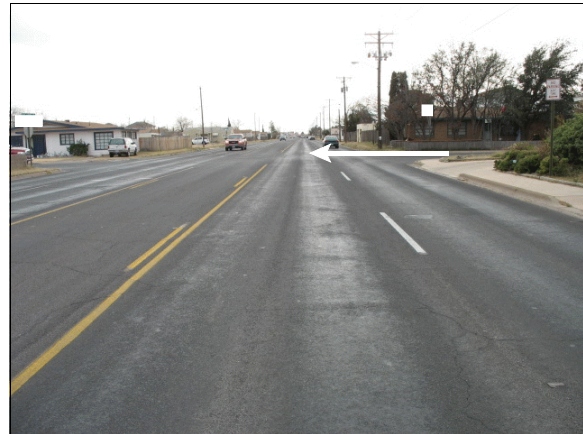
Figure 2: Hyundai's approach to the impact area; arrow shows approach of the Chevrolet

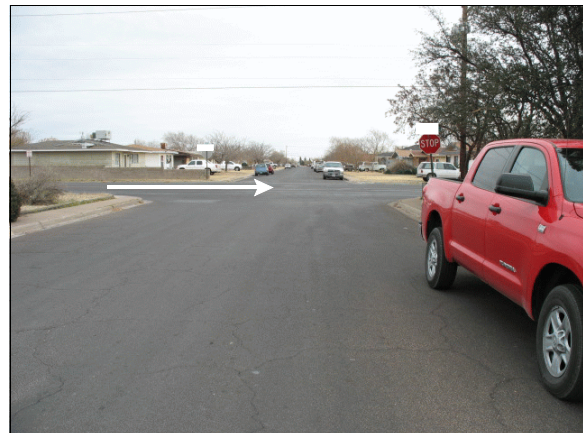
Figure 3: Chevrolet's approach to the impact area; arrow shows approach of the Hyundai

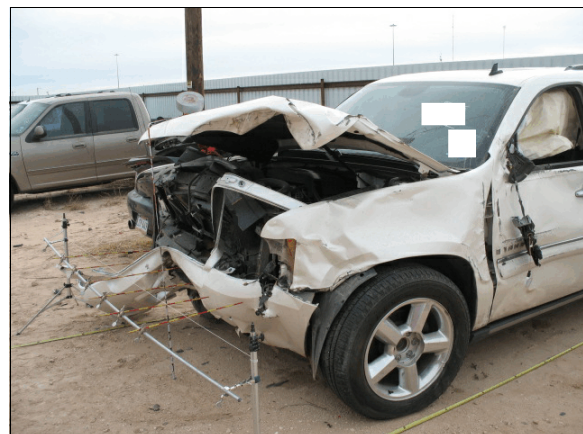
Crash: The front of the Chevrolet (**Figure 4**) impacted the right side of the Hyundai (event 1). The Hyundai's direction of force was within the 2 o'clock sector and the impact force was sufficient to trigger deployment of the front right seat back-mounted side impact air bag and the frontal air bags. The impact caused the Hyundai and Chevrolet to rotate clockwise and be redirected southeast. As the vehicles rotated, the Chevrolet began to roll over, left side leading (event 2), and the left front portion of the Chevrolet rolled onto the top back portion of the Hyundai (event 3, **Figure 5**). The Hyundai's left side wheels impacted the curb (events 4 and 5) on the southeast quadrant of the intersection. The Hyundai continued into the yard of the residence with its left side leading and the left fender impacted the right quarter panel of the 1998 Ford Taurus (event 6, **Figures 6 and 7**). The impact force was not sufficient to trigger deployment of the Hyundai's driver's seat back-mounted side impact air bag. The Hyundai came to final rest in the front yard of the residence against the Taurus facing southwest (**Figure 7**). Following separation from the Hyundai, the Chevrolet was on its left side. It continued its clockwise rotation with its left side contacting the sidewalk and ground, and it came to final rest on its wheels in the yard of the residence heading southeast. Following impact with the Hyundai, the Taurus' left fender impacted the residence (event 7) and its left quarter panel impacted the Explorer's right side plane (event 8).

Figure 4: Damage to the front plane of the Chevrolet due to the impact with the right side plane of the Hyundai

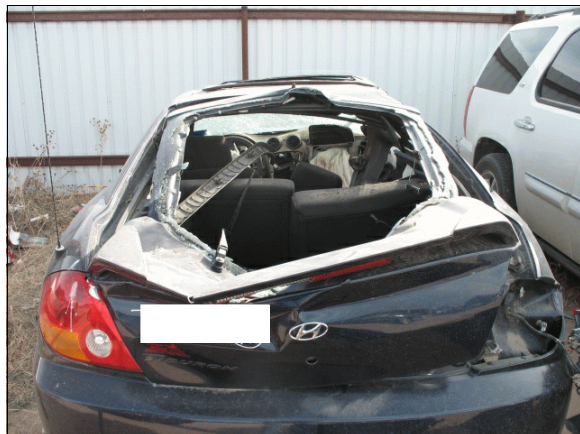
Figure 5: Damage to the top plane on the back of the Hyundai due to impact from the Chevrolet as it rolled over

The Hyundai’s second impact (event 3) with the Chevrolet (event 3) involved the Hyundai’s right quarter panel and top of the rear hatch. The right quarter panel, backlight, rear hatch, and rear spoiler were all directly damaged. No crush measurements were taken due to the non-horizontal nature of the impact. The back panel of the hatch sustained induced damage from this impact.

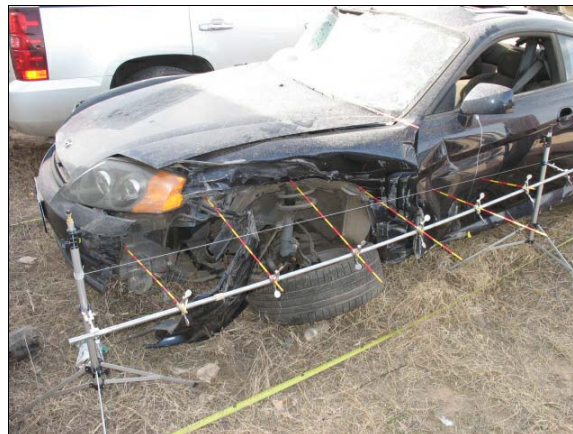
Figure 6: Hyundai's damage from impact with parked Ford Taurus

The Hyundai’s impact with the parked Ford Taurus (event 6) involved the front portion of the vehicle’s left side plane (**Figure 6**). The bumper fascia, left fender, left front wheel, and door were directly damaged. The direct damage began 326 cm (128.3 in) forward of the left rear axle and extended 166 cm (65.4 in) rearward. The crush measurements were taken at the mid-door level and the maximum residual crush was 32 cm (12.6 in) occurring at C₅. The induced damage involved the hood, left fender and left front door. The table below shows the crush profile for this impact.

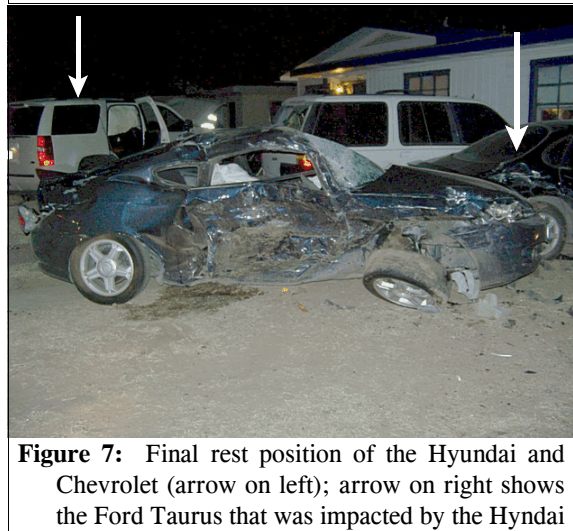
Figure 7: Final rest position of the Hyundai and Chevrolet (arrow on left); arrow on right shows the Ford Taurus that was impacted by the Hyundai

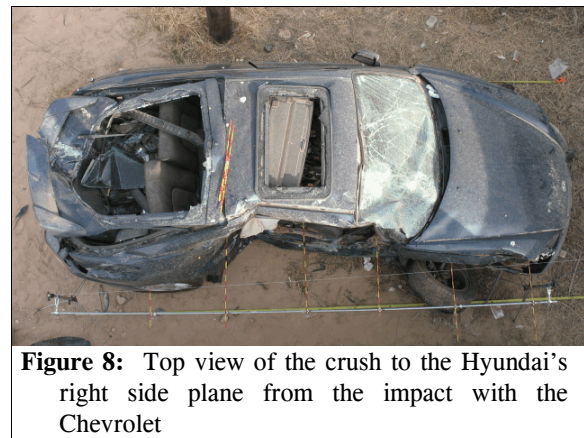
Exterior Damage: The Hyundai's impact with the Chevrolet (event 1) involved the right side plane (Figure 7). The right fender, front wheel, door, A-pillar, roof rail, and quarter panel were all directly damaged. The direct damage began 278 cm (109.4 in) forward of the right rear axle and extended 243 cm (95.7 in) rearward. The crush measurements were taken at the mid-door

level, and the maximum residual crush was 46 cm (18.1 in) occurring at C₃ (**Figure 8**). Due to the missing right front door, the crush was estimated at C₃ and C₄ based on the crush at the lower A-pillar and quarter panel. The vehicle’s sill height was 27 cm (10.6 in). The height of the maximum door crush was 26 cm (10.2 in) and the Door Sill Differential was 20 cm (7.9 in). The table below shows the vehicle’s right side crush profile.

The right side wheelbase was reduced 19 cm (7.5 in) while the left side wheelbase was extended 1 cm (0.4 in). Induced damage involved the windshield, hood, right quarter panel, and roof rail.

Figure 8: Top view of the crush to the Hyundai’s right side plane from the impact with the Chevrolet

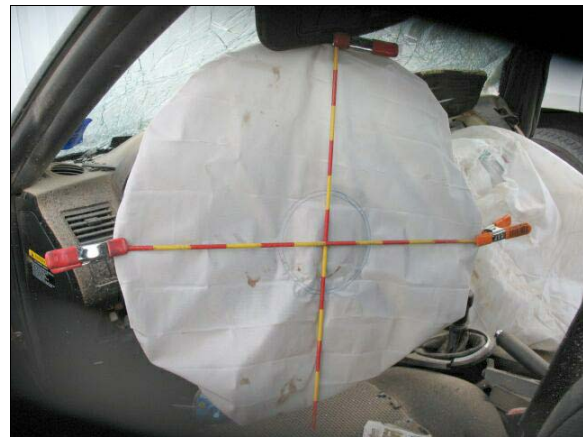
The driver's air bag module cover consisted of two flaps constructed of pliable vinyl. The top flap was 17 cm (6.9 in) in width and 4 cm (1.6 in) in height. The bottom flap was 17 cm (6.9 in) width and 10 cm (3.9 in) in height. The flaps opened at the designated tear points and were undamaged. The deployed driver's air bag (**Figure 9**) was 63 cm (25 in) in diameter. It had two vent ports located at the 10 and 2 o'clock positions and two tethers. There were several blood transfers on the air bag in the upper and lower left quadrants.

Figure 9: The driver's deployed frontal air bag

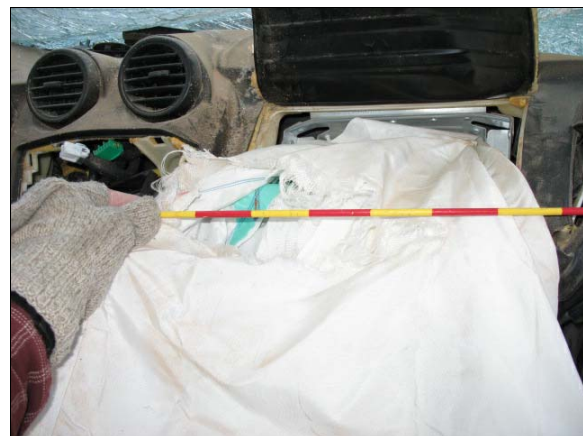
The front right passenger's air bag module cover consisted of a single flap constructed of pliable vinyl. It was 30 cm (11.8 in) in width and 16 cm (6.3 in) in height. The flap opened at the designated tear points and was undamaged. The deployed front right passenger air bag was 48 cm (18.9 in) in width and 57 cm (22.4 in) in height. It was equipped with two wide tethers and one vent port on the left side at the 9 o'clock position. Inspection of the air bag revealed a 26 cm (10.2 in) tear in the fabric (**Figure 10**) on the top left. The source of the tear is unknown.

Figure 10: Tear in top of front right passenger's frontal air bag

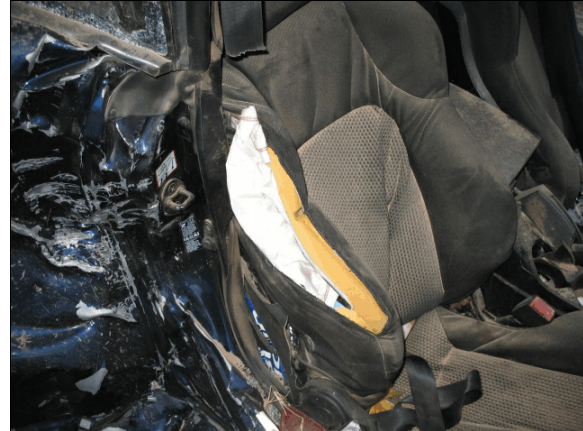
The vehicle's side impact air bag system consisted of front seat back-mounted side impact air bags, which were located in the outboard side of the seat backs and deployed through a tear

seam (**Figure 11**). Based on the Holmatro Rescuer's Guide to Vehicle Safety Systems, the side impact sensors were located below the left and right B-pillars on the floorboard.

Figure 11: Location of the Hyundai's front right passenger's seat back-mounted side impact air bag

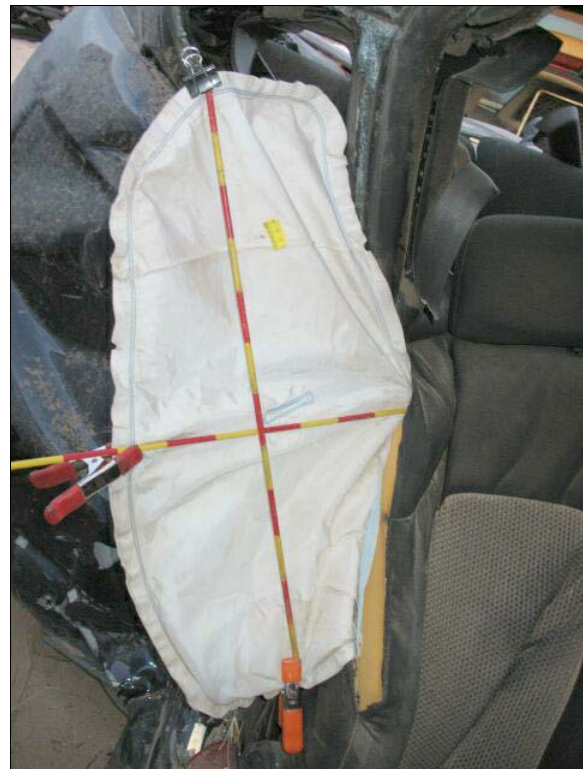
The deployed front right passenger seat back-mounted side impact air bag (**Figure 12**) was 63 cm (24.8 in) in height and 36 cm (14.2 in) in width. Inspection of the air bag revealed a small blood transfer on the upper right quadrant on the inboard side of the air bag. There was no damage on the air bag. The driver's side impact air bag did not deploy in this crash.

Figure 12: The deployed front right seat back-mounted side impact air bag

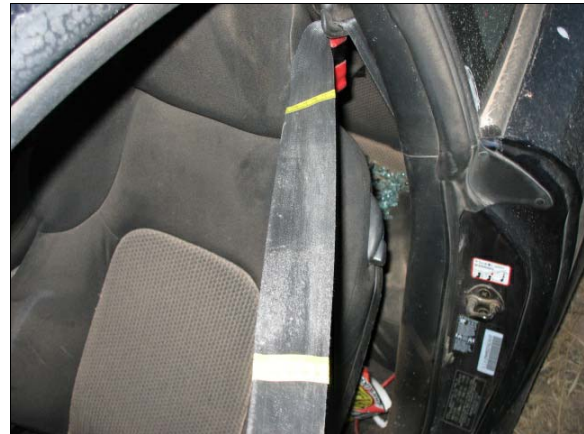
Inspection of the driver's seat belt system revealed a load abrasion (**Figure 13**) on the seat belt webbing that was 32 cm (12.6 in) in length. It was located 103 cm (40.6 in) above the stop button. Historical usage scratches were also found on the latch plate. This evidence indicated that the driver was restrained at the time of the crash.

Figure 13: Load abrasion on the driver’s seat belt

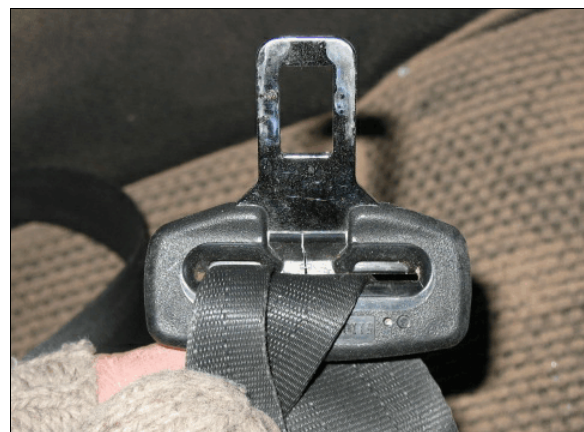
The front right passenger's seat belt was cut by rescue personnel to extricate the passenger. Inspection of the remainder of the seat belt system revealed that the webbing was partially folded over on itself and jammed in the latch plate belt guide (**Figure 14**). This evidence indicated that

the front right passenger was restrained at the time of the crash.

Figure 14: The front right passenger’s seat belt webbing was folded over on itself and jammed in the latch plate belt guide

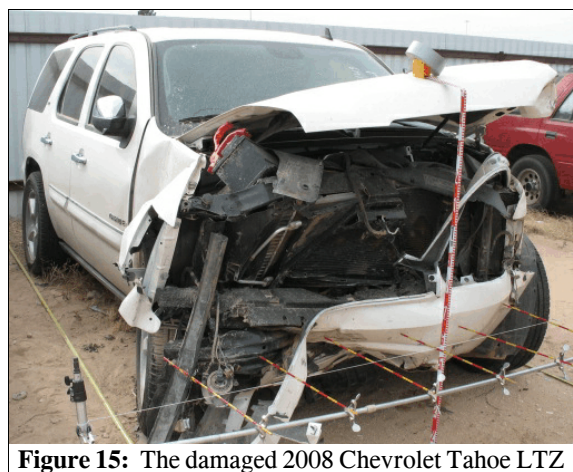
Figure 15: The damaged 2008 Chevrolet Tahoe LTZ

Exterior Damage: The Chevrolet’s impact with the Hyundai involved the Chevrolet’s front plane. The direct damage involved the front bumper, grille, hood, right and left headlamp/turn lamp assemblies, and left fender. The direct damage began on the front left bumper corner and extended 145 cm (57.1 in) across the front (**Figure 15**). The maximum residual crush was 43 cm (16.9 in) occurring at C₄. The table below shows the vehicle’s front crush profile.
