## ON-SITE OTHER INFLATABLE OCCUPANT PROTECTION INVESTIGATION

CASE NUMBER - IN08050

VEHICLE - 2007 JEEP COMPASS LIMITED

CRASH DATE - November 2008

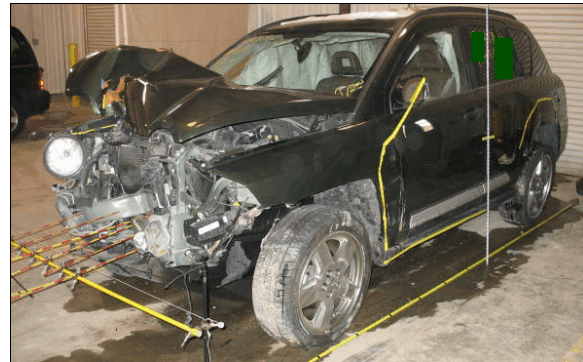
**Figure 1:** The damaged 2007 Jeep Compass Limited

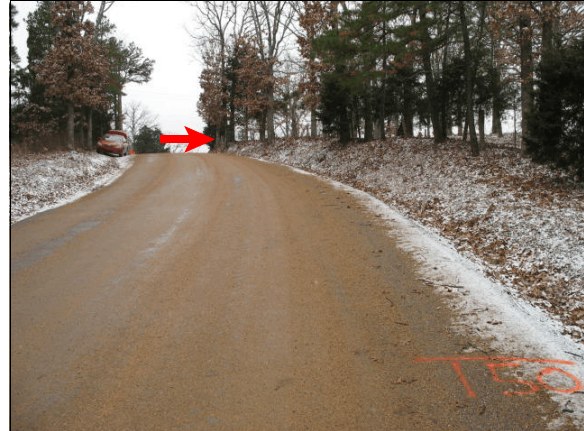
**Figure 2:** Approach of the Jeep in the left curve; number shows feet to tree impact; arrow shows impacted tree

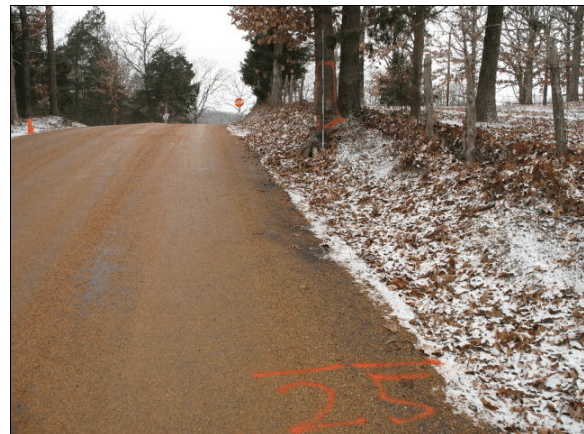
**Crash:** The Jeep traveled up the embankment along a positive 31% grade (**Figure 3**) and the front of the vehicle (**Figure 4**) impacted a tree (event 1). The tree was 38 cm (15 in) in diameter at the approximate hood level and 58 cm (22.8 in) in diameter at the approximate bumper level. The Jeep's direction of force was within the 12 o'clock sector and the impact force was sufficient to deploy the driver's frontal air bag. The vehicle rotated slightly clockwise and rolled over (event 2) one quarter turn onto its left side (**Figure 5**). The vehicle was equipped with IC air bags with rollover sensing and the IC air bags deployed. The vehicle came to final rest on the roadway on its left side heading northwest.

**Figure 3:** Approach of the Jeep to impact with the tree

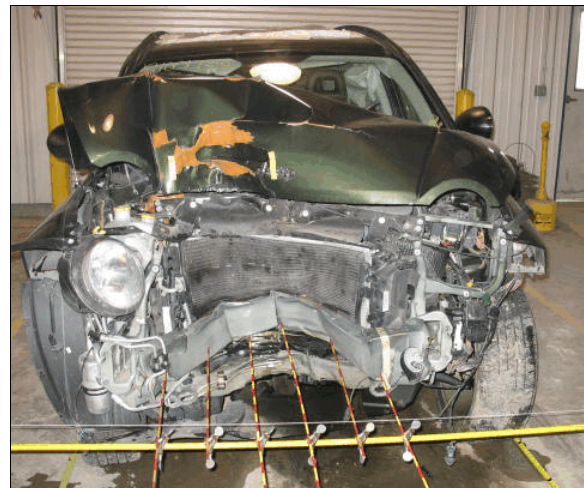
**Figure 4:** Damage to the front of the Jeep from impact with the tree

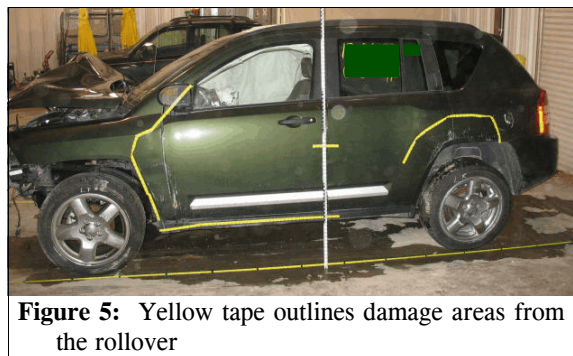
The rollover involved the vehicle’s left side plane (**Figure 5**) and the extent of the damage consisted of scratches on the sheet metal and abrasions on the left front and left rear wheels. The direct damage began 19 cm (7.5 in) rear of the left rear axle and extended 244 cm (96.1 in) forward along the side. The vertical extent of damage extended from the wheels to the left side view mirror. There was no damage to the roof side rail and no lateral crush to the vehicle’s roof structure. The right side wheelbase was reduced 2 cm (0.8 in) while the left side wheelbase was extended 2 cm (0.8 in).

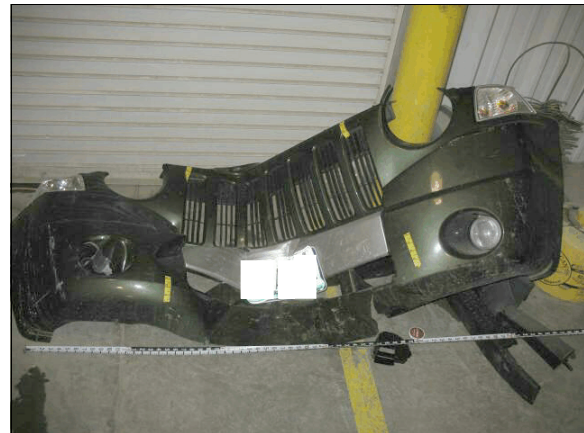
**Exterior Damage:** The Jeep’s impact with the tree involved the front plane. The front bumper, grille, and hood were directly damaged. The direct damage was measured on the bumper fascia (**Figure 6**) and began 49 cm (19.3 in) right of the front left bumper corner. It extended 72 cm (28.3 in) across the front bumper. The crush measurements were taken at the bumper level (**Figure 4**) and the residual maximum crush was 62 cm (24.4 in) occurring at C<sub>3</sub> (**Figure 7**). The induced damage involved both fenders and the hood. The table below shows the vehicle’s front crush profile.

**Figure 6:** Yellow tape shows ends of direct contact damage on the front bumper fascia

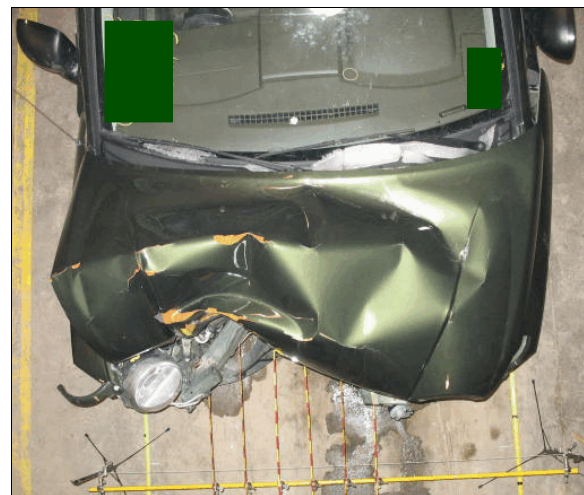
**Figure 7:** Crush to the front of the Jeep from the tree impact

**Damage Classification:** The Jeep’s Collision Deformation Classifications were **12-FDEW-3 (0 degrees)** for the front impact with the tree (event1), and **00-LDAO-2** for the rollover. The Barrier algorithm of the WinSMASH program calculated the vehicle’s total Delta-V for the front impact as 47 km/h (29.2 mph). The longitudinal and lateral velocity changes were -47 km/h (-29.2 mph) and 0.0 km/h, respectively. The WinSMASH results appeared reasonable based on the extent of damage. The severity of the rollover damage was minor based on the damage on the vehicle’s left side.

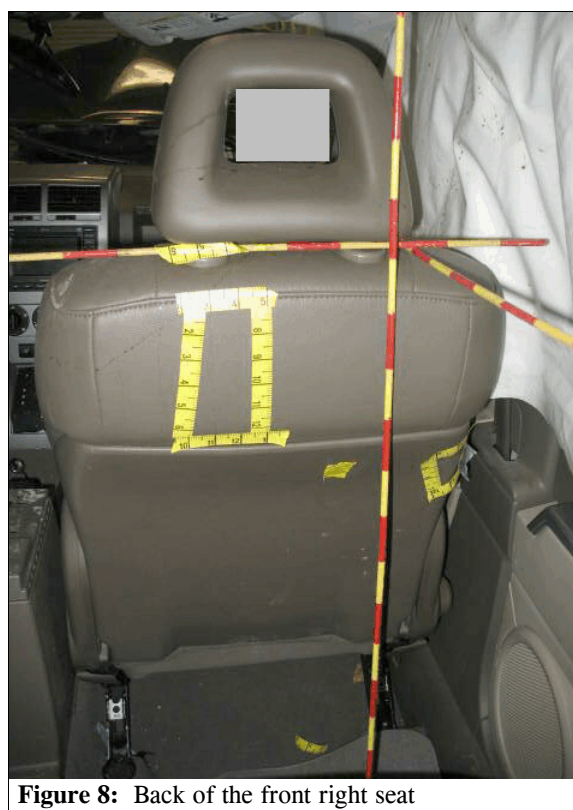
**Vehicle Interior:** The inspection of the Jeep's interior revealed occupant contact evidence associated with the driver and second row right passenger. A transfer of makeup was present on the driver's frontal air bag and the IC air bag indicating that the driver's face contacted both air bags during the crash. There were also scuffs on the lower left instrument panel on each side of the steering column due to contact by the driver's knees. There was occupant contact evidence on the back of the front right seat (**Figure 8**), which consisted of a 5 cm (2 in) by 3 cm (1.2 in) abrasion on the plastic located 31 cm (12.2 in) below the top of the seat back and 21 cm (8.3 in) to the right of the seat back's centerline. A second abrasion, 3 cm (1.2 in) by 1 cm (0.4 in), was located 23 cm (9.1 in) below the top of the seat back and 7 cm (2.8 in) to the right of the seat back's centerline. These abrasions were probably due to contact by the second row right passenger's feet. A probable occupant contact, which consisted of a 13 cm (5.1 in) by 3 cm (1.2 in) area of discoloration in the seat material was also present at the top of the seat back located 6 cm (2.4 in) left of the seat back's centerline. The seat material in this area was lighter in color and appeared to have been stressed. The source of this contact was probably the second row right passenger's face. The front right seat track was adjusted to within 7 cm (2.8 in) of its full-rear position and the seat back was reclined 26 degrees. There was no discernable evidence of occupant contact on the right or left IC air bags in the second row.

Figure 8: Back of the front right seat

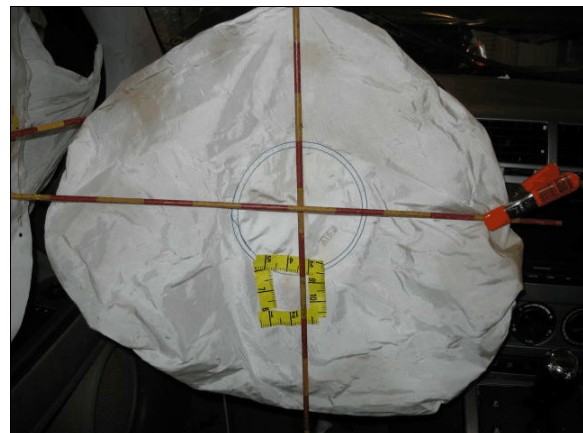
The driver's frontal air bag was located in the steering wheel hub. The deployed air bag (**Figure 9**) was 56 cm (22 in) in diameter and had two vent ports, each 2 cm (.08 in) in diameter located on the back of the air bag at the 11 and 1 o'clock positions. The air bag module was

**Figure 9:** The driver's frontal air bag; yellow tape shows makeup transfer on the air bag

equipped with two cover flaps, which opened at the designated tear seams. The makeup transfer identified above in the vehicle interior section was located 9 cm (3.5 in) below the center of the air bag and 3 cm (1.2 in) left of the air bag's centerline.

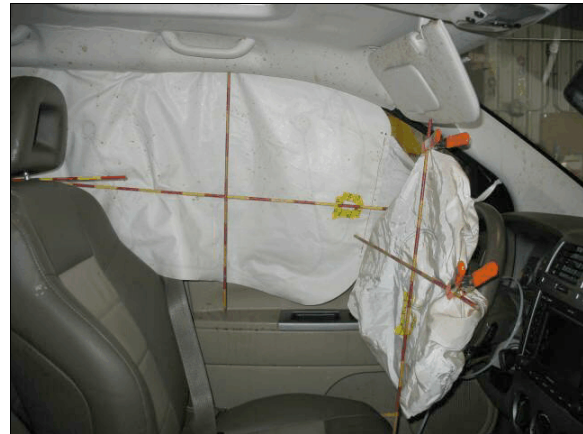
Figure 10: Driver's portion of the left IC air bag; yellow tape shows small transfer of makeup

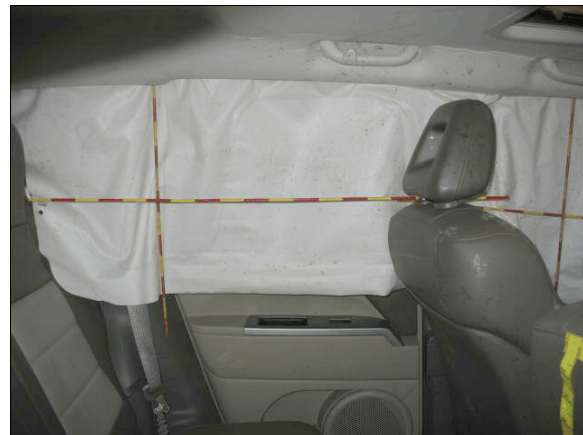
Figure 11: Second row left portion of left IC air bag

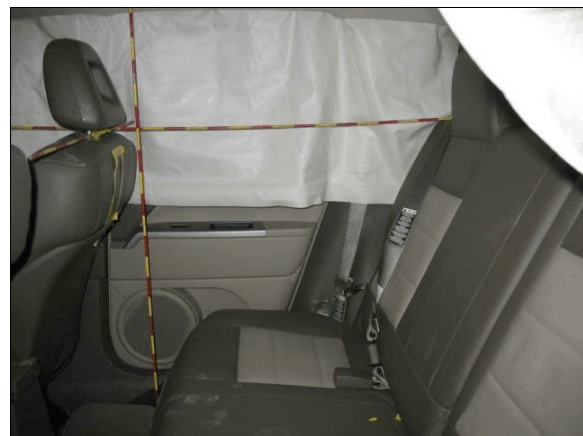
Figure 12: Second row right portion of right IC air bag

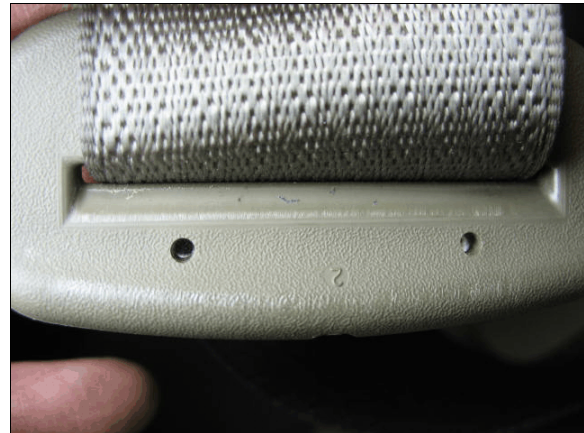
The inspection of the second row right safety belt assembly revealed two abrasions on the safety belt webbing. They were located 10 cm (3.9 in) and 90 cm (35.4 in) above the stop loop. The latch plate belt guide was also abraded (**Figure 13**). This evidence and the load abrasions found on the BBS's right shoulder belt guide indicated that the second row right passenger was restrained by the lap-and-shoulder safety belt. The driver stated during the SCI interview that after she routed the safety belt through the shoulder belt guide and buckled the belt, she pulled the safety belt out of the retractor to actuate the ALR, then let the belt retract until it was snug on the passenger.

**Figure 13:** Load abrasion on second row right passenger's latch plate belt guide

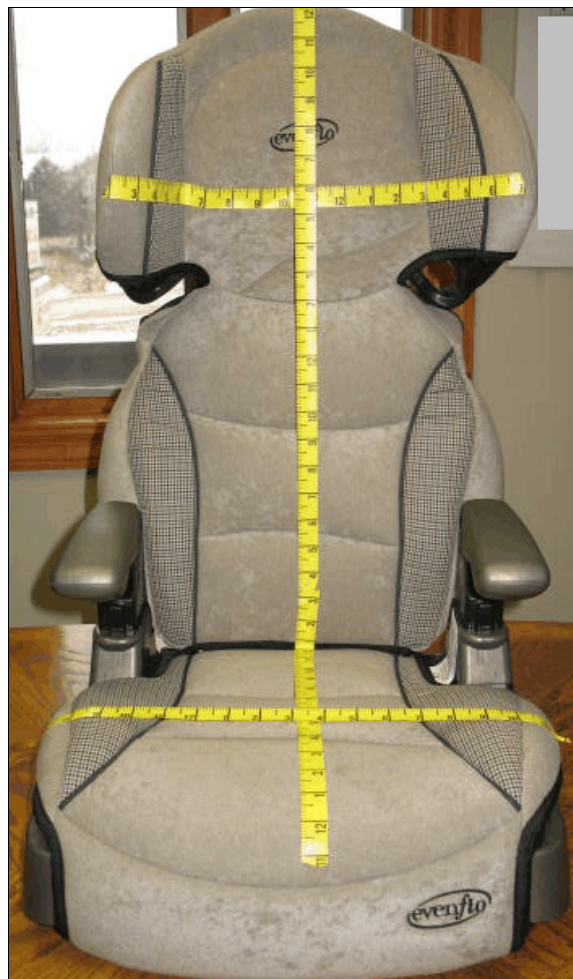
**Second Row Right Child Safety Seat:** The Jeep's second row right passenger [4-year-old, male; 104 cm and 16 kg (41 in, 36 lbs)] was seated in an Evenflo Big Kid BBS (**Figure 14**). It was manufactured on May 16, 2008 and the model number was 3371689A. The BBS was equipped with a removable back support with head restraint. When used with the back support, the BBS was designed for children who weighed 14-45 kilograms (30-100 pounds) and were 96 cm (38 in) to 145 cm (57 in) in height. When used without the back support, the BBS was designed for children who weighed 18-45 kilograms (40-100 pounds) and who were 101 cm (40 in) to 145 cm (57 in) in height and whose ears were below the top of the vehicle's head restraint. The BBS was used with the back support in this crash.

**Figure 14:** The Evenflo Big Kid BBS

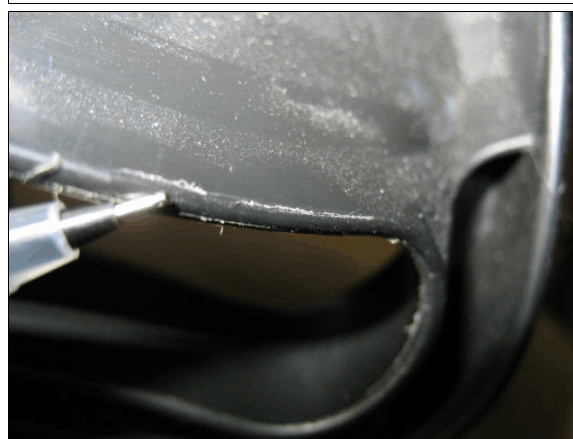
Inspection of the BBS revealed load marks in the plastic on the top back and back inside surfaces of the right shoulder belt guide (**Figures 15 and 16**). The right portion of the head restraint was also bent forward 5 cm (2 in) to an angle of 17 degrees (**Figure 17**). The undamaged left side of the head restraint was angled forward 9 degrees. The load abrasions on the shoulder belt guide indicated that the right portion of the head restraint was deformed forward due to loading by the safety belt during the frontal impact as the passenger was displaced forward and loaded the safety belt.

**Figure 15:** Safety belt abrasion on top back of BBS's right shoulder belt guide

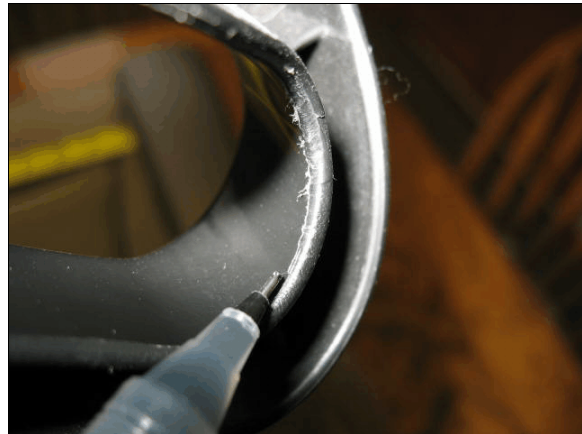
**Figure 16:** Safety belt abrasion on back inside surface of BBS's right shoulder belt guide

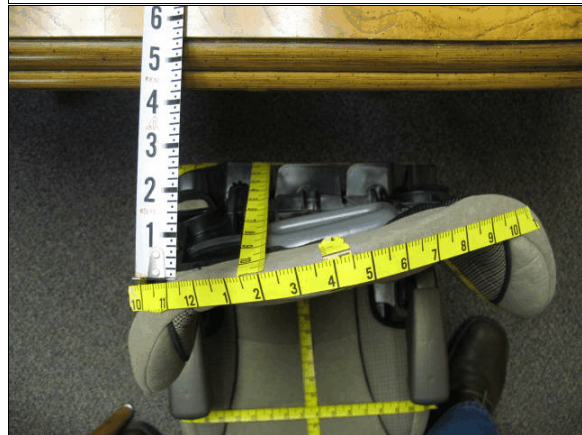
**Figure 17:** Top view of deformation to the BBS's head restraint
