CALSPAN ON-SITE CHILD RESTRAINT SYSTEM CRASH INVESTIGATION

SCI CASE NO: CA08051

VEHICLE: 2000 CHEVROLET MALIBU

CRASH DATE: OCTOBER 2008

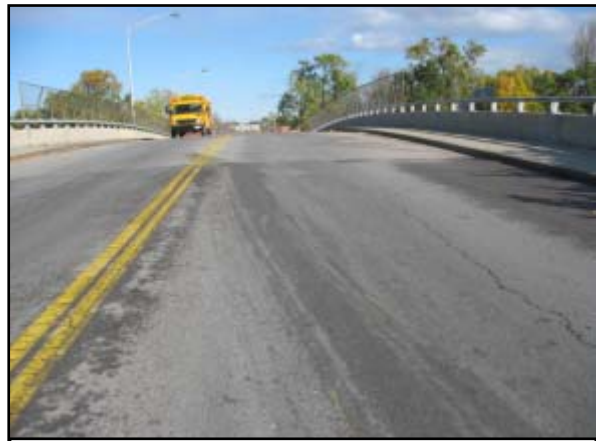
The front plane of the Oldsmobile struck the front plane of the Chevrolet in an offset right head-on configuration (Event 1). **Figure 4** is a view of the area of impact from the northbound approach of the Chevrolet. Both vehicles experienced impact forces of 12 o'clock. The force of the impact caused the deployment of the frontal air bag systems in both vehicles. The southbound momentum of the Oldsmobile stopped and reversed the direction of the northbound Chevrolet.

Figure 4. Point of impact from the Chevrolet's northbound approach.

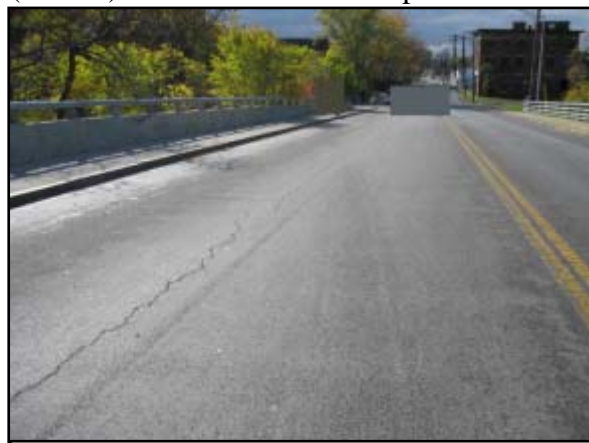
The Chevrolet came to rest facing southeast 55 meters (180 feet) south of the initial impact at the east curb line. During its post-impact travel, the Chevrolet rotated approximately 190 degrees CCW. A 35 meter (115 feet) long fluid trail defined the trajectory of the Chevrolet as it slid to final rest (**Figure 5**). The trail began at the roadway centerline and was directed to the southeast.

Figure 5. Fluid trail depicting the Chevrolet's travel to final rest.

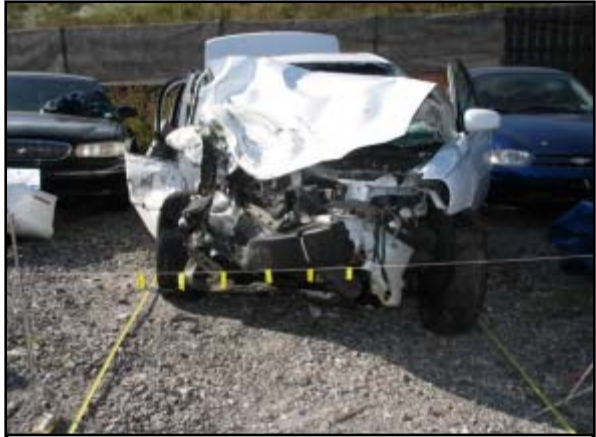
The 2000 Chevrolet Malibu sustained severe frontal damage as a result of the head-on impact with the Oldsmobile (**Figure 6 and 7**). The damage from this impact consisted of longitudinal deformation of the frontal structure that involved the following components: bumper fascia, bumper beam, upper and lower radiator supports, frame members, hood, and the right fender. The damage was slightly off-set to the right resulting in 66 cm (26 in) of compression to the right wheelbase. The direct contact damage began 30 cm (12 in) left of the centerline and extended 76 cm (30 in) to the right bumper corner. The maximum crush was located 13 cm (5 in) inboard of the right bumper corner and measured 111 cm (43.7 in) in depth. Six equidistant crush measurements were documented along the bumper beam and were as follows: C1 = 4 cm (1.6 in), C2 = 25 cm (9.8 in), C3 = 45 cm (17.7 in), C4 = 97 cm (38.2 in), C5 = 111 cm (43.7 in), C6 = 110 cm (43.3 in). The Collision Deformation Classification (CDC) for the impact with the Oldsmobile was 12-FDEW-5.

Figure 7. Overall view of the Chevrolet's frontal crush profile.

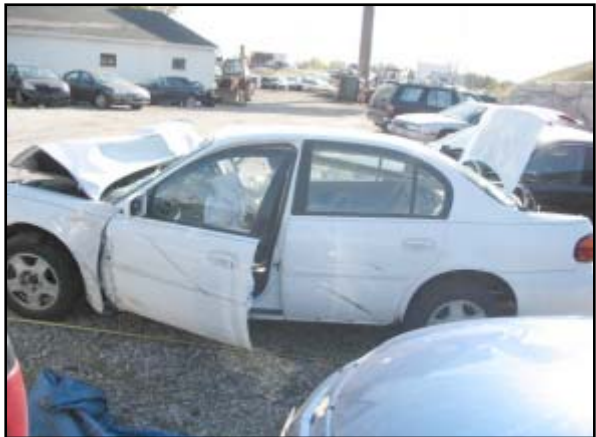
The Chevrolet sustained minor damage to the left plane from the secondary impact with the Ford (**Figure 8**). This impact consisted of abrasions to the left fender and doors and minor lateral deformation to the fender and left front door. The direct contact damage which contained rubber transfers from the left rear tire of the Ford measured 252 cm (9.2 in) beginning on the center of the left rear rim and extended forward. The direct contact had a maximum height of 83 cm (32.7 in). The maximum crush measured 6 cm (2.3 in) and was located at the rear aspect of the left fender. The CDC assigned to this impact was 12-LDES-1.

Figure 8. Left side damage to the Chevrolet from the impact with the Ford.

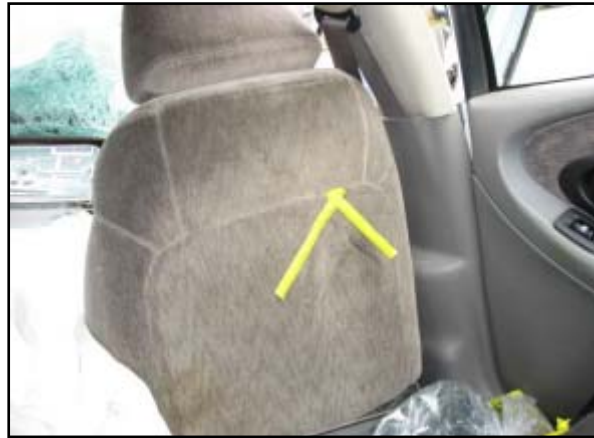
Figure 9. Occupant contact to the rear of right front seat back.

This contact was evidenced by deformation of the seat back over an area that measured 13 cm (5 in) in height and 9 cm (3.5 in) in width. Although not considered an occupant contact point, the child passenger loaded the CRS which resulted in loading marks to the vehicle's seat cushion from the CRS.

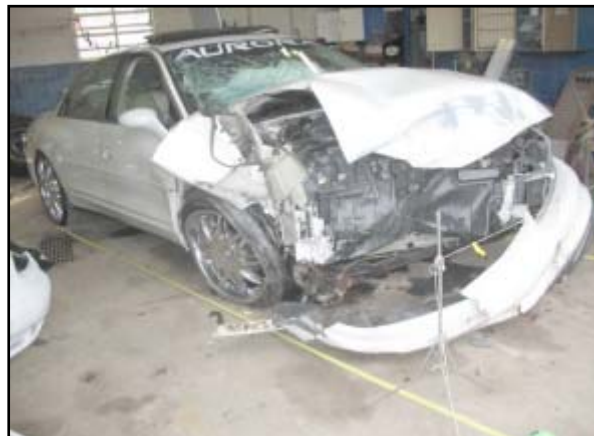
The 1997 Oldsmobile Aurora sustained severe damage as a result of the collision with the Chevrolet (Figure 10). The direct contact damage extended across the 142 cm (56 in) wide bumper fascia. The bumper beam was separated from its mounting points; therefore the crush documentation was obtained at the upper radiator support. The maximum crush was located 19 cm (7.5 in) inboard of the right end of the upper radiator support and was 83 cm (32.7 in) in depth. The crush profile along this component was as follows: C1 = 18 cm (7.1 in), C2 = 31 cm (12.2

Figure 10. Resultant damage to the front of the Oldsmobile.

in), C3 = 64 cm (25.2 in), C4 = 79 cm (31.1 in), C5 = 83 cm (32.7 in), C6 = 79 cm (31.1 in). The CDC for the impact with the Chevrolet was 12-FDEW-3.

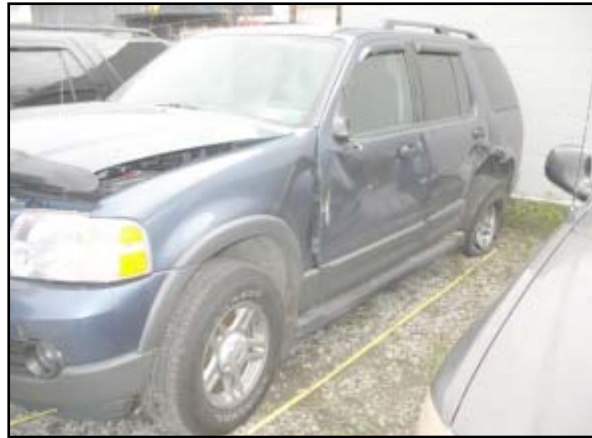
The 2003 Ford Explorer sustained moderate damage to the front and left side planes from this multiple event crash. The second event in this crash sequence consisted of the left plane of the Ford impacting the rear right aspect of the Oldsmobile. This impact resulted in sideswipe-type damage to the left fender and left front door areas on the Ford. The direct contact damage was 59 cm (23.2 in) in length and began 58 cm (23 in) rear of the left front axle. The direct contact damage extended to 117 cm (46 in) rear of the referenced point.

Figure 11. Overall view of the left side damage.

Minor lateral deformation of approximately 4 cm (1.5 in) in depth occurred during this event. In addition to the deformation, the side view mirror was fractured and separated from its mount. The resultant CDC for this impact was 12-LYES-1.

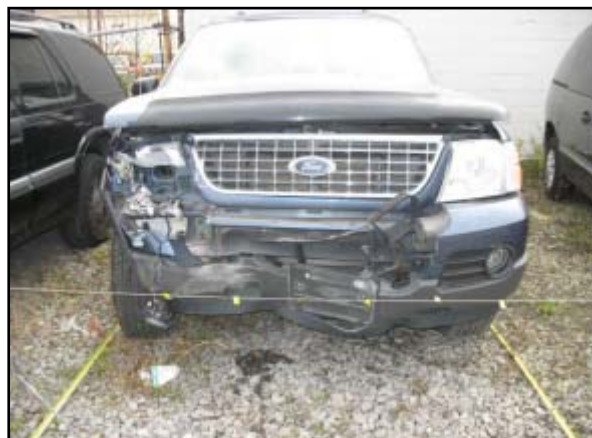
The Ford departed the roadside where it impacted a concrete wall (Event 4). This event resulted in moderate damage to the front of the Ford (**Figure 12**). The direct contact damage measured 100 cm (39.3 in) in width and began 19 cm (7.3 in) left of the centerline and

Figure 12. Frontal damage from the wall impact.

extended 81 cm (32 in) to the right corner. Longitudinal deformation was present at the bumper beam was documented at six points along the bumper beam. The maximum deformation occurred 22 cm (8.7 in) inboard of the right corner and measured 17 cm (6.7 in). The six crush measurements were as follows: C1 = 0 cm, C2 = 0 cm, C3 = 0 cm, C4 = 9 cm (3.5 in), C5 = 17 cm (6.7 in), C6 = 9 cm (3.5 in). The CDC for this frontal impact was 12-FDEW-1.

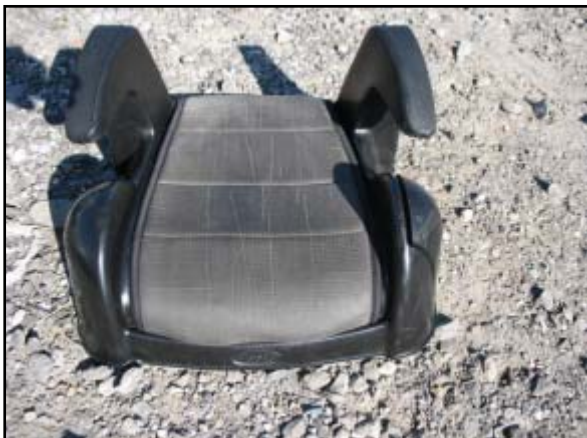
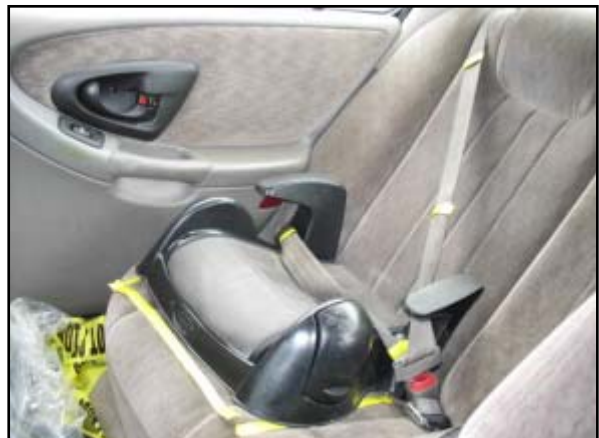
The 5-year-old male was positioned in a Cosco/Dorel High Rise backless booster seat (**Figures 13 and 14**) and was restrained by the vehicle's lap and shoulder belt system.

In this crash, the backless booster seat was used to position the 5-year-old male passenger in the rear right of the vehicle. These types of booster seats are designed to raise the profile of the child passenger to correctly position the vehicle's safety belt across the child. Based on the loading evidence on the belt webbing, the lap and shoulder portions were snug against the child. There was no crash related damage to the safety seat; however, minor surface scratches were scattered throughout the shell of the seat.
