TRANSPORTATION RESEARCH CENTER

SCI-NASS COMBINATION INFLATABLE CURTAIN WITH EJECTION INVESTIGATION

CASE NUMBER - 2009-11-016A
LOCATION - Michigan
VEHICLE - 2007 MERCURY MARINER
CRASH DATE - January 2009

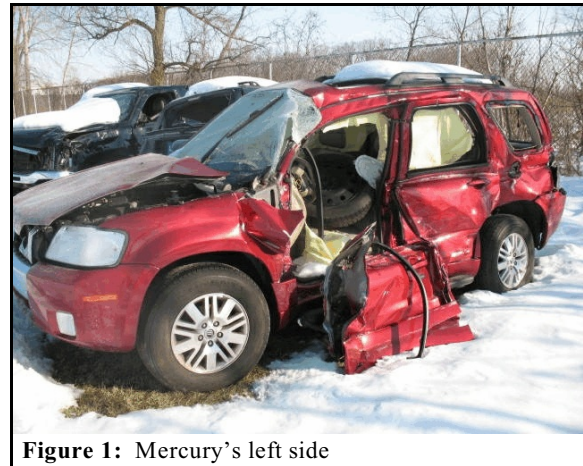
Figure 1: Mercury's left side

Exterior Damage: The Mercury sustained direct contact on its left side from its impact with the rear of the semi-trailer, longitudinally from slightly aft of the front door hinges rearward to the rear bumper corner and vertically from the mid-door to the roof rail **Figures 1, 4 and 5**). The Mercury's left side structures above the belt line engaged the back surface of the semi-trailer's cargo box. All of

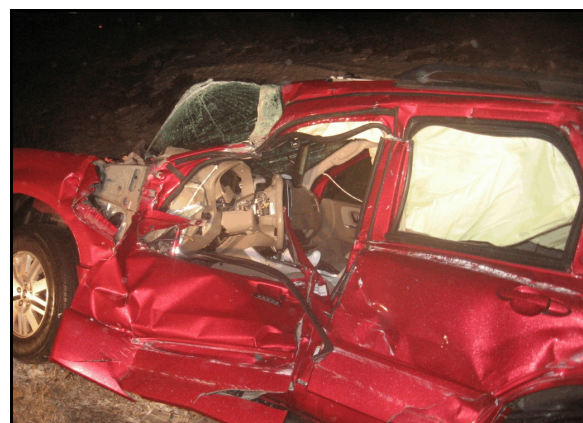
Figure 4: On-scene view of Mercury's left side damage, after extrication of the occupants

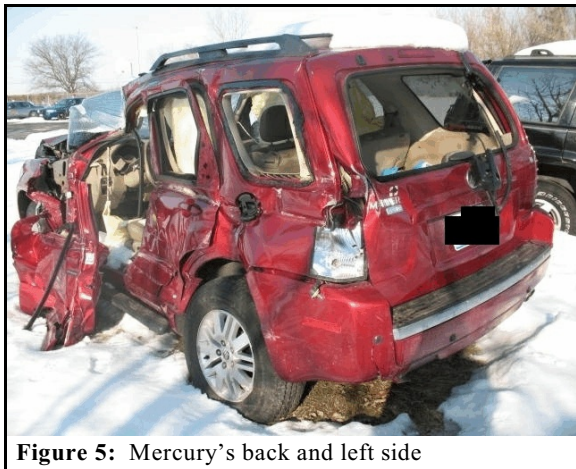
Figure 5: Mercury’s back and left side

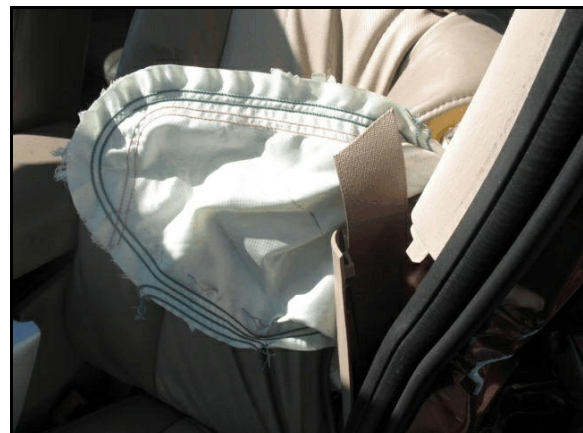
Figure 7: Driver's seat-mounted side impact air bag, showing the outboard surface of the air bag and the stub of the driver's safety belt, which was cut by emergency response personnel

The driver's seat-mounted side impact air bag deployed via a pre-stressed seam in the upholstery on the outboard edge of the driver's seat back (**Figure 7**). There was no evidence of damage to the air bag and no evidence of occupant contact.

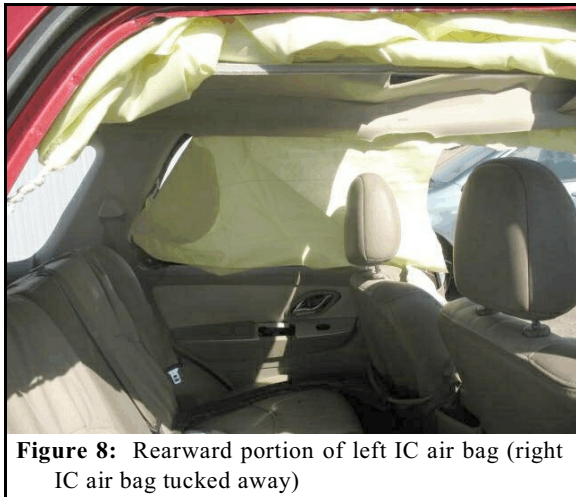
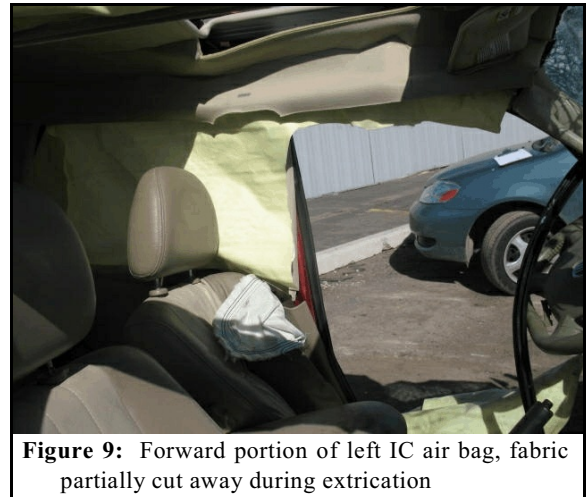
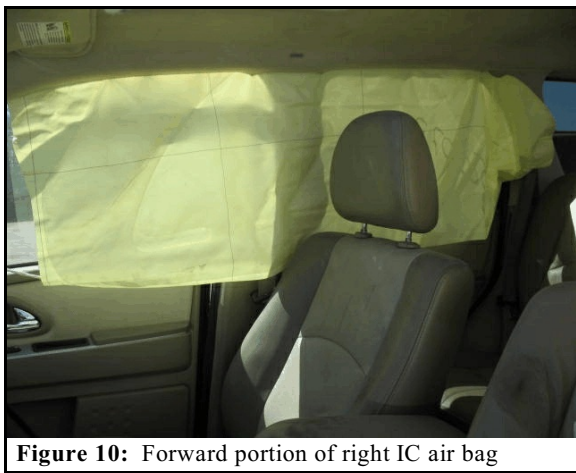
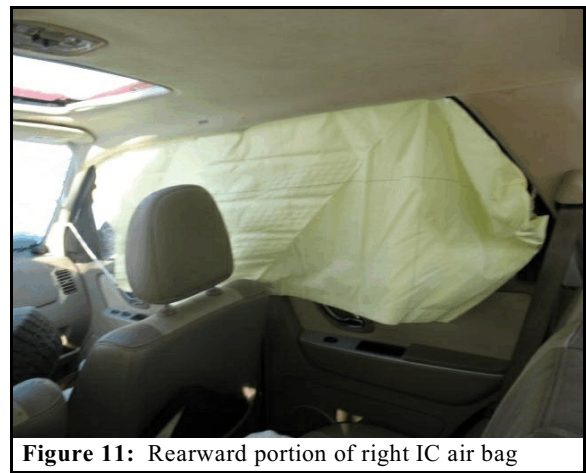
The left (**Figures 8 and 9**) and right (**Figures 10, 11, 12**) IC air bags deployed from behind a trim panel that runs along the junction of the respective side structures and the roof. Both IC air bags extended down to slightly below the base of the side window glazing. The forward edges of the deployed IC air bags extended to the junction of the respective A-pillars and the roof rails and were approximately perpendicular to the roof rails. The A-pillars slope forward and there was a triangle-shaped gap that was not covered by the deployed IC air bags, between the forward edge of the IC air bags and the A-pillars (**Figure 12**). The front lower corner of each IC was tethered to the respective A-pillars and the back lower corner was tethered to the respective C-pillars. There was no evidence of contact on either IC air bag. The fabric of the left IC air bag was sliced away from the driver's seat area during extrication.

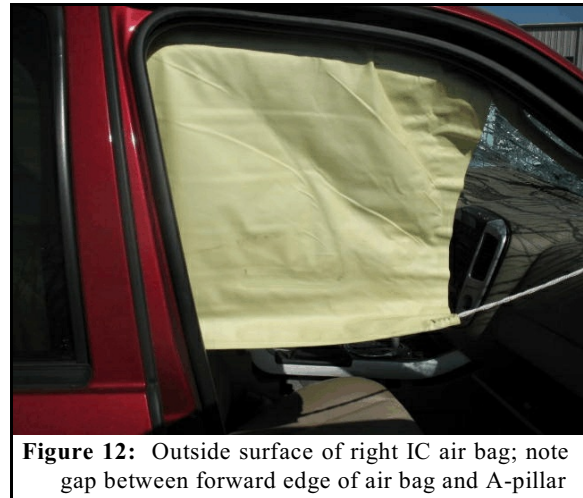
Figure 12: Outside surface of right IC air bag; note gap between forward edge of air bag and A-pillar

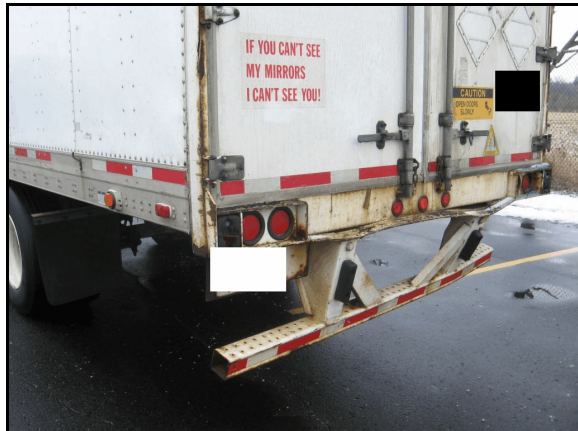
The other vehicle was a 1996 International 9200 6x4 truck tractor (VIN: 2HSFMAHR6TC-----) coupled to a single box van semi-trailer (VIN: unknown). Damage to the tractor-trailer was limited to the rear underride guard and the components on the under side of the trailer's cargo deck where the underride guard was attached (**Figures 13 - 16**). The Truck Deformation Classification (TDC) for the International tractor-trailer is **07BDAWA** (200 degrees). The International tractor-trailer was towed to an impound lot, but not due to damage.

Figure 13: Back of semi-trailer, view from left rear

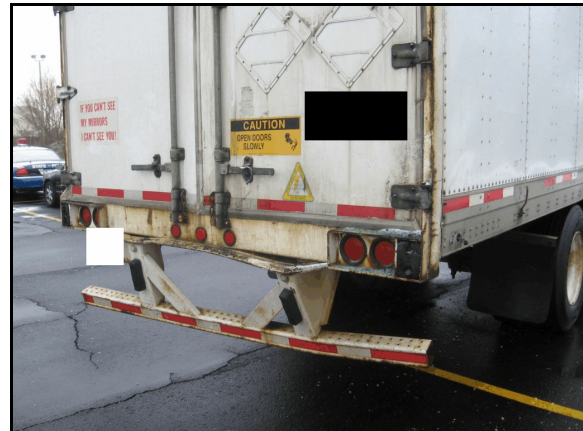
Figure 14: Back of semi-trailer, view from right rear
