Child Restraint System Investigation
Dynamic Science, Inc. (DSI), Case Number DS09003
2002 Mitsubishi Montero
California
January 2009

14. Sponsoring Agency Code	
15. Supplemental Notes				
16. Abstract <p>This on-site investigation focused on the child restraint systems that were installed in the second row of a 2002 Mitsubishi Montero. The Mitsubishi was occupied by a 32-year-old male driver, a 27-year-old female front row right occupant, a 3-year-old female second row left occupant who was restrained in a backless booster seat, an 8-year-old second row middle occupant, and a 4-year-old male second row right occupant who was restrained in a backless booster seat. This two-vehicle crash occurred in January 2009 at 0255 hours. The Mitsubishi was traveling southbound on an interstate highway. The other vehicle was a 2004 Mazda RX8 that was being driven by a 25-year-old male. The Mazda was traveling southbound, and initiated a lane change prior to the impact. The front end of the Mazda impacted the rear end of the Mitsubishi. After the initial impact, the Mitsubishi initiated a rollover, struck a guardrail, and then impacted a utility pole. The driver of the Mitsubishi sustained mult

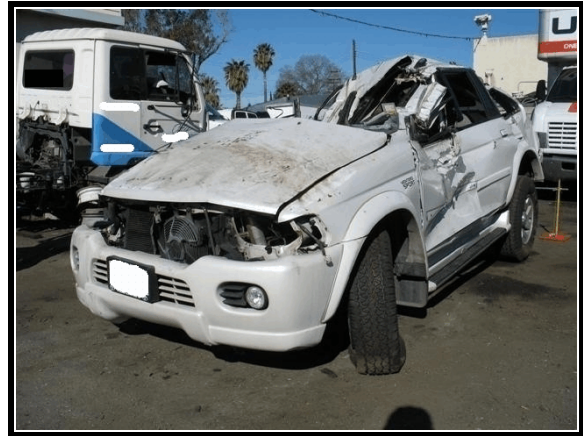
This on-site investigation focused on two child seats that were installed in the second row of a 2002 Mitsubishi Montero (Figure 1). The Mitsubishi was occupied by a 32-year-old male driver, a 27-year-old female front row right occupant, a 3-year-old female second row left occupant who was restrained in a backless booster safety seat (BSS), an 8-year-old second row middle occupant in a lap belt, and a 4-year-old male second row right occupant who was restrained in a backless BSS. This two-vehicle crash occurred in January 2009 at 0255 hours. The Mitsubishi was traveling southbound on an interstate highway. The other vehicle was a 2004

Figure 1. 2002 Mitsubishi Montero Sport

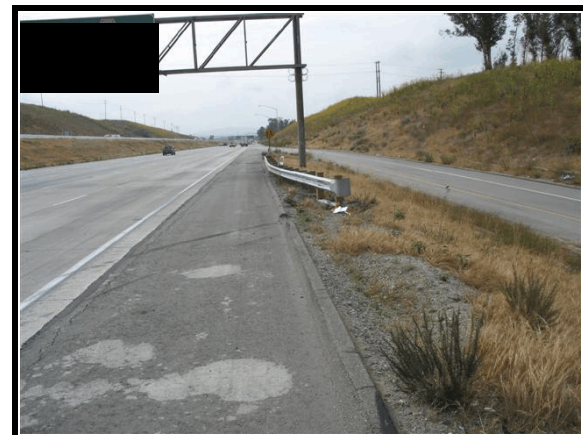
Figure 3. Area of rollover, guardrail contact, and pole impact (skid on shoulder not related to this crash)

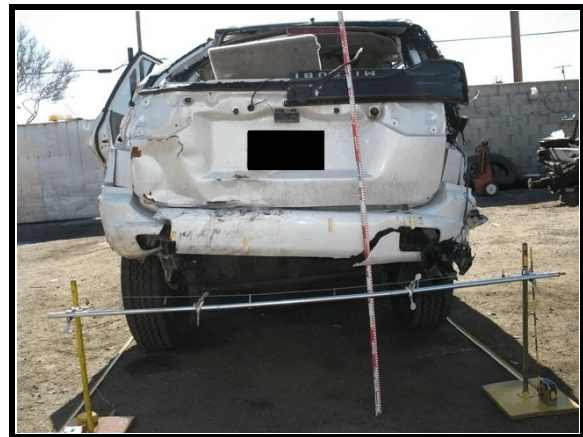
The Mitsubishi sustained moderate rear-end damage from the impact with the Mazda (**Figure 4**). The direct damage began at the left rear bumper corner and extended 82 cm (32.3 in) to the right. Six crush measurements were documented at the bumper level as follows: $C_1 = 14$ cm (5.5 in), $C_2 = 18$ cm (7.0 in), $C_3 = 14$ cm (5.5 in), $C_4 = 8$ cm (3.1 in), $C_5 = 5$ cm (1.9 in), $C_6 = 3$ cm (1.2 in). The Mazda underrode the Mitsubishi and impacted the rear axle stabilizer bar (**Figure 5**). The distance from the reference line to the stabilizer bar measured 94 cm (37 in). The distance from the reference line to the differential measured 101 cm (39.8 in). There was 93 cm (36.6 in) of direct contact to the bar. The Collision Deformation Classification (CDC) for the impact with Mazda was 06BYEW1.

Figure 5. Rear end damage

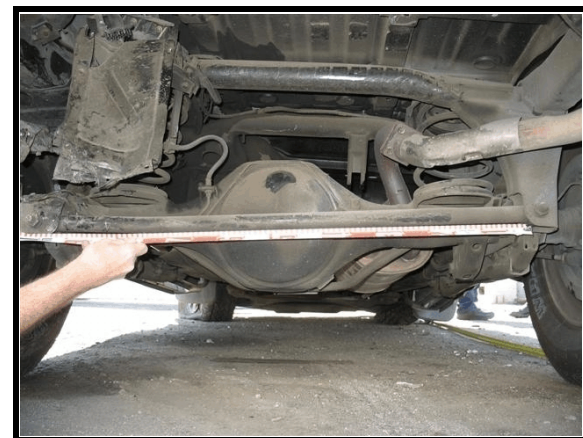
Figure 4. Rear axle stabilizer contact

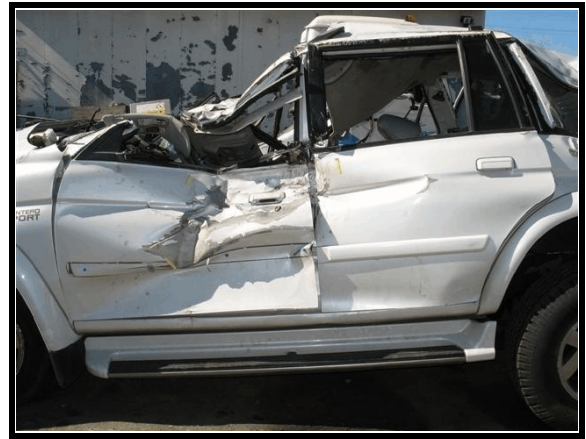
The vehicle sustained moderate non-horizontal left side damage as a result of the contact to the top

of the guardrail (**Figure 6**). The direct damage began 115 cm (45.3 in) forward of the rear axle and extended 60 cm (23.6 in) forward. The direct and induced damage began 28 cm (11 in) forward of the rear axle and extended 190 cm (74.8 in) forward. Six crush measurements were documented at the upper door level as follows: $C_1 = 0$ cm, $C_2 = 2$ cm (0.8 in), $C_3 = 11$ cm (4.3 in), $C_4 = 22$ cm (8.7 in), $C_5 = 10$ cm (3.9 in), $C_6 = 0$ cm. The CDC for impact with the guardrail was 00LPAW3.

Figure 6. Left side damage from guardrail

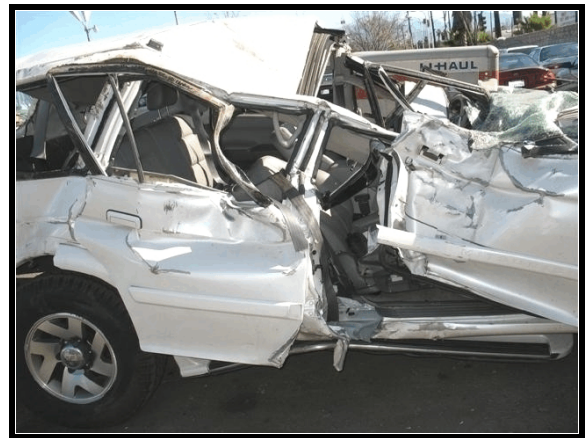
The vehicle sustained severe non-horizontal damage to the right as a result of the impact with the metal pole (**Figure 7**). The direct damage began 82 cm (32.2 in) aft of the front axle. The damage measured 39 cm (15.3 in) along the right front door. There was a 29 cm (11.4 in) gap between the aft edge of the door panel to the B-pillar. The direct damage continued rearward for an additional 40 cm (15.7 in). The vertical damage extended from the sill to the roof side rail. The maximum lateral crush was located at the mid door area and measured 28 cm (11 in). The CDC for the pole impact was 00RPAW3.

Figure 7. Right side damage from pole

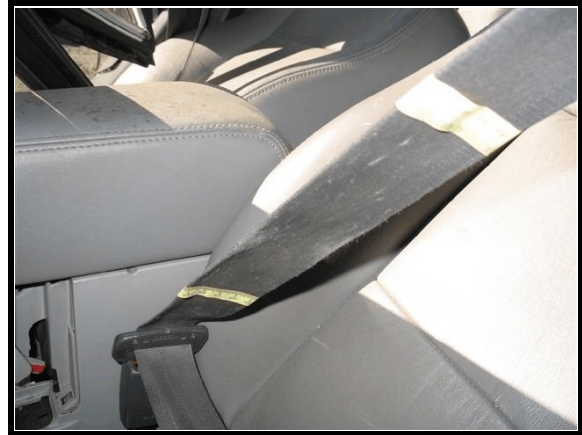
The Mitsubishi was configured with manual 3-point lap and shoulder belts for the outboard seating positions and a lap belt for the second row middle seat position. The front seat belts were configured with retractor pretensioners that did not actuate. The driver's safety belt was equipped with an anchorage adjustment that was in the mid-position. The front right safety belt was equipped with an anchorage adjustment that was in the full-up position. The driver's safety belt was configured with a sliding latch plate and an Emergency Locking Retractor (ELR). The remaining outboard safety belts were configured with sliding latch plates and switchable ELR/Automatic Locking Retractors (ALR). The driver's belt exhibited loading marks located 60 cm (23.6 in) from the anchor that measured 19 cm (7.5 in) in length (**Figure 8**).

Figure 8. Loading to driver's seat belt webbing

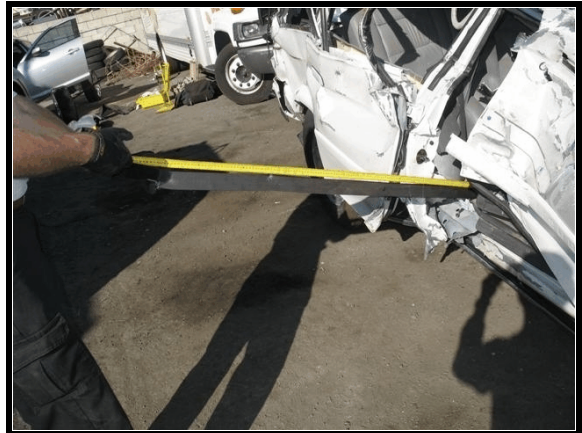
The front right latch plate was in the buckle at the time of the inspection. The belt webbing had been cut at a point 136 cm (53.5 in) from the lower anchor (**Figure 9**).

Figure 9. Front right safety belt

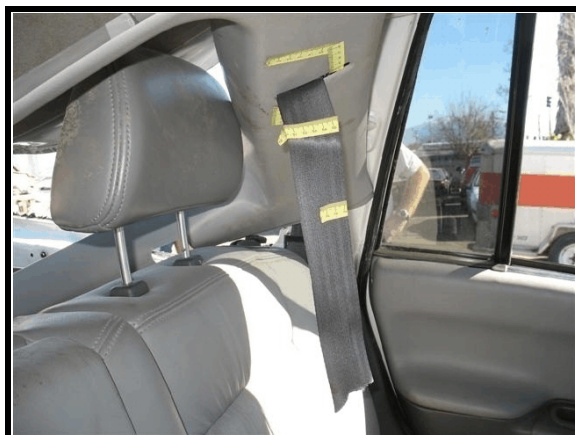
The second row left seat belt was being used in combination with a backless BSS (**Figure 10**). The belt had been cut by emergency personnel at a point 43 cm (16.9 in) from the anchor. The remaining segment of the webbing remained attached to the retractor and measured 79 cm (31.1 in) in length. An area of loading/bending was located 29 cm (11.4 in) from the D-ring. At the time the inspection, the cover over the C-pillar had been pulled away from the D-ring assembly.

Figure 10. Left rear safety belt

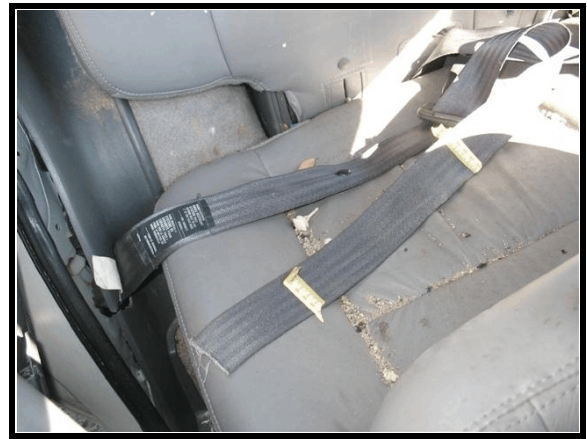
The second row right seat belt was being used in combination with a backless BSS (**Figure 11**). The belt webbing had been cut by emergency personnel. One segment of the webbing was attached to the retractor and the other to its corresponding anchor. The webbing segment was fully

wound within the retractor and would not unspool. The latch plate was found inserted into its corresponding buckle. The non-adjustable D-ring assembly was located in place; however, the cover over the C-pillar was missing. The segment of the belt webbing that was attached to the anchor measured 112 cm (44 in). The distance from the anchor to the plastic stop button measured 30 cm (11.8 in). Abrasions were observed on the side of the belt webbing that was in contact with the D-ring. The 21 cm (8.3 in) long abrasion began 11 cm (4.3 in) from the cut end of the belt and ended 80 cm (31.5 in) from the anchor.

Figure 11. Right rear safety belt

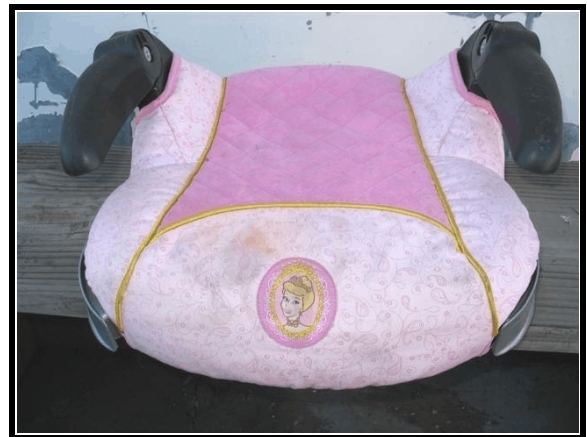
The second row left occupant was a 3-year-old female seated in a Dorel Eddie Bauer Auto Booster backless BSS (**Figure 12**). The model number was 22828-ENJ and the date of manufacture was 10/26/07. The seat was designed to be used by children whose weight was between 18.1-45.4 kg (40-100 lbs), whose height was between 110.1-144.8 cm (43-57 in), and whose age was greater than 1 year. The height and weight of the child using this seat is not known. The BSS was being used in combination with the vehicle's 3-point manual lap and shoulder belt.

Figure 12. Booster seat, second row left

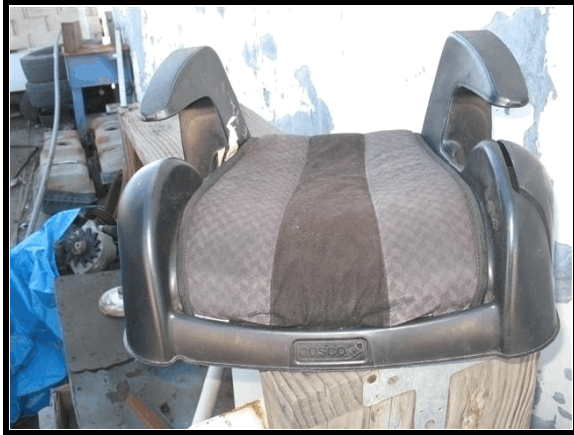
The 4-year-old male seated in second row right in a Cosco Ambassador backless BSS (**Figure 13**). The model number was 22-293-BVL and the date of manufacture was 7/19/2007. The seat was designed to be used by children whose weight was between 13.6-45.4 kg (30-100 lbs), whose height was between 85.1-144.8 cm (34-57 in), and whose age was greater than 1 year. The right rear occupant was within the recommended parameters for this child seat. The seat was being used in combination with the vehicle's manual 3-point lap and shoulder belt. It was indeterminate if the lap and shoulder belt was in the ELR or ALR mode at time of the crash. The outboard base of the seat sustained a V-shaped fracture (**Figure 14**). The 6 x 5 cm (2.4 x 1.9 in) fracture was oriented with

Figure 13. BSS, second row right

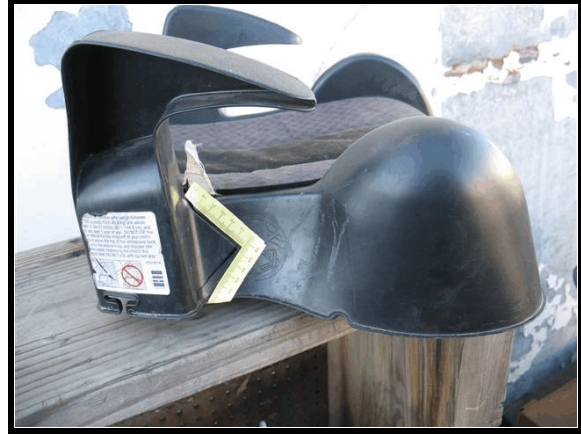
the bottom of the V pointed toward the front of the BSS. The damage was caused by the intrusion of the right interior door surface. The seat pad exhibited regular usage and was soiled.

Figure 14. Right side BSS damage

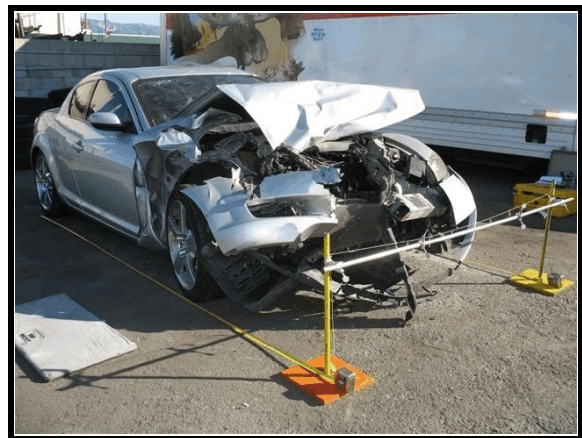
The Mazda sustained moderate front end damage as a result of the impact with the Mitsubishi (**Figure 15**). The direct damage began 55 cm (21.2 in) to the right of the left front bumper corner and extended 82 cm (32.2 in) to the right. The bumper fascia was fractured and displaced. The bumper backing bar had separated from the bumper mount, and had been pulled forward as the vehicles disengaged. Crush measurements were taken at the bumper level and at the upper radiator support level. The crush measurements were averaged and the resultant crush profile was as follows: $C_1 = 0$ cm, $C_2 = 0$ cm, $C_3 = 8$ cm (3.1 in), $C_4 = 18$ cm (7.0 in), $C_5 = 23$ cm (9.0 in), and $C_6 = 19$ cm (7.5 in). The CDC for the impact with Mitsubishi was 12FZEW2.

Figure 15. Other vehicle, 2004 Mazda RX-8

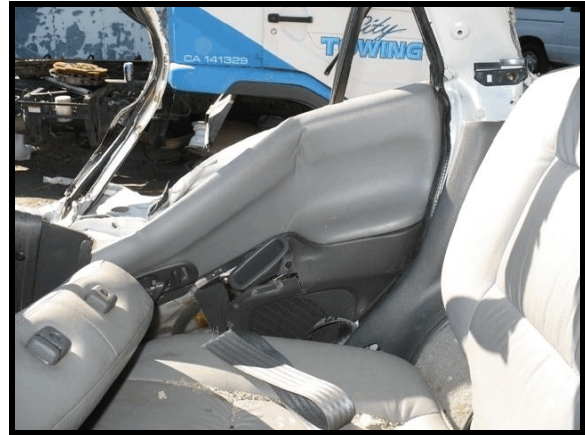
The second row right 4-year-old male occupant was in a BSS and was using the manual lap and shoulder belt. This occupant was displaced rearward during the impact with the Mazda, and as the vehicle rolled, he was displaced to the left and right. The seat belt webbing showed evidence of loading. The BSS did not exhibit any signs of occupant loading, but was cracked from the intruding right rear door. Due to the extended rollover sequence, this occupant was moving about his seating position, which resulted in the webbing being spooled out just prior to the impact with the pole. This occupant was partially ejected through the second row right side window during the rollover, and his torso was positioned between the right B-pillar and the pole at impact. There was an indentation across his left chest due to the body's positioning between the B-pillar and pole. He sustained multiple blunt force injuries, including: separation between 1st and 2nd cervical vertebrae, a basilar skull fracture, subdural and subarachnoid hemorrhage, subcutaneous hemorrhages of scalp, left clavicle fracture, left 1st through 3rd rib fractures, and multiple contusions, abrasions, and lacerations. According to the coroner, the presence of petechiae around both eyes and lower eyelids in conjunction with the positioning of the body indicated there may have been a component of mechanical asphyxia. He was pronounced deceased at the scene.

Figure 16. Right rear occupant seating position
