**CALSPAN ON-SITE SIDE IMPACT INFLATABLE OCCUPANT PROTECTION  
SYSTEM CRASH INVESTIGATION**

**SCI CASE NO: – CA09007**

**VEHICLE – 2005 NISSAN MAXIMA 3.5 SL**

**CRASH DATE – FEBRUARY 2009**

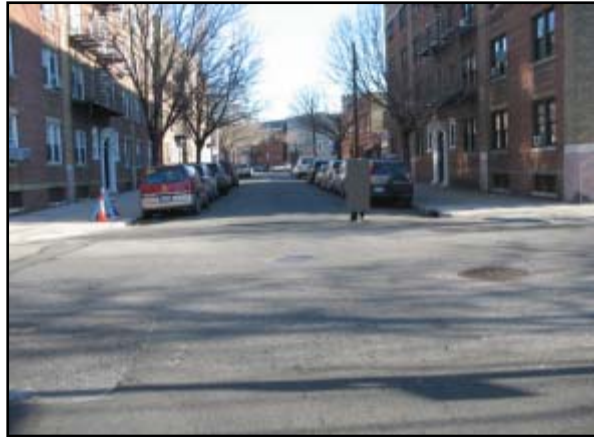
The front left aspect of the Chevrolet impacted the right front of the Nissan within the intersection. **Figure 4** is a view of the area of impact from the Nissan's northbound approach. The resultant directions of force for the Nissan and the Chevrolet were within the 3 and 12 o'clock sectors, respectively. The Damage Algorithm of the WinSMASH program was used to compute the severity of the crash (delta-V). The total velocity change for the Nissan was 12 km/h (8 mph), with a longitudinal component of -2

**Figure 4. Area of impact from the northbound approach of the Nissan.**

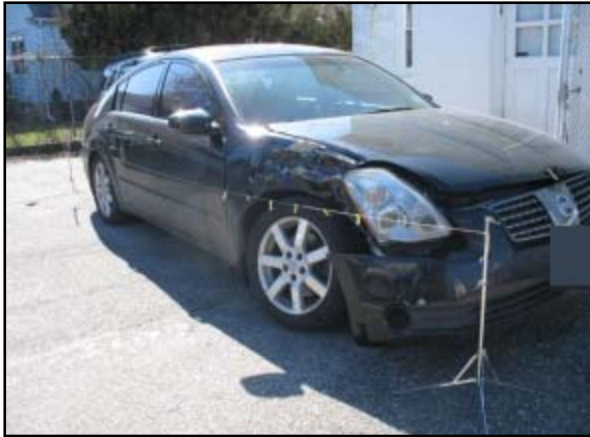
The exterior of the Nissan sustained moderate severity damage as a result of the intersection crash (**Figures 5 and 6**). The direct contact damage for the impact with the Chevrolet began 257 cm (101") forward of the right rear axle and extended 113 cm (45") forward to the right front bumper corner. The maximum crush measured 14 cm (5.5") and was located 337 cm (133") forward of the right rear axle. The impact involved the right front tire and wheel resulting in lateral deformation of the strut tower. A crush profile was documented along the right fender and was as follows: C1 = 0 cm, C2 = 3 cm (1.2"), C3 = 12 cm (4.7"), C4 = 14 cm (5.5"), C5 = 13 cm (5.1"), C6 = 0 cm. The Collision Deformation Classification (CDC) for this impact was 03-RFEW-2. The four doors remained closed during the crash and were operational at the time of the SCI

**Figure 5. Overall view of the right front damage.**

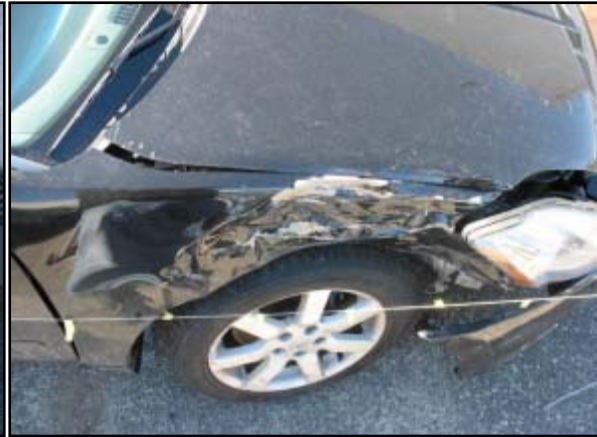
**Figure 6. Overhead view of the deformation.**

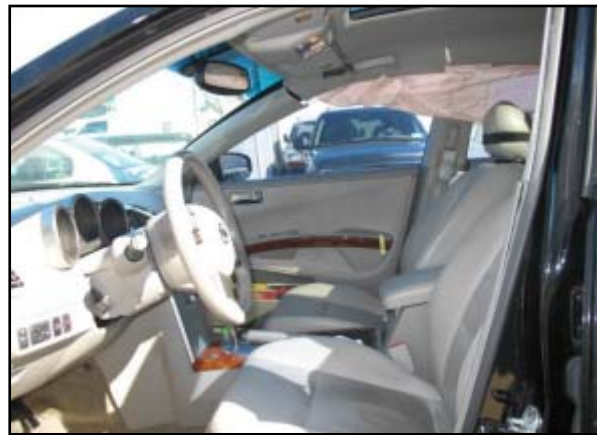
Inspection of the passenger compartment of the Nissan was unremarkable. There was no intrusion or interior damage associated with the exterior crash force. There was no observed evidence of interior occupant contact points. A fabric transfer was noted to the wood trim of the right front door panel from contact with the deploying front right seat back mounted air bag.

**Figure 7. Front passenger compartment area.**

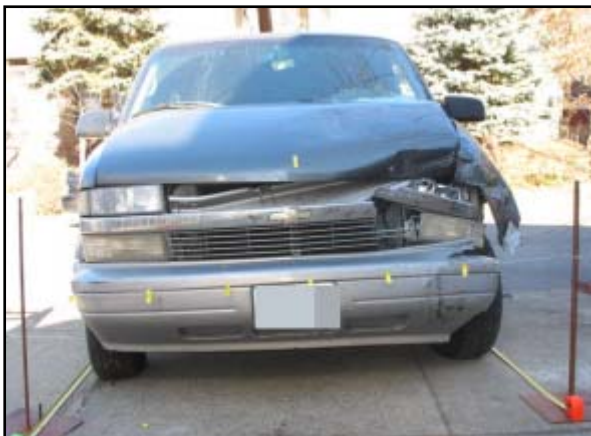
The 2000 Chevrolet Astro sustained moderate damage as a result of the impact with the Nissan (**Figures 8 and 9**). The direct contact damage was confined to the center and left aspects of the front plane and measured 103 cm (40.5”) in width. The direct damage began 13 cm (5”) right of the centerline and extended 90 cm (35”) to left bumper corner. The maximum crush measured 11 cm (4.3”) and was located at the front left bumper corner. Six equidistant crush measurements were documented along the bumper beam of the vehicle and were as follows: C1 = 11 cm (4.3”), C2 = 0 cm, C3 = 0 cm, C4 = 0 cm, C5 = 0 cm, C6 = 0 cm. The CDC assigned for this impact was 12-FYEW-1.

**Figure 8. Residual frontal damage to the Chevrolet.**

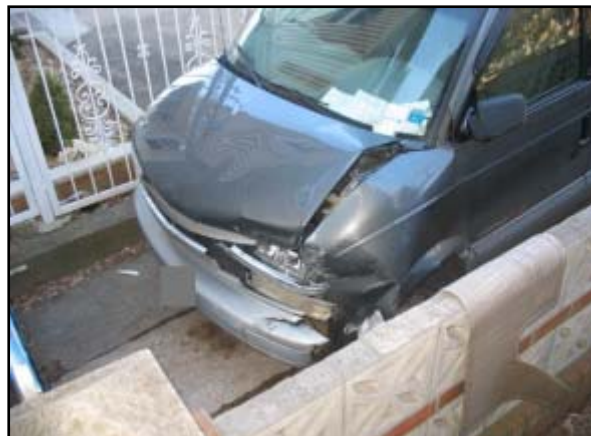
**Figure 9. Oblique view of the residual frontal damage.**

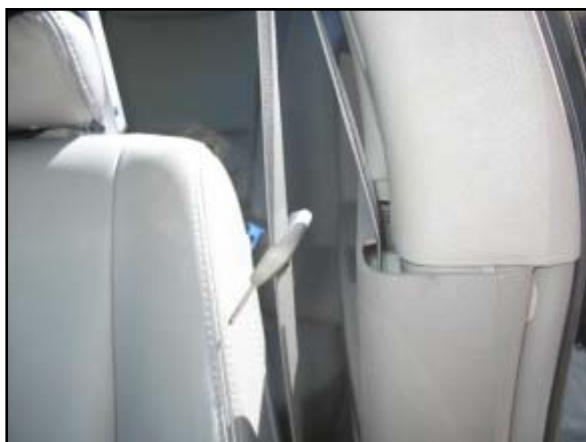
The Nissan was equipped with manual 3-point lap and shoulder safety belts for the five designated seat positions. All belt systems utilized continuous loop webbing with sliding latch plates. The driver's belt was equipped with an Emergency Locking Retractor (ELR) and a retractor pretensioner. The upper D-ring was adjustable and was set to the full-up position. The driver used the safety belt at the time of the crash; however, this low delta-V crash did not produce any evidence of frictional abrasions to the latch plate or transfers to the webbing. Evidence of usage at the time of the crash consisted of the B-pillar trim panel that was dislodged from its mounting points from the driver loading of the belt system (**Figure 10**). The driver's pretensioner did not actuate during the crash.

**Figure 10. Dislodged left B-pillar trim panel.**

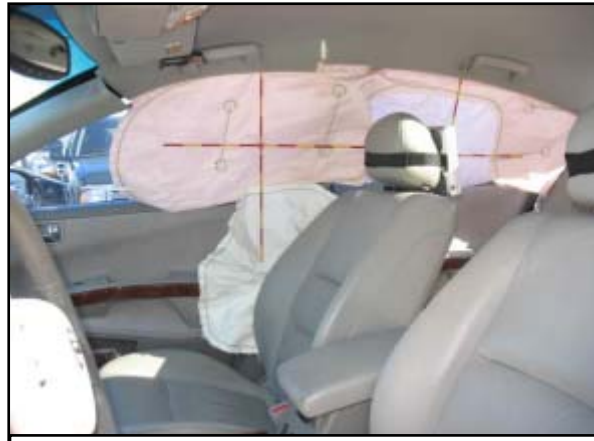
The Nissan was equipped with front seat back mounted side impact air bags and roof rail mounted side impact curtain air bags. The right seat back mounted air bag and the right curtain air bag deployed during the crash (**Figure 11**).

**Figure 11. Deployed right side impact air bag system.**

The right curtain air bag deployed from the roof rail. The air bag membrane measured 164 cm (64.6") in length. At the front right seating position, the membrane measured 38 cm (15") in height extending 4 cm (1.6") below the top of the beltline. The height of the curtain air bag membrane at the right rear position was 38 cm (15") and extended 6 cm (2.4") below the beltline. The height of the curtain air bag membrane provided head protection from the roof rail to belt line of the vehicle.

The curtain air bag was equipped with a single tether at the A-pillar, which measured 60 cm (23.6") in length. Longitudinally, the coverage area of this curtain air bag did not span across the full length of the right front glazing. A triangular shaped gap was present which began at the A-pillar and extended 47 cm (18.5") rearward. In height, the gap measured 37 cm (14.6").

The rear aspect of the curtain air bag contained a non-inflatable section. This section was rectangular in shape and measured 48 cm (18.9") in length and 30 cm (11.8") in height. This non-inflatable section was located 36 cm (14.2") forward of the C-pillar and extended forward 84 cm (33") of the referenced point. The curtain air bag was free of damage and occupant contact points.

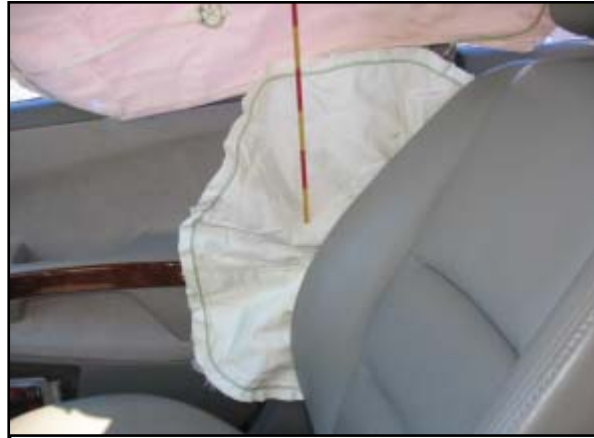
The right seat back mounted side impact air bag was concealed within the outboard aspect of the seat back. The air bag deployed through a 50 cm (19.7”) tear seam at the forward aspect of the seat back. The air bag membrane measured 54 cm (21.2”) in height and 30 cm (11.8”) in width and was comprised of two panels sewn together at the forward edge. The air bag membrane extended vertically beyond the curtain air bag 12 cm (4.7”). There was no damage or occupant contact points to the seat back mounted side air bag. **Figure 12** depicts the inboard aspect of the right seat back mounted side impact air bag,

**Figure 12. Right seat back mounted side impact air bag.**
