On-Site Child Restraint System Investigation  
Dynamic Science, Inc. (DSI), Case Number DS09007  
2001 Pontiac Sunfire SE  
Washington  
January 2009

1. Report No. DS09007	2. Government Accession No.	3. Recipient Catalog No.	
4. Title and Subtitle  Child Safety Seat Investigation		5. Report Date  October 23, 2009

This on site investigation focused on a child restraint system (CRS) installed in a 2001 Pontiac Sunfire SE that was involved in a two-vehicle crash (**Figure 1**). The subject vehicle was being driven by a restrained 35-year-old male. A 13-month-old female seated in a forward-facing Cosco/Dorel Regal Ride CRS occupied the second row center seat position. The crash occurred in January 2009 in the state of Washington. The other vehicle was a 1985 GMC K3500 pickup truck that was being driven by a 39-year-old male. The crash site was a two-lane north/south state highway.

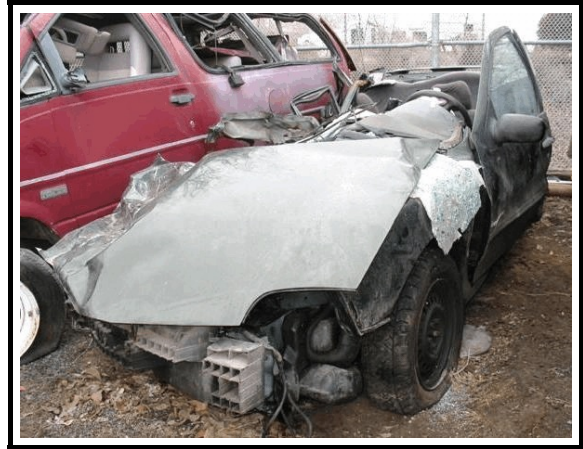
**Figure 1.** Subject vehicle, 2001 Pontiac Sunfire SE

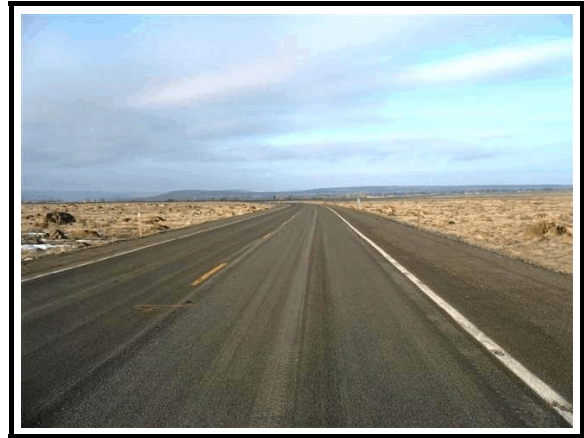
The crash site was a two-lane, north/south undivided state highway (**Figure 2**). The roadway comprised one bituminous lane for each direction of travel and each lane measured 3.7 m (12.2 ft) in width. The travel lanes were separated by a single yellow dashed stripe and were bordered on the edges by white fog lines. Outboard of the travel lanes were paved shoulders followed by descending gravel shoulders. The east paved shoulder measured 1.9 m (6.3 ft) in width and the gravel shoulder measured 3.1 m (10.0 ft) in width. The west paved shoulder measured 2.2 m (7.1 ft) in width and the gravel shoulder measured 3.1 m (10.0 ft) in width. The roadway character was a slight curve left for northbound traffic, a slight curve right for southbound traffic; and the profile was level and the roadway surface was dry. The speed limit at this location was 97 km/h (60 mph).

**Figure 2.** Crash site, northbound approach

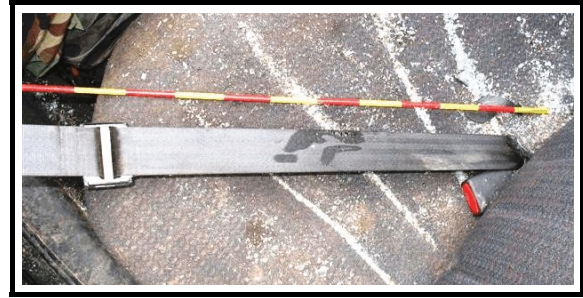
The second row center seat was equipped with a non-retractable lap belt and a locking latch plate (**Figure 4**). The belt was used to secure a Cosco/Dorel Regal Ride CRS. The safety belt webbing measured 45 cm (17.7 in) from the seat cushion to the buckle with 51 cm (20.1in) of excess webbing extending past the buckle. A measurement of the CRS indicated that the latch plate was adjusted to the approximate length needed to install the CRS in the vehicle. The latch plate was scratched and the webbing had conformed to the shape of the cinching mechanism indicating historical usage.

**Figure 4.** Second row center safety belt used to secure CRS

The safety belt webbing revealed a scuff to the inner side that began 10 cm (3.9 in) from the seat cushion and measured 7 cm ( 2.8 in) in length and 3 cm (1.2 in) in width. The location and nature of the scuff correlated to load marks on the belt path slot on the left side of the CRS shell. The scuff was evidence of occupant loading of the belt during the crash. A section of webbing contained three dried fluid deposits that began 20 cm (7.8 in) from the seat cushion and measured 10 cm (3.9 in) in length and 4 cm (1.6 in) in width. The affected area was routed within the CRS shell at the time of the crash and the source of the deposits was not identified.

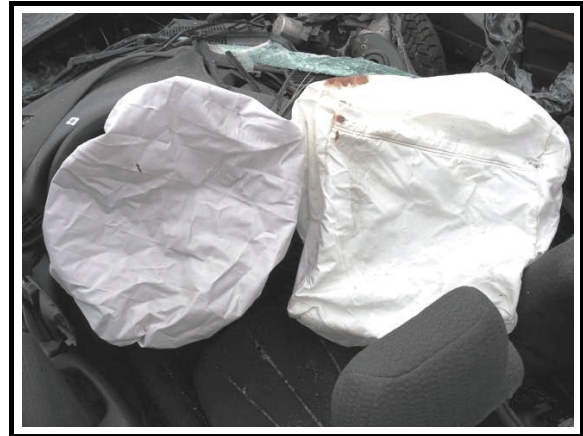
The air bag revealed evidence of occupant loading and contact damage. A blood deposit measuring 1 x 2 cm (0.4 x 0.8) in size and was located in the upper left quadrant, 15 cm ( 5.9 in) left of center. Within the same quadrant was a transfer of skin oil that measured 5 x 9 cm (2.0 x 3.2 in) and was located 15 cm ( 5.9 in) above center.

**Figure 5.** Frontal air bags deployed

The air bag revealed a 4 cm (1.6 in) tear and two small scuffs that were located in the upper right quadrant of the back panel. The damage probably was a result of contact with the windshield glazing. A 1 cm (0.4 in) tear on the upper aspect of the back panel resulted from contact with a corner of the right cover flap. The air bag's front panel revealed vinyl striations that were deposited by the cover flaps at deployment.

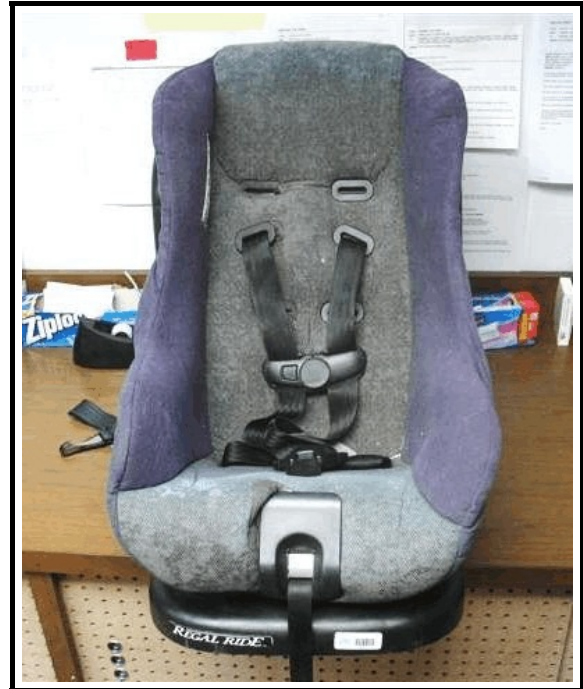
The 13-month-old female second row center position occupant was seated in a forward-facing Cosco/Dorel Regal Ride CRS and restrained by the seat's 5-point harness system (**Figure 6**). The CRS's model number was 22-110-BRS and the date of manufacture was 12/28/2004. The convertible CRS was designed to be used either forward or rear facing. The 5-point harness system was configured with a 2-part retainer clip and a lower buckle that received latches from the two leg straps. The shoulder harness straps were routed through the middle set of slots. The Regal Ride was configured with LATCH straps and hardware, although they were not used to install the CRS.

**Figure 6.** Cosco/Dorel Regal Ride CRS

The CRS was damaged by a combination of occupant loading and vehicle intrusion contact. The safety belt routing slots on the left and right sides revealed scuff marks where the child and CRS loaded the safety belt. The right side of the shell revealed damage in the form of fractures, holes, gouges and discoloration. An irregularly shaped fracture on the right side began on the outboard edge and extended 9 cm (3.5 in) inboard. The plastic shell was deformed at the inboard aspect of the fracture and a 2 x 3 cm (0.8 x 1.2 in) hole was present. A crack that measured 4 cm (1.6 in) was located 12 cm (4.7 in) above the aforementioned fracture. A 1 cm (0.4 in) gouge mark was located 4 cm (1.6 in) above the crack.

The right side of the CRS shell also revealed evidence of stress in the form of discoloration of the plastic that was lighter in appearance than the undamaged areas. The stressed areas were intermittent beginning at the bottom edge and extending up the right side for approximately 30 cm (11.8 in). The noted fracture, crack, and gouge mark fell within that area as well. The damage to the right side of the CRS shell was due to the intrusion of the right B-pillar and second row door panel.

The CRS's seat cushion exhibited evidence of occupant contact on its right aspect. An impression in the fabric cover measured 3 x 1 cm (1.2 x 0.4 in) and was located on the forward aspect of the inboard side panel. Based on the child's kinematics and injuries, her right leg possibly contacted the CRS shell at impact. Two small deposits of dried blood were noted on the upper right aspect of the cover, as well as one drop of dried blood on the upper left aspect. The fabric had separated from the buckle adjustment at the front of the seat cushion, probably resulting from occupant contact.

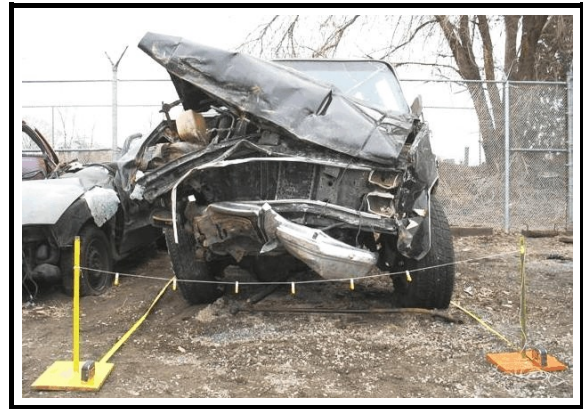
The GMC sustained moderate front end damage from the impact with the Pontiac (**Figure 7**). Measurement of direct damage to the frontal plane began at the front left bumper corner, extended 150 cm (59.1 in) along the damaged profile, and ended at the front right bumper corner. The Field L for the frontal damage measured 130 cm (51.2 in) from bumper corner to bumper corner. Six crush measurements were taken at bumper level as follows:  $C_1 = 14$  cm (5.5 in),  $C_2 = 15$  cm (5.9 in),  $C_3 = 58$  cm (22.8 in),  $C_4 = 67$  cm (26.4 in),  $C_5 = 64$  cm (25.2 in),  $C_6 = 91$  cm (35.8 in). Maximum crush at bumper level was located at  $C_6$  at the front right bumper corner. The CDC for the side impact was 12FDEW4.

**Figure 7.** Front end crush profile measurement, 1985 GMC K3500
