Certified Advanced 208-Compliant Air Bag Investigation  
Dynamic Science, Inc. (DSI), Case Number DS09008  
2007 Ford Fusion  
Washington  
December 2008

**Dynamic Science, Inc.**  
**Crash Investigation**  
**Case Number: DS09008**

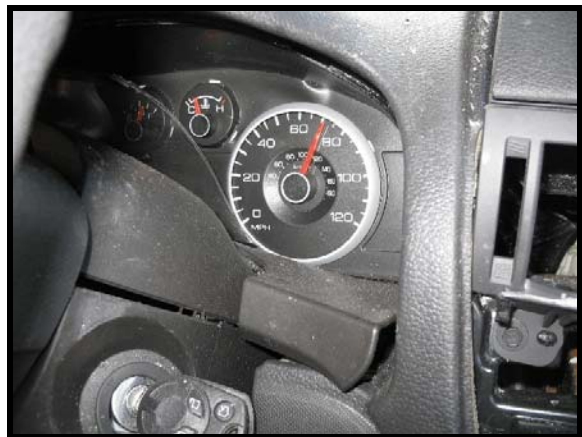
**Figure 5.** Ford speedometer needle position

The Ford was traveling northbound at approximately 114 km/h (71 mph) and had just passed over a hillcrest (**Figure 3**). The Lincoln was traveling southbound at approximately 64 km/h (40 mph) (**Figure 4**). The speeds were based on the post-crash positions of the speedometer needles in each vehicle (**Figures 5-6**). For unknown reasons, the driver of the Ford crossed the center line and entered the southbound travel lane into the path of the Lincoln.

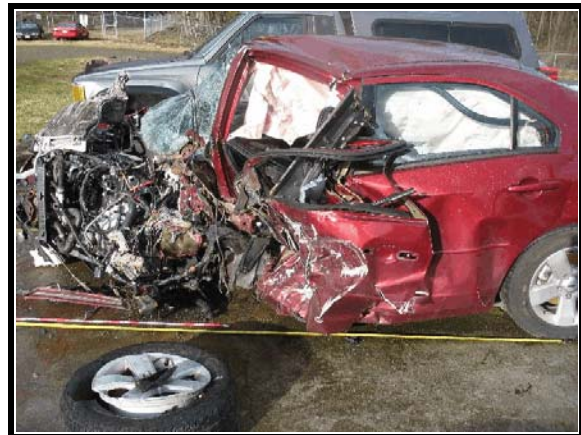
**Figure 8.** View of damage from left

The Ford sustained severe front end damage from the impact with the Lincoln (**Figure 8**). The direct damage began at the front left bumper corner and extended 80 cm (31.4 in) laterally to the right. The bumper fascia and backing bar were displaced from the vehicle. There was direct contact down the left side of the vehicle that began at the front left corner of the subframe, extended 102 cm (40.1 in) down the left side, and terminated 110 cm (43.3 in) forward of the rear axle. Both left side doors were jammed shut. The left front door was displaced rearward 29 cm (11.4 in) to the mid-point of the left rear door. The left front tire

rim/wheel assembly was fractured and displaced from the vehicle.

Six crush measurements were documented along the frontal subframe as follows:  $C_1 = 110$  cm (43.3 in),  $C_2 = 97$  cm (38.1 in),  $C_3 = 84$  cm (33 in),  $C_4 = 47$  cm (18.5 in),  $C_5 = 40$  cm (15.7 in),  $C_6 = 29$  cm (11.4 in). Two crush measurements were documented at the bumper mounting brackets as follows:  $C1 = 147$  cm (57.8 in) and  $C2 = 63$  cm (24.8 in). The right frame was shifted 93 cm (36.6 in) to the left. The Collision Deformation Classification (CDC) for the impact with the Lincoln was 12FYEW6.

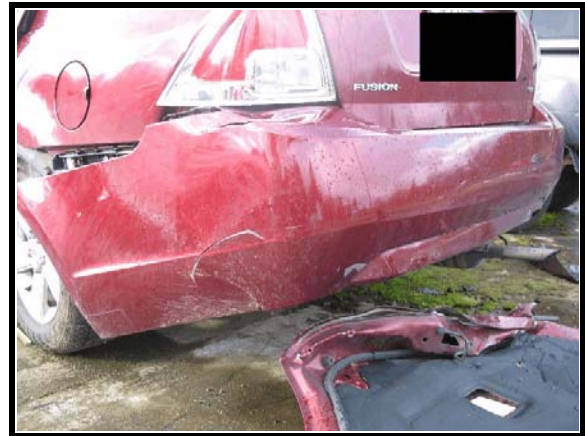
**Figure 9.** Left rear bumper damage

The Ford sustained minor damage to the left bumper corner as a result of the non-horizontal impact with the edge of the ditch (**Figure 9**). As the Ford departed the roadway, the back end of the vehicle dropped down into the ditch/embankment area. The direct damage began at the left bumper corner and extended 40 cm (15.7 in) laterally to the right. There was also direct contact up the left side of the vehicle that began at the bumper corner and extended 37 cm (14.6 in) forward along the left side. The CDC for the impact with the ditch was 00BLLE4.

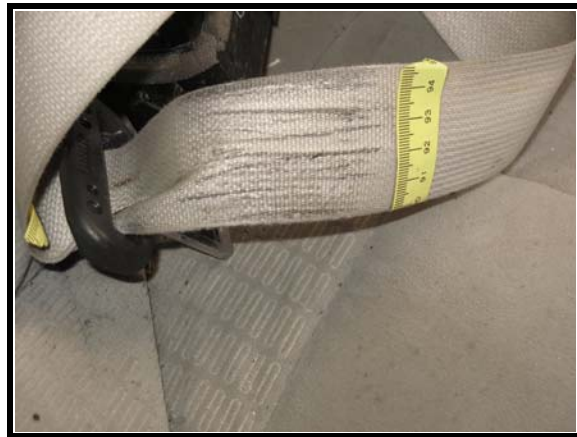
**Figure 10.** Loading to driver's safety belt

The Ford was configured with 3-point manual lap and shoulder belts for all five seating positions. The vehicle was equipped with driver and front passenger safety belt retractor pretensioners. The driver's seat belt anchorage adjustment was in the full-down position; the front right passenger's seat belt anchorage adjustment was in the full-up position. The driver's safety belt was configured with a sliding latch plate and an Emergency Locking Retractor (ELR); it was being used at the time of the crash. There was evidence of occupant loading to the belt webbing. The loading marks measured 8 cm (3.1 in) in length and began 20 cm (7.9 in) from the stop button (**Figure 10**). There was also a 5 cm (1.9 in) area of the belt that was trapped by the latch plate. The seat belt anchor was not visible due to the door intrusion.

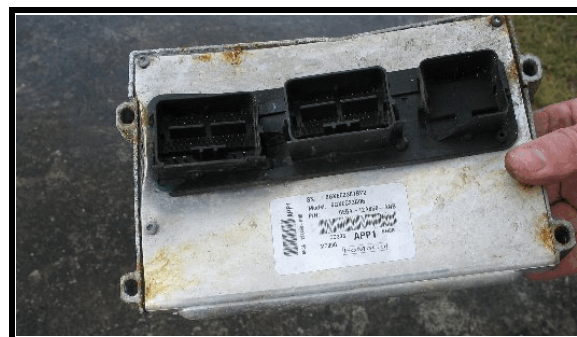
**Figure 11.** Damaged PCM

seconds of "pre-crash" and record 5 seconds of "post crash" data in the PCM's memory. The PCM was located on the left side of the firewall. Efforts were made by the investigating officers to image the data from PCM while it was still attached to the vehicle and then later after it had been removed, but the PCM was too badly damaged to provide any data (**Figure 11**).

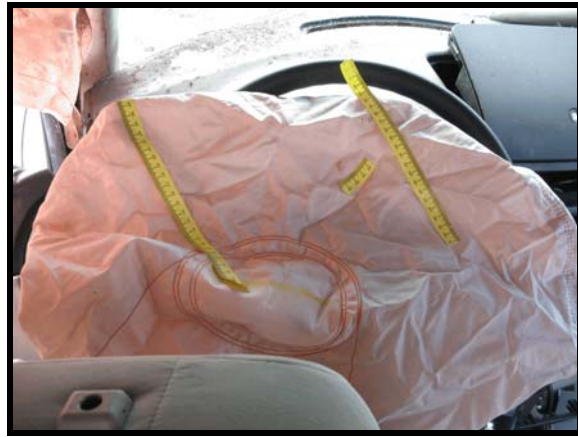
**Figure 12.** Driver's frontal air bag

The driver's frontal air bag deployed from the center of the steering wheel hub through H-configuration module cover flaps (**Figure 12**). The top flap measured 17.5 cm (6.9 in) in width and 5 cm (1.9 in) in height; the lower flap measured 17.5 cm (6.9 in) in width and 8 cm (3.1 in) in height. The deployed air bag measured 53 cm (20.8 in) in width in its deflated state. The air bag was tethered by a single internal flap. The tether was attached to stitched circle in the center of the air bag face. Two X-shaped vent ports that measured 5 cm (1.9 in) in diameter were located at the 11 and 1 o'clock aspects on the rear of the air bag. There was an area of linear scuffing to the upper air bag face that measured 23 cm (9 in) in width by 15 cm (5.9 in) in height. Within this area, there was 2 cm (0.8 in) deposit of dried fluid that may have been blood. In the center of the stitched circle on the face of the air bag there was a linear burn mark that measured 11 cm (4.3 in) in length by 0.5 cm (0.2 in) in width.

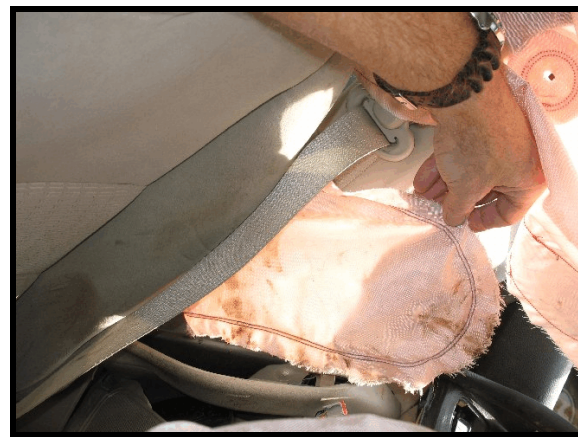
**Figure 13.** Driver's seat-mounted side air bag

The driver's seat-mounted side air bag deployed from the seat back through a rectangular module cover flap (**Figure 13**). The flap measured 11.5 cm (4.5 in) in length by 32 cm (12.6 in) in height. The deployed air bag was oval-shaped and measured 29 cm (11.4 in) in width and 18 cm (7 in) in height. There was a 1 cm (0.4 in) vent port on the outboard aspect of the bag. There were areas of blood located on the inner aspect of the air bag. The first area was located at the lower rear portion of the air bag and measured 9 cm (3.5 in) in height by 7 cm (2.5 in) in width. The second area was located at the forward middle portion of the air bag and measured 4 cm (1.6

in) in height by 9 cm (3.5 in) in width.

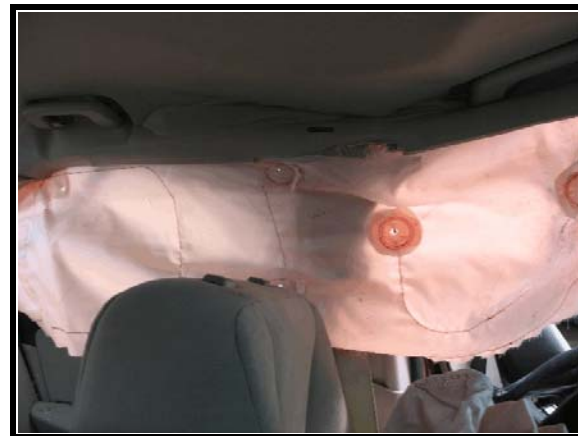
**Figure 14.** Left IC air bag

The left IC air bag deployed through the roof rail cladding from a module located at the roof side rail (**Figure 14**). The air bag was generally rectangular and measured 136 cm (53.5 in) in length and 40 cm (15.7 in) in height. The forward aspect of the air bag was attached to the left A-pillar by a triangular sail that measured 33 cm (12.9 in) in length and was 22 cm (8.7 in) in height at the point it attached to the air bag; the rear aspect of the bag was attached to the left C-pillar. The longitudinal area of coverage began near the midpoint A-pillar and extended to the C-pillar. The air bag's vertical coverage began at the roof rail and extended to approximately 3.0 cm (1.2 in) below the bottom of the side glass. There were no contacts or damage to the air bag. There was dirt, fluids, and glass fragments located on the outboard aspect of the air bag.

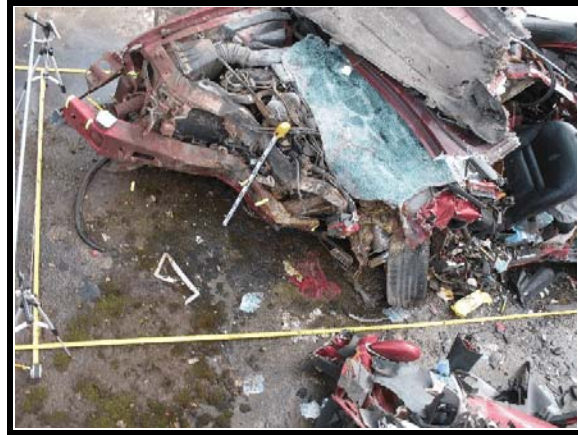
**Figure 15.** Overview of frontal damage

The Lincoln sustained severe front end damage from the impact with the Ford (**Figure 15**). The direct damage began at the front left bumper corner and extended 80 cm (31.4 in) to the right. There was extensive damage due to extrication efforts; the roof and left door were cut off the vehicle. Six crush measurements were documented at the bumper level as follows:  $C_1 = 133$  cm (52.4 in),  $C_2 = 108$  cm (42.5 in),  $C_3 = 103$  cm (40.5 in),  $C_4 = 78$  cm (30.7 in),  $C_5 = 14$  cm (5.5 in),  $C_6 = 0$  cm. The CDC for the impact with the Ford was 12FYEW6.

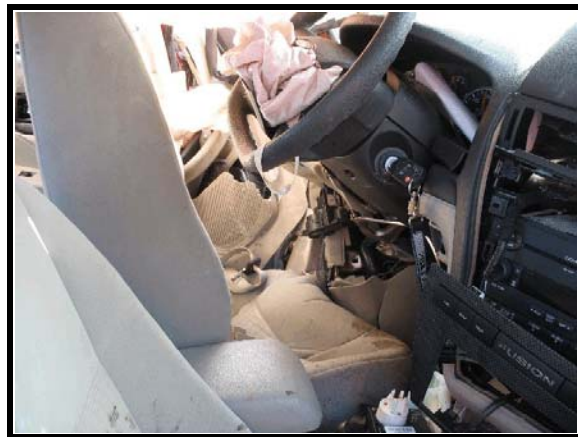
**Figure 16.** Driver's seated position

The 17-year-old male driver of the Ford was seated in an unknown posture and the seat was adjusted to the mid-track position (**Figure 16**). He was restrained by the 3-point manual lap and shoulder belt and the safety belt anchorage was in the full-down position. There were no indications that the driver braked prior to impact. His right foot was probably on the accelerator and the left was on the floorboard. At impact with the Lincoln, the driver was displaced forward. He loaded the safety belt and contacted the frontal air bag. He sustained a corneal abrasion from the contact with the air bag. He also loaded and deformed the steering wheel rim causing a blunt aortic injury and liver and kidney lacerations. His left knee engaged the lower instrument panel causing an indirect left femur fracture. His right knee and lower leg contacted and deformed the lower instrument panel resulting in a knee laceration and abrasions to the lower leg. His left foot flexed upward while in contact with the toe pan area and his sustained a fracture to the navicular bone. He required extrication from the vehicle and was transported to an area trauma center for treatment and was hospitalized for seven days. The driver reported that he was amnesiac for events immediately before and after the crash.
