**CALSPAN ON-SITE HYBRID VEHICLE CRASH INVESTIGATION
SCI CASE NO.:CA09012**

VEHICLE: 2005 TOYOTA PRIUS HATCHBACK

LOCATION: NORTH CAROLINA

CRASH DATE: JANUARY 2009

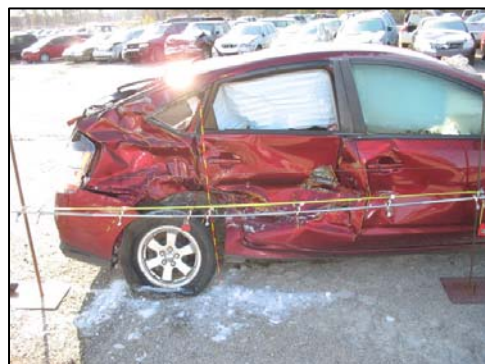
The right side of the Toyota Prius was damaged in this multiple event crash. The initial impact involved moderate severity damage to the right rear side area of the Prius (**Figure 3**). The direct contact damage began on the right front door 130 cm (51.2 in) aft of the right front axle and extended 173 cm (68.1 in) rearward to the right rear taillight area. Lateral crush was present to the right doors, C-pillar, and quarter panel. The right front and right rear door hinges were intact

Figure 3: Initial impact damage to the right rear side area of the Prius.

and remained attached to the A- and B-pillars, respectively. Both right side door latches remained engaged as both right side doors remained closed during the crash. The right rear tire and wheel were engaged by the bus that resulted in separation of the suspension components. The combined direct and induced damage (Field L) began 88 cm (34.6 in) rear of the right front axle and extended 256 cm (100.8 in) rearward. The residual crush profile was measured at the mid door elevation and was as follows: C1 = 2 cm (0.8 in), C2 = 21 cm (8.3 in), C3 = 31 cm (12.2 in), C4 = 20 cm (7.9 in) C5 = 6 cm (2.4 in), C6 = 0 cm. The maximum crush was located aft of the C-pillar, 252 cm (99.2 in) rearward of the right front axle and measured 33 cm (13 in). The elevation of the maximum crush was 59 cm (23.2 in), consistent with the measured front bumper height of the bus, which extended 50 cm (20.1 in) to 89 cm (35 in) above ground level. The Door Sill Differential (DSD) was 23 cm (9.1 in). The right roof side rail deformed laterally and buckled the roof upward along the backlight header. The Collision Deformation Classification (CDC) of this impact was 03-RZAW-3.

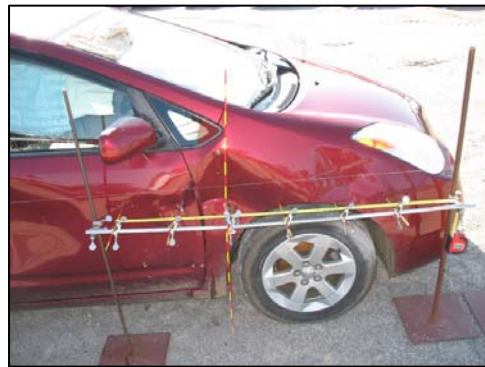
The secondary sideslap damage involved the right front door and fender of the Prius in the area of the right A-pillar. The direct damage began on the right front door 70 cm (27.6 in) rear of the right front axle and extended forward 92 cm (36.2 in) onto the right front fender (**Figure 4**). The Field L for this damage began 76 cm (29.9 in) rear of the right front axle and extended forward 106 cm (41.7 in). The residual crush profile measured at the mid door elevation was as follows: C1 = 0 cm, C2 = 2 cm (0.8 in), C3 = 6 cm (2.4 in), C4 = 4 cm (1.6 in), C5 = 3 cm (1.2 in), C6 = 0 cm. The maximum crush was located at C3, located 33 cm (13 in) rearward of the right front axle. The CDC for this impact was 03-RYEW-1.

Figure 4: Side-slap damage to the Prius

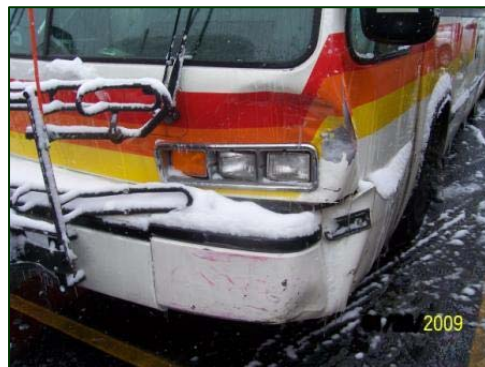
The front left and right front side areas of the transit bus were damaged in this crash. The bus was driven from the scene and was fully repaired and returned to service prior to the assignment of this case. Images of the initial impact damage to the front left area were obtained from the company that operates the transit bus. The damage involved the front bumper fascia, the front cowl in the area of the left headlamp assembly, and to the bicycle rack on the front of the bus (**Figure 5**). No images of the secondary side-slap damage to the right front side area were available. The representative of the company

Figure 5: Initial impact damage to front left area of bus (Image provided by the bus company).

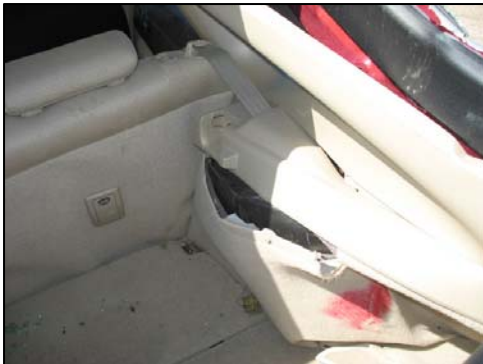
The Toyota Prius sustained moderate right side intrusion in the front right and rear right seat positions as a result of the initial impact. The right B-pillar was displaced laterally into the outboard aspect of the front right seat back. This engagement did not compress the seat back. The right rear door and C-pillar intruded laterally and compressed the rear seat backs. The right roof side rail in the second row intruded laterally. The rear right and center seat backs intruded laterally 12 cm (4.7 in), causing them to move forward over the left rear seat back, causing a 15 cm (5.9 in) longitudinal intrusion of the right and center rear seat backs. The damage to the rear seats made it impossible to fold down the rear seats to access the front of the panels covering the hybrid battery and remove the panels to photograph the battery. The side panel aft of the right C-pillar intruded laterally and compressed the floor of the trunk/cargo area at the location of the hybrid battery and is depicted in **Figure 6**. The rear seat damage is depicted in **Figure 7**.

Figure 6: Cargo area intrusion.

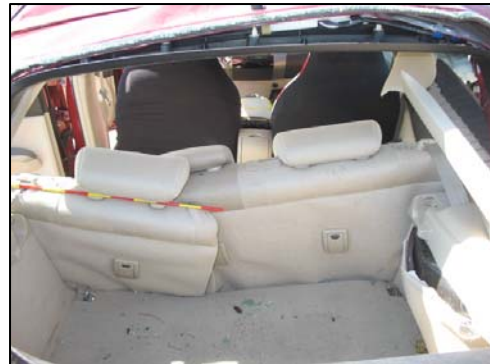
Figure 7: Rear seat lateral and longitudinal intrusion

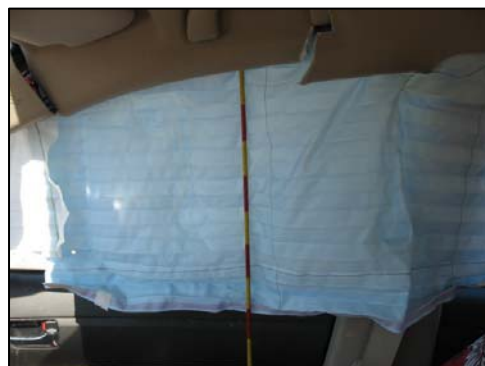
Figure 8: Right side inflatable curtain

The IC deployed from the right roof side rail. The air bag membrane measured 157 cm (61.8 in) in length. At the front seating position, the membrane measured 44 cm (17.3 in) in height (**Figure 8**) and at the rear seating position; the membrane measured 46 cm (18.1 in) in height.

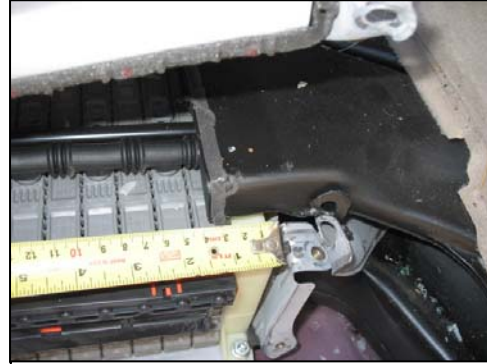
The battery compartment was vented to right side of the vehicle by a plastic duct that extended to the right side of the rear bumper fascia (**Figure 10**). The electrical connections and fuse were under a service panel on the left side of the hybrid battery. There was no damage to the cells of the hybrid battery or leakage of electrolyte. The intrusion of the C-pillar and side panel aft of the C-pillar resulted in displacement of the plastic duct of approximately 3 cm (1.2 in) to the left. There was no damage to the battery pack.

Figure 10: Right side of hybrid battery and ventilation duct

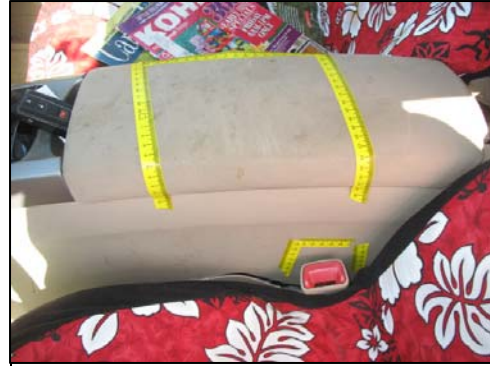
The initial right side impact with the bus deployed the right IC air bag. As a result of the side impact, the driver initiated a lateral trajectory to the right within the front left seating position. During his lateral trajectory, his right hip contacted the center console and the vehicle safety belt buckle, causing a scuff on the console from the vehicle safety belt buckle and a crack in the left side of the console (**Figure 11**). This contact sequence

resulted in a complaint of pain to the hip without contusion. The driver's right forearm scuffed the top of the console as it traveled across the console from left to right. As the driver loaded into the center console, his upper torso loaded the safety belt, causing a section to stretch and the belt to abrade where it passed through the sliding latchplate. As his upper torso loaded the safety belt, his head continued to the right, causing the neck strain. The driver did not engage the IC air bag. He did not seek treatment for his injuries.

Figure 11: Driver contact to center console
