Hybrid Vehicle Investigation  
Dynamic Science, Inc. (DSI), Case Number DS09013  
2008 Toyota Prius  
California  
December 2008

1. Report No. DS09013	2. Government Accession No.	3. Recipient Catalog No.	
4. Title and Subtitle  On-Site Hybrid Vehicle Investigation		5. Report Date November 13, 2009

**Dynamic Science, Inc.**  
**Crash Investigation**  
**Case Number: DS09013**

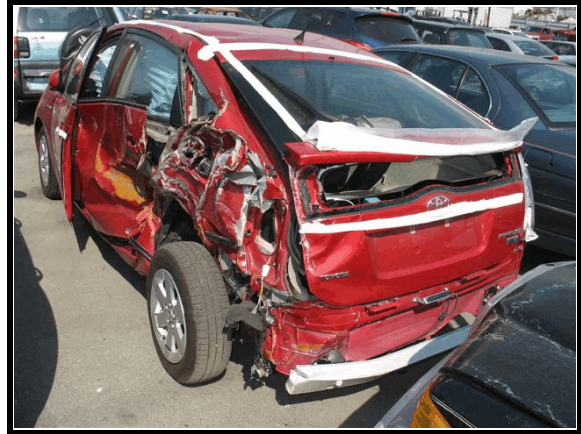
This investigation focused on a 2008 Toyota Prius hybrid vehicle that sustained a back end impact (**Figure 1**). The crash occurred in the westbound lanes of a two-lane divided roadway. The Toyota was being driven in the inboard lane by a 48-year-old female. The other vehicle was a 2000 Chevrolet Silverado pickup that was being driven by a 23-year-old male. The Chevrolet was traveling behind the Toyota. The driver of the Toyota noticed that the Chevrolet was approaching her vehicle at a high speed. In an effort to avoid the crash, she initiated a lane change to the right. During the maneuver, the front of the Chevrolet struck the left rear of the Toyota. The driver of the Toyota did not sustain any injuries. The driver of the Chevrolet sustained a nasal fracture and a laceration above the right eye. He was transported to a local hospital where he was treated and then arrested for driving under the influence of alcohol. Both vehicles were towed from the scene due to damage. The Toyota was later declared a total loss by the insurance company.

**Figure 1.** Subject vehicle, 2008 Toyota Prius

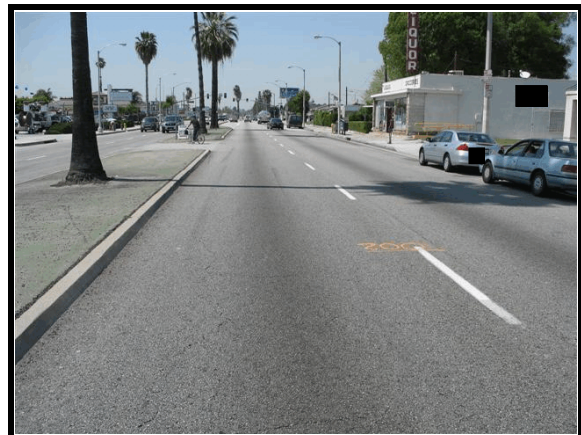
This two-vehicle crash occurred in December 2008 at 0155 hours. The crash occurred on a straight two-lane divided roadway (**Figure 2**). The inboard travel lane was bordered by a raised median; the outboard lane was bordered by raised concrete curb followed by a sidewalk. The asphalt roadway was dry and the streetlights in the area were illuminated. The posted speed limit was 40 km/h (25 mph).

**Figure 2.** Westbound approach to area of impact

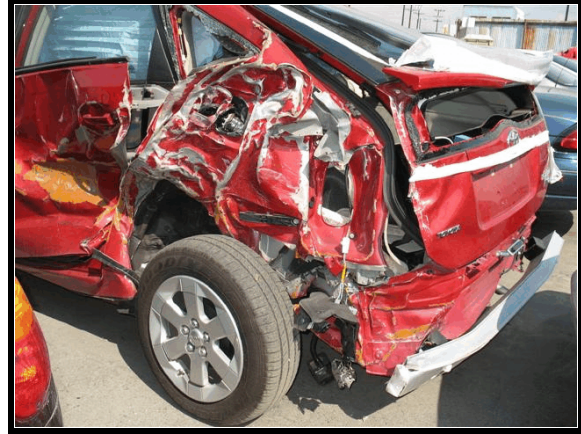
The Toyota sustained moderate back end damage from the impact with the Chevrolet (**Figure 3**). The direct damage began at the rear left bumper corner and extended 27 cm (10.6 in) to the right. The bumper fascia was displaced from the vehicle. There was direct contact damage up the left side of the vehicle that began at the left bumper corner and extended forward 173 cm (68.1 in). Vertically, the direct damage terminated 114 cm (44.8 in) above the ground. The sheet metal above the left rear tire was displaced laterally 24 cm (9.4 in). The gas cap top was torn away but the filler neck remained sealed.

**Figure 3.** Back end, left side

Six crush measurements were documented along the back bumper reinforcement as follows:  $C_1 = 17$  cm (6.7 in),  $C_2 = 12$  cm (4.7 in),  $C_3 = 10$  cm (3.9 in),  $C_4 = 7$  cm (2.7 in),  $C_5 = 6$  cm (2.4 in),  $C_6 = 3$  cm (1.2 in). The Collision Deformation Classification (CDC) for the impact with the Chevrolet was 06BLEE7.

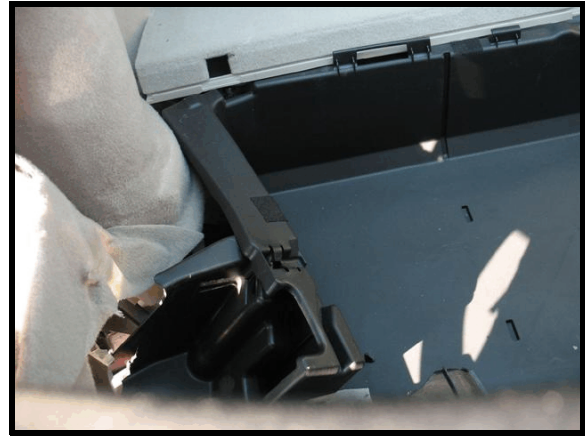
There was damage to the left cargo area aft of the rear seat. The left side panel of the cargo area was deformed inward 20 cm (7.8 in) and it deformed and fractured the left side of the rear deck floor box (**Figure 4**).

**Figure 4.** Cargo area intrusion

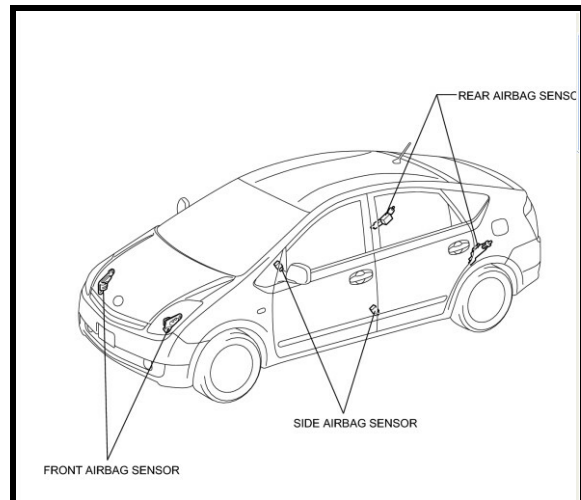
The Toyota's supplemental restraint system consisted of driver and passenger air bags, left and right side IC air bags, and left and right seat-mounted side air bags. The vehicle was configured with front electronic side impact sensors mounted near the base of the B-pillars and rear side impact sensors mounted near the base of the C-pillars (**Figure 5**). According to Toyota reference material:

**Figure 5.** Impact sensor locations (Supplemental Restraint System - Air Bag System RS-1)

The left side IC air bag deployed during this crash. While this was not a side impact, it is probable that the air bag deployed as a result of contact to the sensor during the rear end impact. There were no other air bag deployments, and the pretensioners did not actuate.

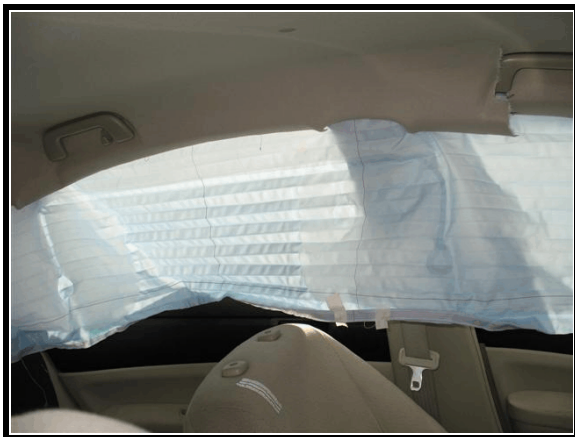
The left side impact IC air bag deployed through the roof rail cladding (**Figures 6-7**). The air bag was generally rectangular and measured 167 cm (65.7 in) in length and 45 cm (17.7 in) in height. The forward aspect of the bag was attached to the left A-pillar by a sail panel that measured 22 cm (8.7 in) in length and was 25 cm (9.8 in) in height at the point it attached to the air bag; the rear aspect of the bag was attached to the left D-pillar. The longitudinal area of coverage began near the midpoint A-pillar and extended to the D-pillar. The bag's vertical coverage began at the roof rail and extended to approximately 7.0 cm (2.8 in) below the bottom of the side glass. The bag was configured with 20 pleats and did not have any internal tethers or ports. There were no contacts or damage to the air bag. The interior A-pillar cover was displaced 3 cm (1.2 in) laterally. There was a 13 cm (5.1 in) tear in the roof cladding at the rear aspect of the driver's grab handle.

**Figure 6.** Second row IC air bag

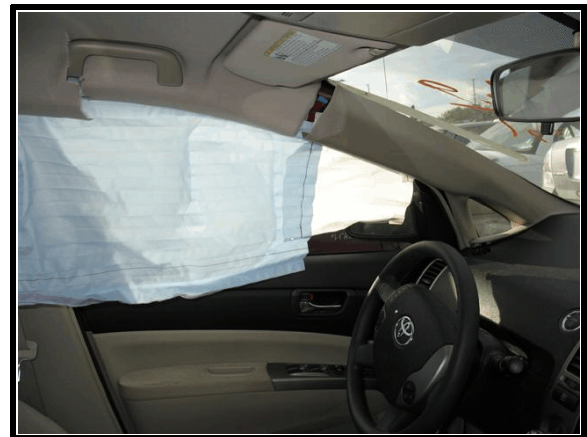
**Figure 7.** Front row IC air bag

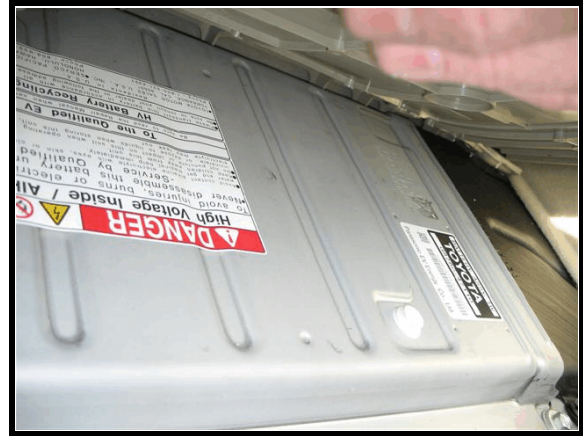
The battery system was a 201-volt Nickel Metal-Hydride (NiMH) battery that was mounted in the rear cargo floor, aft of the second row seat (**Figure 8**). This high-voltage (HV) battery system was mounted laterally in the vehicle and was concealed and protected by an aluminum cover that was bolted to the rear floor. Orange -color power cables carry high voltage direct current between the HV battery pack and the inverter/converter. The cables extended along the left side of the vehicle, from the cargo area to the engine compartment. The Prius was equipped with a regenerative braking system that utilized the motor to decelerate the vehicle and convert power back into the batteries for recharging purposes.

**Figure 8.** Traction battery

- There were no indications of electrolyte spillage from the propulsion battery.
- There was no movement of the battery module.
- The isolation test was not conducted; there was no power to the vehicle or to the traction battery.

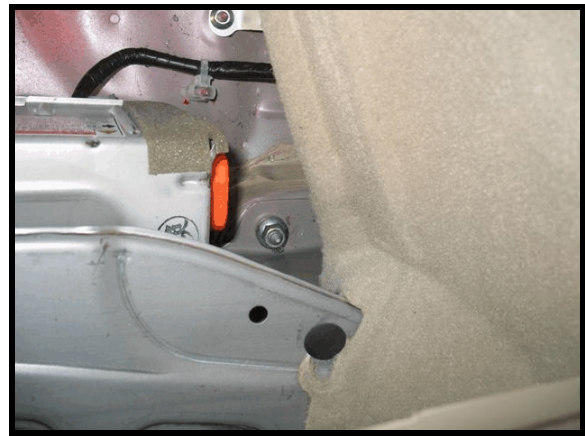
**Figure 9.** Traction battery service plug

The service plug was located on the left side of the battery and was in place at the time of the vehicle inspection (**Figure 9**). The service plug shuts off the high voltage circuit of the HV battery when this plug is removed for vehicle inspection or maintenance.
