CALSPAN REMOTE FALLING VEHICLE INCIDENT INVESTIGATION

SCI CASE NO.: CA09014

VEHICLE: 2006 TOYOTA AVALON

INCIDENT DATE: MARCH 2009

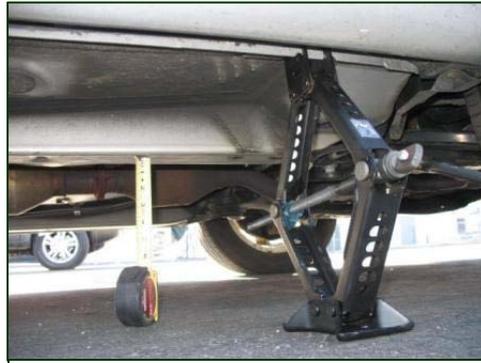
The victim retrieved the OEM jack from the trunk of the Toyota. He further stated to the SCI investigator that he had never used this jack before. He positioned the jack at the designated jacking point on the forward aspect of the right sill (**Figure 3**). The victim jacked the Avalon to a height where the right front tire was off the concrete surface. None of the tires were removed from the vehicle. As he crawled under the Toyota, his wife handed him a flashlight that he grasped with his right hand. Almost immediately, and without touching the undercarriage of the Avalon, the victim heard a “cracking” noise and the vehicle rolled slightly rearward causing the jack to fall over and the vehicle to drop back onto the tires, compressing the right side suspension. The victim estimated that he was under the vehicle for approximately five seconds prior to the fall.

Figure 3. OEM jack positioned at proper jack point on the exemplar vehicle.

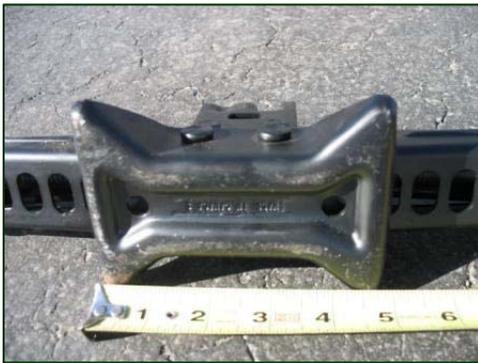
The exemplar OEM jack was a typical scissors-type jack with a center mounted jack-screw to raise and lower the saddle. The base of the jack (**Figure 4**) was 9x12 cm (3.5x4.75"). With the jack properly positioned, the narrow width of the jack base was parallel to the wheelbase of the vehicle. The top saddle of the jack was U-shaped and engaged a designated cutout at the bottom of the sill. An arrow molded into the outer plastic sill panel identified the designated jacking point on the vehicle (**Figure 5**). The jack had a maximum lifting height of 36 cm (14").

Figure 4. Base of the exemplar jack.

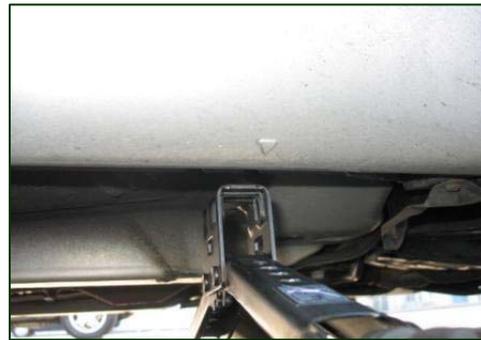
Figure 5. Proper jacking location on the right sill of the exemplar vehicle.

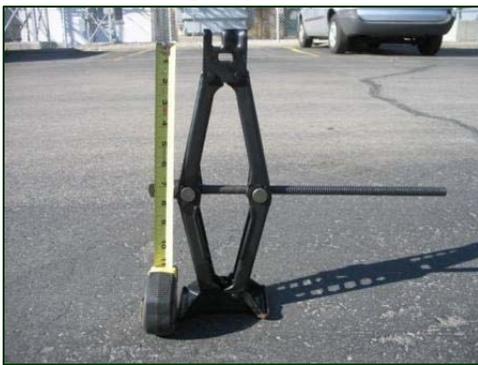
The frame of the exemplar Toyota Avalon had a ground clearance height of 15 cm (6") with the vehicle resting on all four tires. The OEM jack was positioned at the designated jack point on the forward aspect of the right sill and the exemplar vehicle was raised to a point where the right front tire was approximately 3 cm (1") off the pavement. In this position, the ground clearance at the same location on the frame was (9.5"). The jack was raised to full height and the clearance increased to a maximum height of (11"). (Note: These exemplar measurements were obtained by jacking the exemplar vehicle on a level surface.) It should be noted that although the parking brake was set on the exemplar vehicle, the jack appeared to be unstable at this maximum height. **Figures 6 and 7** are views of the exemplar jack fully extended.

Figure 6. Full extended height of the exemplar jack.

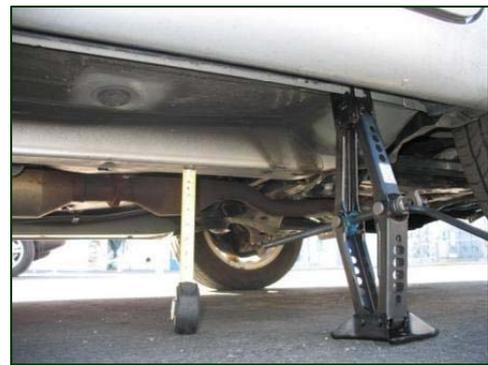
Figure 7. Full extended height under the exemplar vehicle.

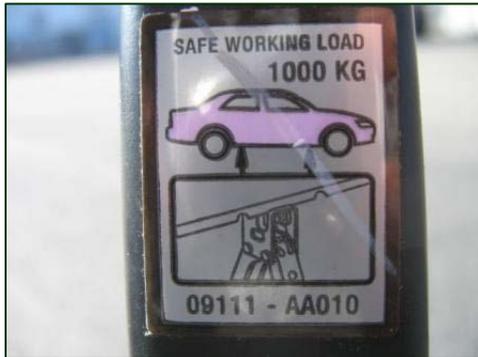
The jack was labeled with a Safe Working Load of 1,000 kg (2,204 lb). The vehicle curb weight of the Avalon was 1,615 kg (3,560 lb). The jack was also labeled with the following Caution:

Figure 8. Safe Working Load of the exemplar jack.

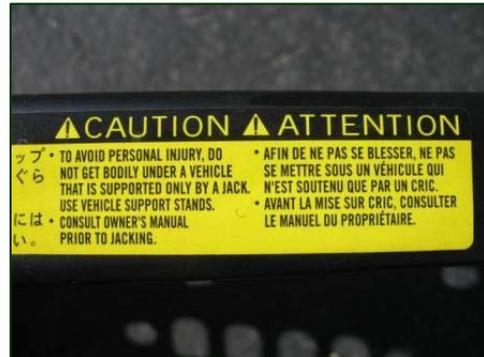
TO AVOID PERSONAL INJURY, DO
NOT GET BODILY UNDER A VEHICLE
THAT IS SUPPORTED BY A JACK.
USE VEHICLE SUPPORT STANDS.
CONSULT OWNER'S MANUAL
PRIOR TO JACKING.

Figure 9. Caution label on the exemplar vehicle jack.

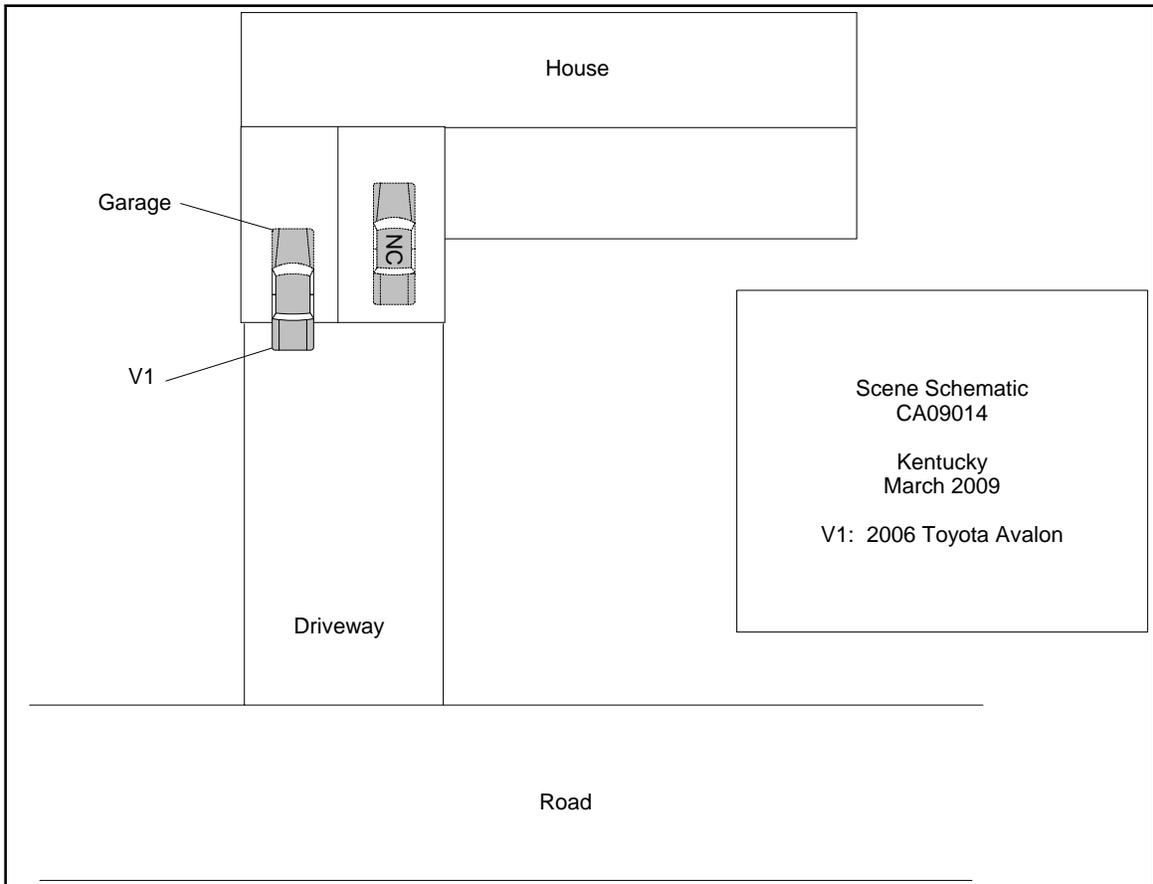
Figure 10 – Incident Schematic

The victim stated that he returned to his residence on the evening of this incident and drove the Avalon into the garage adjacent to his wife’s minivan. As he exited the vehicle, he noted a large oil trail on the driveway that led to the parked position of his vehicle. The victim opened the hood of the Avalon and checked the engine oil dipstick to determine the extent of oil lost. He then decided to examine the undercarriage of the vehicle to determine to source of the leak. The victim backed the Toyota partially out of the garage in order to obtain more room to access the vehicle. He stated that the rear axle of the vehicle was out of the garage on the driveway. The automatic transmission was placed in the park-position. The victim stated that he did not set the foot activated parking brake. A non-scaled schematic of the Incident Site is attached as **Figure 10**.
