INDIANA UNIVERSITY

TRANSPORTATION RESEARCH CENTER

ON-SITE CERTIFIED ADVANCED 208-COMPLIANT VEHICLE INVESTIGATION

CASE NUMBER - IN09017
LOCATION - TEXAS
VEHICLE - 2008 VOLKSWAGEN RABBIT
CRASH DATE - April 2009

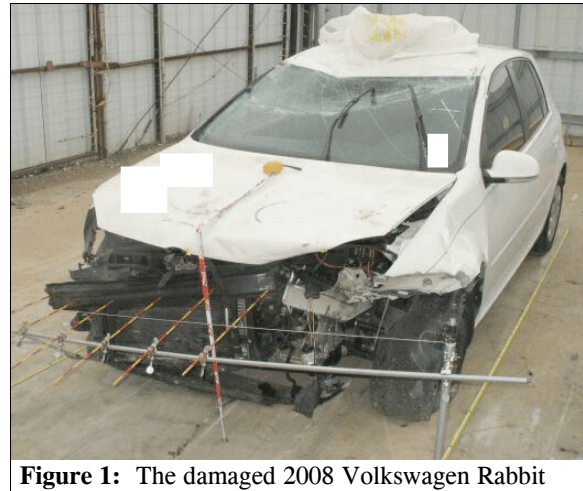
Figure 1: The damaged 2008 Volkswagen Rabbit

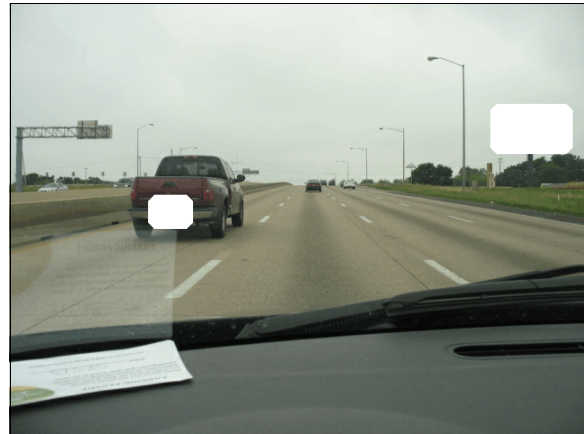
Figure 2: Approach of the Volkswagen and Ford to the police reported area of the crash

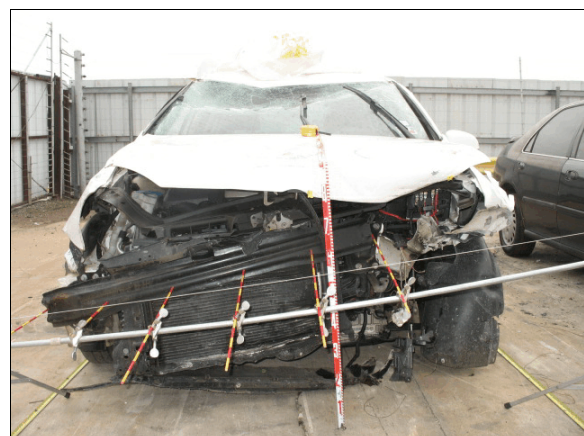
Figure 3: Damage to the front plane of the Volkswagen due to impact with the concrete Jersey barrier and on the roof due to the rollover

When the front plane of the Volkswagen impacted the concrete Jersey barrier, the vehicle rode up and deflected off the barrier in a clockwise rotation, which caused the vehicle to roll over over, right side leading. The damage on the vehicle indicated that it rolled over two quarter turns. The distance the vehicle traveled during the rollover could not be determined. The police crash scene schematic depicted no crash induced physical evidence nor accompanying measurements.

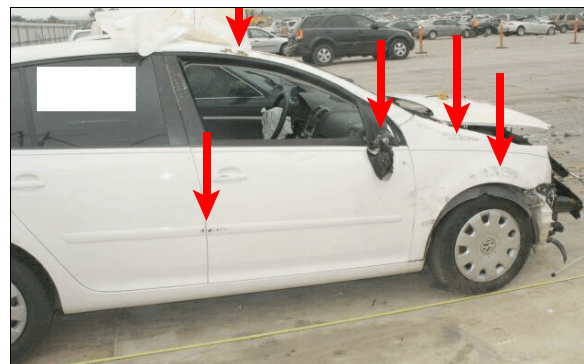
Figure 4: Arrows show damage to the right side plane due to the rollover.

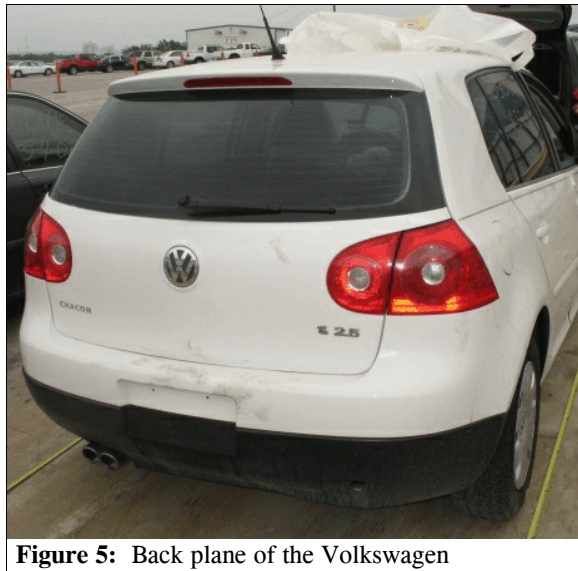
Exterior Damage: The back plane impact with the front plane of the Ford (event 1) involved only the plastic bumper fascia of the Volkswagen and there was no discernable damage on the bumper fascia (**Figure 5**) or the bumper bar. Due to the absence of any residual deformation, no crush measurements were taken on the back bumper.

Figure 5: Back plane of the Volkswagen

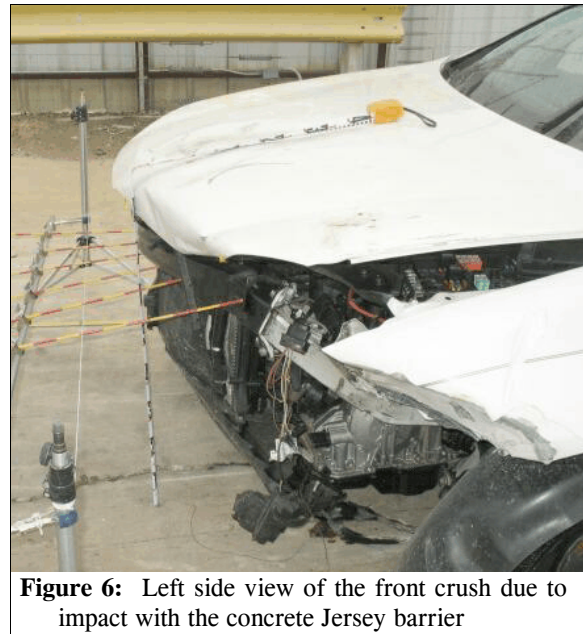
in) across the bumper. The bumper fascia was detached from the vehicle and the crush measurements were taken on the front bumper bar (**Figure 6**). The maximum residual crush was 20 cm (9.1 in) occurring at C₁. The vehicle’s left side wheelbase was reduced 10 cm (3.9 in) while the right side wheelbase was unchanged. The table below shows the front crush profile.

Figure 6: Left side view of the front crush due to impact with the concrete Jersey barrier

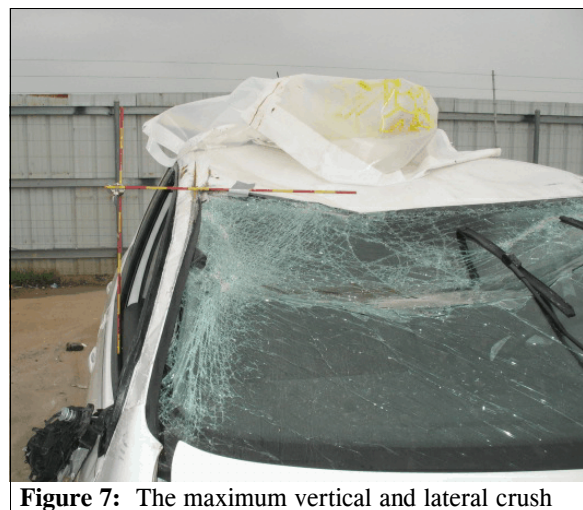
The damage from the rollover involved the top plane and the right side plane. The direct damage on the top plane began on the hood 70 cm (27.6 in) forward of the right front axle and extended 280 cm (110.2 in) rearward along the hood, right roof side rail, and the roof. The direct damage also involved the full width of the roof, 108 cm (42.5 in). The direct damage on the right side plane began at the front of the right fender and involved the fender, side of the right roof side rail, side view mirror, and the right front and right rear doors. The maximum vertical crush was 7 cm (2.8 in) and occurred on the windshield header 38 cm (15 in) left of the right A-pillar (**Figure 7**). The maximum lateral crush was 1 cm (0.4) and

Figure 7: The maximum vertical and lateral crush

involved the right A-pillar. The induced damage involved the hood, roof, windshield, and both fenders.

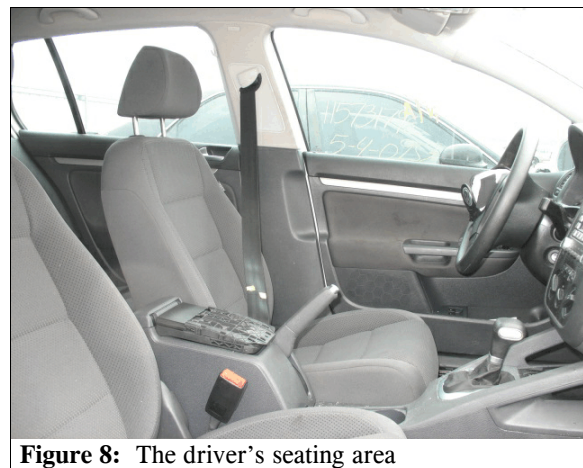
Vehicle Interior: The inspection of the Volkswagen's interior (**Figures 8 and 9**) revealed a blood transfer and several dark scuff marks on the roof above the front and second row. The vehicle came to final rest on its roof and these marks were probably related to the driver exiting the vehicle and/or assisting the second row left passenger following the crash. There was no deformation of the steering wheel or collapse of the energy absorbing steering column.

Figure 8: The driver's seating area

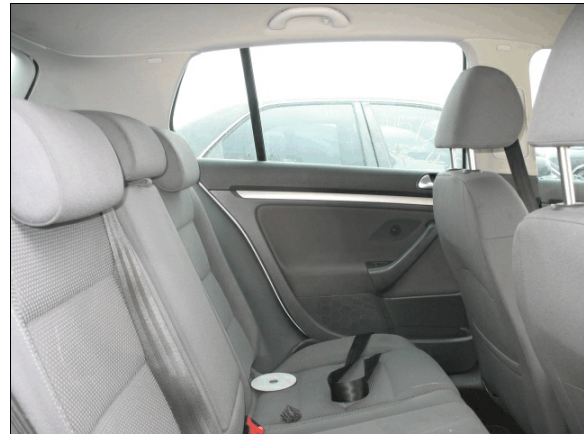
Figure 9: The second row

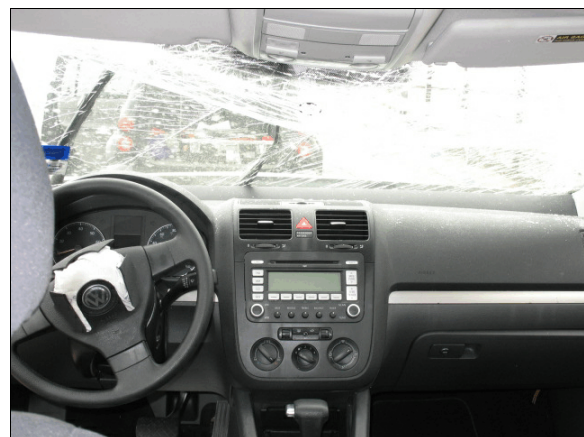
The vehicle sustained three vertical intrusions into the driver's space involving the windshield header, roof, and the windshield. The most severe of these intrusions involved the windshield, which intruded 3 cm (1.2 in). The most severe passenger compartment intrusion occurred in the front row center and involved the windshield header and roof (**Figure 10**). Both of these components intruded vertically 7 cm (2.8 in). No intrusion occurred in the second row passenger's space.

Figure 10: Intrusion of the windshield header and roof

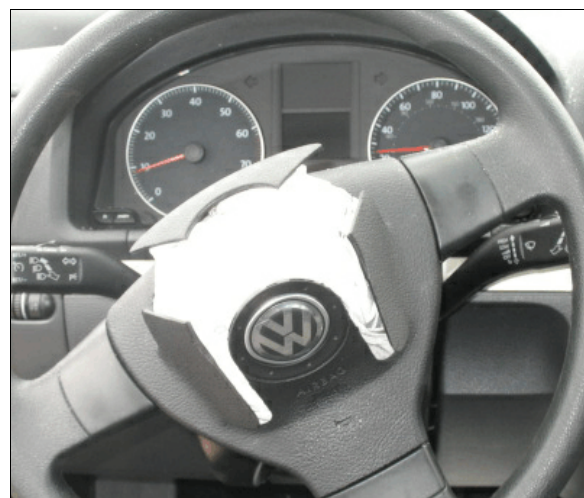
The driver's air bag was located within the steering wheel hub and the air bag module cover was a four-flap configuration constructed of pliable vinyl (**Figure 11**). The cover flap assembly was 13 cm (5.1 in) in width and 11 cm (4.3 in) in height. The cover flaps opened along the designated tear seams and were not damaged. The deployed driver's air bag (**Figure 12**) had a diameter of 62 cm (24.4 in). It was constructed with four tethers and had no external vent ports. There was no discernable evidence of occupant contact or damage to the air bag.

Figure 11: The driver's frontal air bag cover flaps

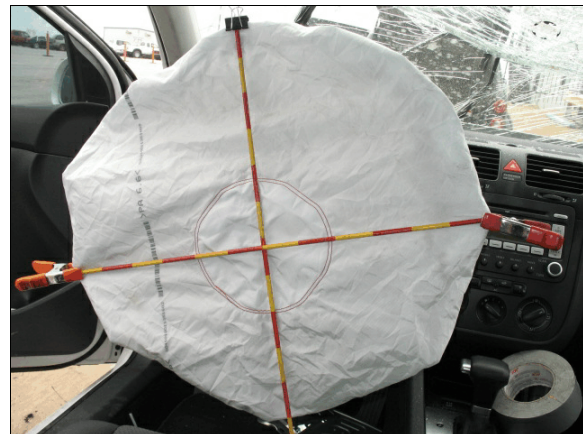
Figure 12: The driver’s deployed frontal air bag

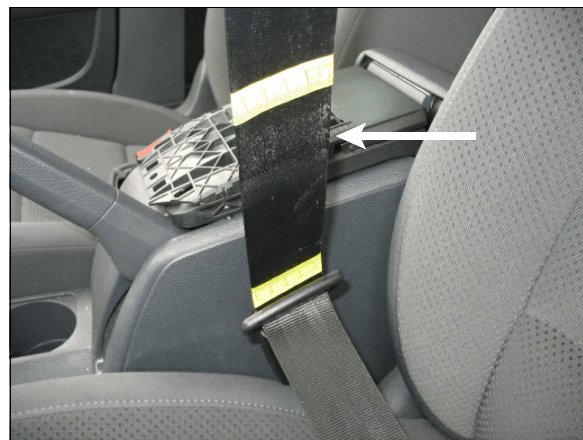
The inspection of the driver’s seat belt assembly revealed a load mark on the belt webbing (**Figure 13**) located 24 cm (9.5 in) above the stop button. The retractor was also jammed indicating that the pretensioner actuated during the crash and that the driver was restrained at the time of the crash.

Figure 13: Load mark on driver’s seat belt

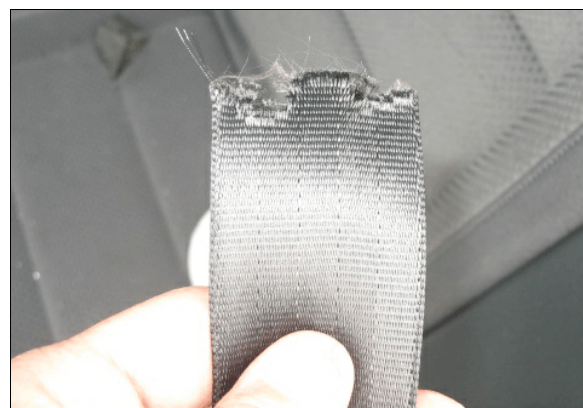
The inspection of the second row left seat belt assembly revealed that the belt webbing had been cut in two (**Figure 14**) and the sliding latch plate was missing. No load marks were observed on the remaining section of the seat belt webbing. The police report indicated that this occupant was restrained in a CSS. The evidence suggested that the seat belt was cut to remove the second row left passenger or the CSS from the vehicle. The remaining seating positions were unoccupied.

Figure 14: The second row left seat belt was cut in two
