**CALSPAN ON-SITE SIDE IMPACT INFLATABLE OCCUPANT PROTECTION
SYSTEM CRASH INVESTIGATION**

SCI CASE NO: – CA09019

VEHICLE – 2008 HONDA ACCORD

CRASH DATE – JANUARY 2009

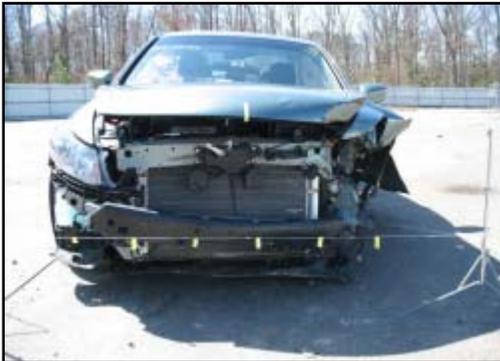
The 2008 Honda Accord sustained moderate damage to the front and left side planes as a result of the impact with the 1994 Honda Accord (**Figure 4**). The damaged components included but were not limited to the bumper fascia, bumper beam, hood, left fender, and the left front wheel and suspension components. All four doors remained closed during the crash and were operational post-crash. The windshield fractured during the crash. The remaining side, rear, and roof glass were intact. The direct contact damage began 29 cm (11.4 in) left of the centerline and extended 52 cm (20.5 in) to the left bumper corner. The combined direct and induced damage extended across the entire front end width. Due to the prolonged engagement, the direct contact damage extended 95 cm (37.4 in) down the left fender. The left front wheel was directly involved as the vehicles crushed, resulting in a separation of the left wheel and brake assembly from the suspension. The maximum crush measured 11 cm (4.3 in) and was located on the left end of the bumper beam. A crush profile was documented along the bumper beam which was as follows: C1 = 11 cm (4.3 in), C2 = 8 cm (3.1 in), C3 = 3 cm (1.2 in), C4 = 0 cm, C5 = 0 cm, C6 = 0 cm. The Collision Deformation Classification (CDC) for this impact was 12-FLEW-1. **Figures 5 - 7** depict the damage to the ACE structure:

Figure 4. Overall view of the frontal damage.

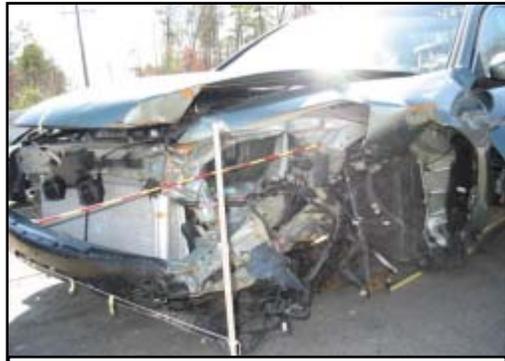
Figure 5. Front left ACE frame damage.

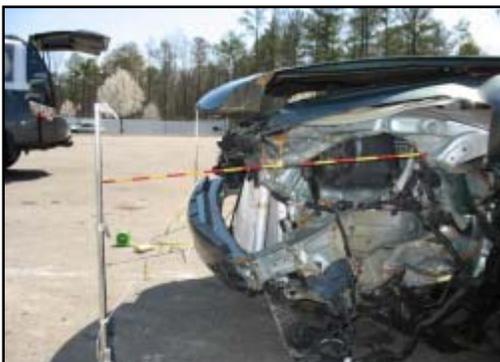
Figure 6. Lateral view of the front ACE frame damage.

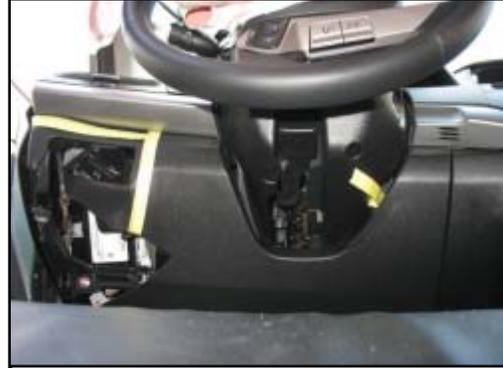
The driver's contact points consisted of two knee impacts to the knee bolster which were evidenced by the fractured rigid plastic panel (**Figure 9**). The turn signal stalk was fractured and the rear view mirror was deflected downward. These contacts were attributed to the driver's left and right hands, respectively. The driver loaded the deployed air bag which resulted in 1 cm (0.5 in) of steering column compression. There was no intrusion into the passenger compartment.

Figure 9. Knee bolster contact points.

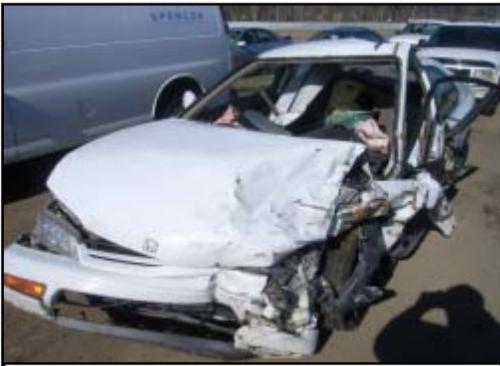
The 1994 Honda Accord sustained severe frontal and left side damage as a result of the crash (**Figures 10 – 11**). The damage assessment was based on the images obtained from the salvage facility; no actual measurements were obtained. The direct damage began left of the centerline and extended to the front left bumper corner. The direct damage continued down left side of the vehicle onto the front left door. The maximum crush was estimated at 20 cm (8 in). The impact configuration and severity resulted in a near vertical deformation of the left A-pillar.

Figure 10. Front left oblique view of the damage.

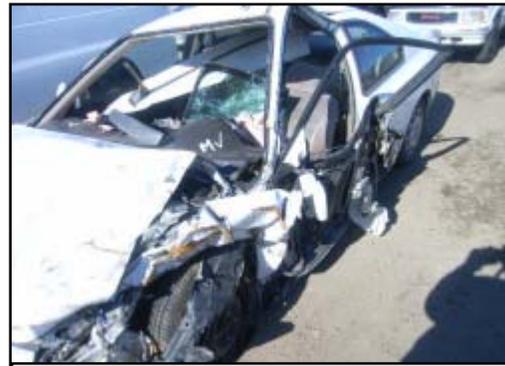
Figure 11. Direct damage extending onto the left door.

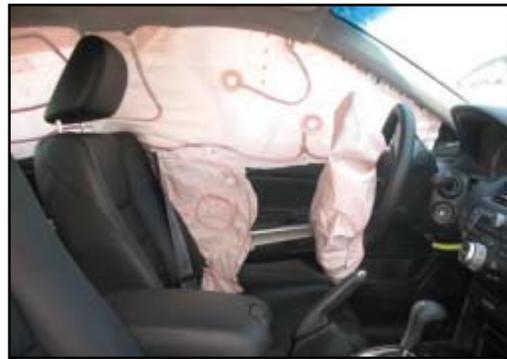
The 2008 Honda Accord was equipped with front seat back-mounted side impact air bags and roof side rail-mounted IC air bags. The left seat back-mounted side impact air bag and both IC air bags deployed during the crash. **Figure 12** depicts the deployed front, seat back mounted, and the left IC air bag in the Honda.

Figure 12. Overall view of the deployed front, seat back mounted, and the IC air bags.

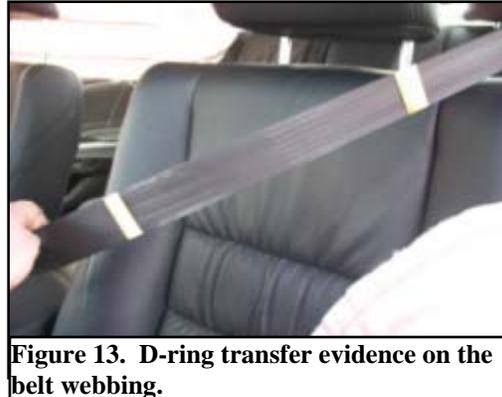
Figure 13. D-ring transfer evidence on the belt webbing.

The driver utilized the safety belt during the crash which was supported by loading evidence on the lap and shoulder portions of the webbing and the latch plate. As a result of the crash, the retractor pretensioner actuated which retracted a portion of the safety belt. During this motion, the belt webbing was pulled through the D-ring and the latch plate resulting in frictional transfers to the webbing from these components. The driver loaded the safety belt which pulled the webbing through the D-ring in a forward motion. The combination of the actuating pretensioner and the driver loading resulted in a 25 cm (9.8 in) transfer from the D-ring. This transfer began 177 cm (69.7 in) above the anchor. A transfer occurred from the latch plate interaction and was located from 86 – 89 cm (33.9 – 35 in) above the anchor. Additionally, the latch plate exhibited full-width frictional abrasions across the plastic surface.
