On-Site Rollover Investigation
Dynamic Science, Inc. (DSI), Case Number DS09020
2009 Ford Escape XLT
Arizona
February 2009

1. Report No. DS09020		2. Government Accession No.		3. Recipient Catalog No.	
4. Title and Subtitle On-Site Rollover Investigation			5. Report Date January 22, 2010

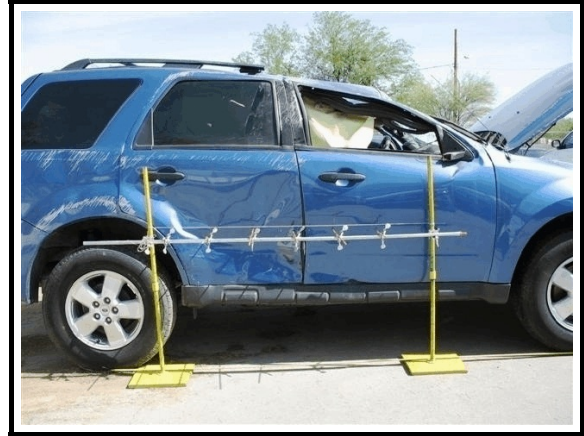
The Ford sustained direct and induced damage to the right side door panels during the vehicle-to-vehicle impact. The direct damage to the right side began 40 cm (15.7 in) forward of the rear axle, extended 95 cm (37.4 in) forward, and ended 125 cm (49.2 in) aft of the front axle. The Field L began 37 cm (14.6 in) forward of the rear axle, extended 106 cm (41.7 in) forward, and ended 117 cm (46.1 in) aft of the front axle. Six crush measurements were taken at mid-door level as follows: $C_1 = 0$ cm, $C_2 = 5$ cm (2.0 in), $C_3 = 6$ cm (2.8 in), $C_4 = 6$ cm (2.8 in), $C_5 = 3$ cm (1.2 in), $C_6 = 0$ cm. Maximum lateral crush measured 6 cm (2.8 in) and was located at C_3 (**Figure 4**). The Collision Deformation Classification (CDC) for the first impact was 02RPEW1.

The Ford's Sill Height measured 50 cm (19.7 in), the Height of Max Door Crush measured 66 cm

(26.0 in), and the Door Sill Differential (DSD) measured 4 cm (1.2 in).

Figure 4. Right side crush measurement

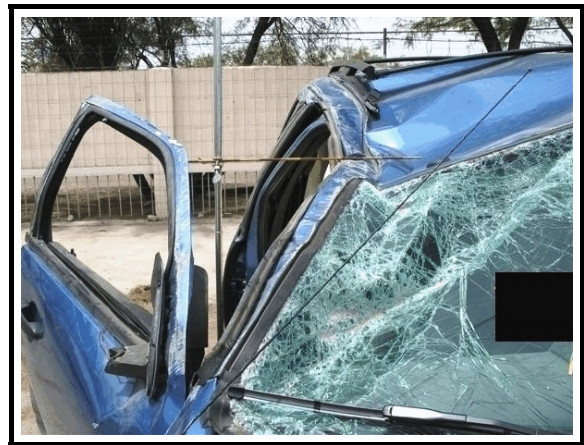
The maximum lateral crush was located on the right roof side rail between the A- and B-pillars, at 138 cm (54.3 in) forward of the rear axle, and measured 16 cm (6.3 in). The maximum vertical crush was located at the windshield header, 50 cm (19.7 in) right of the vehicle's longitudinal centerline, and measured 22 cm (8.7 in) (**Figure 5**). The CDC for the rollover impact was 00TDDO3.

Figure 5. Windshield header vertical crush measurement

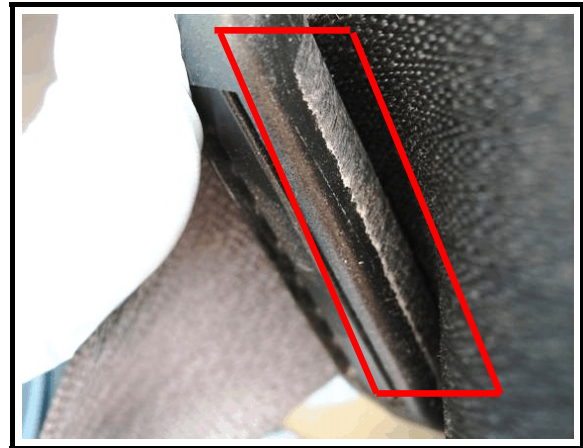
The driver's seat track was set between the middle and full-forward position and the seat back was slightly reclined. The driver's safety belt anchorage was in the full-up position. The latch plate exhibited light scratches indicating historical usage. The safety belt D-ring, the webbing, and the latch plate exhibited evidence of occupant loading (**Figures 6 - 8**).

The safety belt webbing exhibited evidence of occupant loading on both sides of the webbing. On the back side, an abrasion that measured 5 x 10 cm (2.0 x 3.9 in) was located 155 cm (61.0 in) above the lower anchorage. The abrasion resulted from contact between the belt webbing and the D-ring. The plastic D-ring exhibited abrasion where it was contacted by the belt webbing. An area of webbing that included a group of striations was located 15 cm (5.9 in) above the abrasion. The striations measured 12 cm (4.7 in) in length and resulted when the occupant loaded the webbing.

Figure 6. Occupant loading evidence, safety belt D-ring

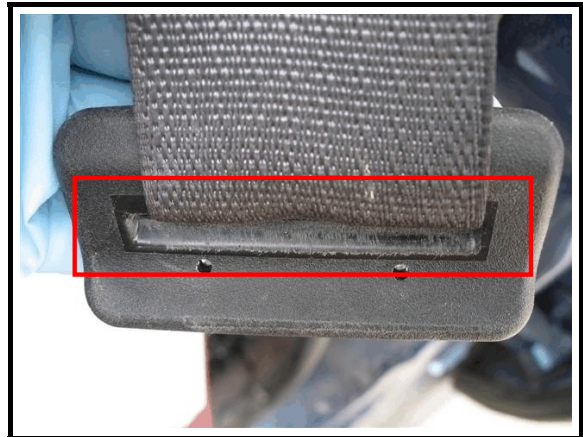
On the front side of the safety belt webbing, an abrasion that measured 4 x 5 cm (1.6 x 2.0 in) was located 75 cm (29.5 in) above the lower anchorage. The abrasion resulted from contact with the plastic latch plate cover. The latch plate cover exhibited abrasion that correlated with the damage to the safety belt webbing. At 70 cm (27.5 in) above the abrasion the webbing was stretched due to contact with the D-ring when the belt was loaded.

Figure 7. Occupant loading evidence, safety belt latch plate

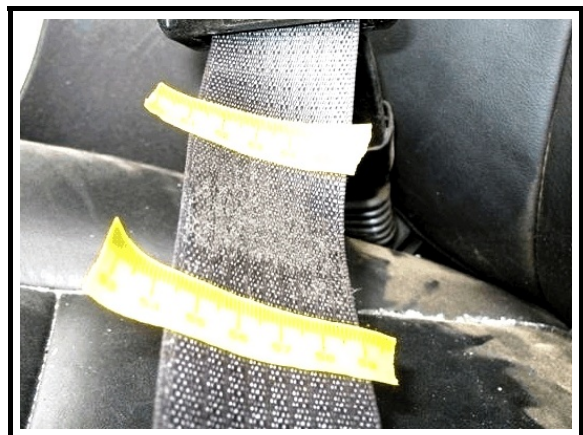
With the safety belt in the buckled position, abraded areas of the belt passed over the D-ring and the sliding latch plate, and a stretched area was within the area of the driver's torso. Based on evidence of loading to the safety belt webbing, latch plate and the D-ring, it was determined that the driver was using the manual lap and shoulder belt at the time of the crash. The safety belt buckle and retractor pretensioners did not actuate.

Figure 8. Occupant loading evidence, safety belt webbing

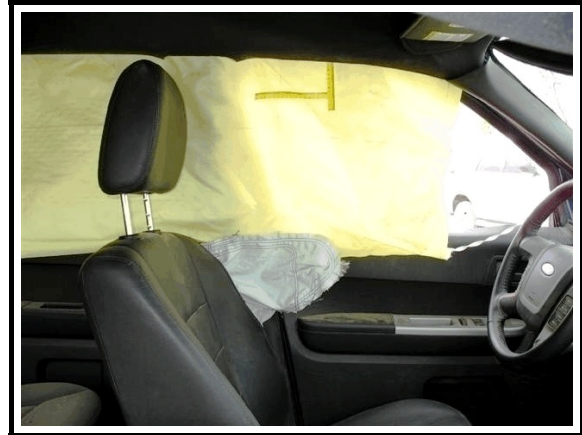
Figure 9. Deployed left IC and seat-mounted air bags

The driver's seat-mounted side air bag and the left and right IC air bags deployed during the rollover (**Figure 9**). The seat-mounted side air bag deployed from a module in the outboard aspect of the

The left IC air bag exhibited an area of damage on the upper inboard aspect consisting of five vertically oriented linear scuff marks that were approximately 3 cm (1.2 in) in length and covered a 14 cm (5.5 in) section of the air bag. Their location on the air bag was above head level and lateral to the driver's seated position. The driver indicated during the interview that her head probably contacted the air bag. However, the scuffs were uniform in nature and presented evidence of module or roof cladding contact versus occupant contact. The left IC air bag exhibited no further contact evidence or damage. The right IC air bag was unremarkable.
