On-Site Child Restraint System Investigation  
Dynamic Science, Inc. (DSI), Case Number DS09022  
2008 Ford Taurus X  
California  
April 2009

1. Report No. DS09022	2. Government Accession No.	3. Recipient Catalog No.	
4. Title and Subtitle  On-Site Child Restraint System Investigation		5. Report Date March 3, 2010

**Dynamic Science, Inc.**  
**Crash Investigation**  
**Case Number: DS09022**

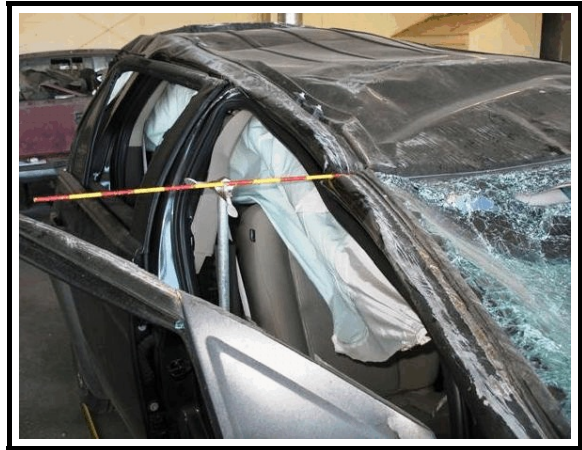
**Figure 3.** Maximum rollover vertical crush measurement

After the impact with the embankment, the vehicle initiated a left side leading trip rollover (Event 4). Direct damage from the rollover was located on the vehicle's left and right sides, and top. Maximum lateral crush was located at the right roof side rail just aft of the A-pillar and measured 10 cm (3.9 in). Maximum lateral crush was located at the right roof side rail just aft of the A-pillar and measured 16 cm (6.3 in) (**Figure 3**). For Event 4 the CDC was 00TDDO3.

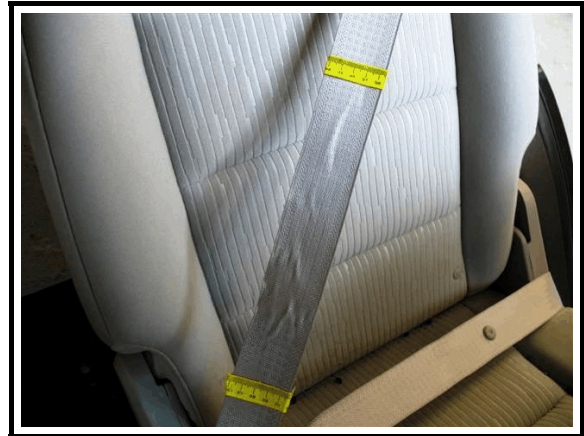
The left safety belt was used to secure a Graco ComfortSport convertible CRS. The latch plate was scratched from historical use. The safety belt webbing exhibited evidence of occupant loading in the form of a scuff mark and stretch marks. A scuff mark was located where the webbing contacted a seat adjustment lever on the outboard aspect of the seat cushion near the lower anchorage. The scuff was light in color, measured 1 x 5 cm (0.4 x 2.0 in), and was distributed across the width of the webbing. At 54 cm (21.3 in) above the lower anchorage a 29.5 cm (9.8 in) section of webbing was stretched (**Figure 4**). The stretched section of belt was in contact with the latch plate and the CRS shell during the crash. The driver stated during the interview that the safety belt retractor was set to ALR mode during the crash.

**Figure 4.** Second row left safety belt showing stretch marks

As the vehicle initiated a clockwise rotation and impacted the dirt embankment, the child was displaced forward and left and the CRS loaded the safety belt. The belt webbing exhibited a pronounced scuff mark near the lower anchor and stretch marks over a length of 29.5 cm (9.8 in) that was routed through the CRS. As the vehicle overturned, the child was displaced to the left. The vehicle came to final rest on its roof. The occupant remained suspended upside down until the driver unbuckled the CRS harness retainer clip and assisted the child from the vehicle. The CRS was not damaged during the crash, and on-scene photographs documented the CRS anchored to the seat in the vehicle at the rest position. The occupant was transported to a local hospital and his medical records reported no injuries.

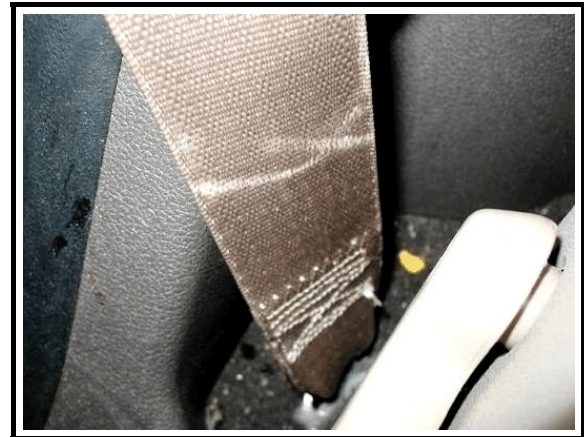
**Figure 5.** Second row right safety belt showing scuff marks

The right safety belt was used to secure an Evenflo Embrace rear-facing CRS. The latch plate was scratched indicating historical usage and exhibited abrasions from CRS loading. The belt webbing exhibited evidence of occupant loading in the form of scuffs and stretch marks. Two scuff marks were located where the webbing contacted a seat adjustment lever on the outboard aspect of the seat cushion near the lower anchorage. The scuffs were light in color and crossed in an X pattern (**Figure 5**). The scuffs measured 1 x 5 cm (0.4 x 2.0 in) and 1 x 6 (0.4 x 2.4 in), respectively, and were distributed across the width of the webbing. At 85 cm (33.5 in) above the lower anchorage a 30 cm (11.8 in) section of webbing was stretched. The loaded section of belt was routed through the CRS shell at the time of the crash. Based on the driver interview and loading evidence to the belt webbing, it was concluded that the safety belt retractor was set to ALR mode during the crash.

As the vehicle impacted the dirt embankment with its front end, the child was displaced forward and left and the CRS loaded the safety belt. The safety belt webbing exhibited a scuff mark near the lower anchor and stretch marks over a length of 30 cm (11.8 in) that was routed through the CRS. As the vehicle overturned, the child was displaced to the left. The vehicle came to final rest on its roof. The occupant remained suspended upside down until the driver unbuckled the CRS harness retainer clip and assisted the child from the vehicle. The CRS was not damaged during the crash and remained in the vehicle post-crash. The occupant was transported to a local hospital for precautionary reasons and was not injured.

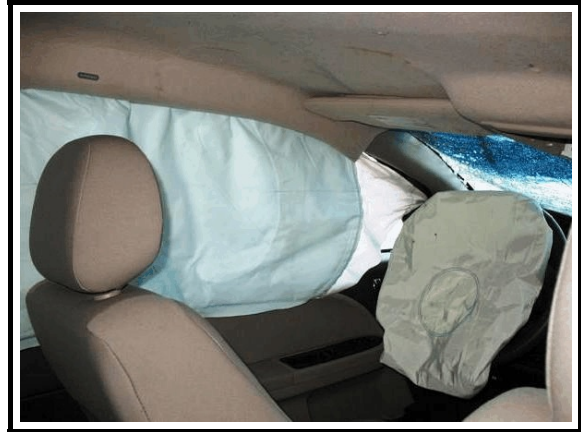
**Figure 6.** Driver's deployed air bags

The driver's air bag module was located in the steering wheel hub (**Figure 6**), and the air bag deployed through I-configured cover flaps. The flaps opened at their tear points and were not damaged. The air bag was circular in shape and measured 54 cm (21.3 in) in diameter in its deflated state. The air bag had one internal tether that terminated at the bag's front center. Two vent ports that measured 3 cm (1.2 in) in diameter were located at the 11 and 1 o'clock positions on the air bag's back panel.

The air bag exhibited occupant loading evidence in the form of a fabric transfer and blood deposits. The transfer measuring 1 cm (0.4 in) in length was located near the seam in the upper left quadrant, and four droplets of blood were deposited in the lower right quadrant. The air bag was not damaged during the crash. Based on the driver interview, injury data and contact evidence, the driver loaded the frontal air bag during the crash and sustained minor air bag related injuries. The injuries included abrasions to the left wrist and hand.

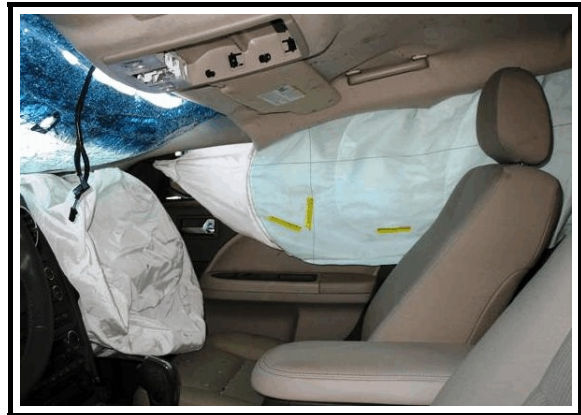
**Figure 7.** Passenger's deployed air bags

The right passenger's frontal air bag deployed through a module in the top right instrument panel (**Figure 7**). The air bag deployed through a single rectangular cover flap measuring 25 cm x 12 cm (9.8 in x 4.7 in). The flap opened at its tear points and was undamaged. The air bag was generally rectangular in shape and measured 60 cm (23.6 in) in height and 42 cm (16.5 in) in width in its deflated state. The air bag was configured with two vent ports that measured 6 cm (2.4 in) in diameter and a single internal tether.

The air bag exhibited occupant contact evidence in the form of transfers and blood deposits, and damage in the form of vinyl striations, tears, abrasions, and burn marks. Three tan-colored fabric transfers were located on the air bag's front panel in the lower right quadrant. The transfers were linear in shape and measured 1 - 2 cm (0.4 - 0.8 in) in length. Blood splatter was located on the back side of the air bag in the upper and lower left quadrants. The scattered droplets all measured less than

The air bag sustained several small tears and abrasions during the crash. The tears and abrasions were grouped in the upper right and lower left quadrants. The damage consisted of holes that measured 1 cm (0.4 in) or less. The upper right quadrant included three holes and three abrasions, and the lower left quadrant included four holes and two abrasions. The damaged areas were otherwise unremarkable and were determined to be caused by flying or broken glass. The front panel of the air bag exhibited two areas of vinyl striations that were deposited by the module cover flap during deployment.

The vent ports and internal seams exhibited dark burn marks on their edges consistent with thermal damage during deployment.

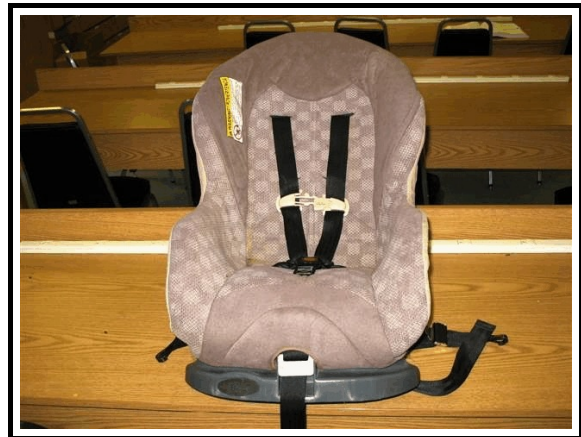
**Figure 8.** Graco ComfortSport CRS

The CRS was inspected for damage and evidence of occupant loading. The harness straps did not sustain any deformation due to intrusion or loading. The occupant's safety belt webbing exhibited loading evidence, but there was no corresponding damage to the CRS frame along the belt routing path. A 1 cm (0.4 in) scuff was located on the upper right side of the CRS adjacent the headrest; a 2 cm (0.8 in) scuff was located on the mid right side adjacent the arm rest. Some discoloration of the plastic frame was documented across the front of the CRS base which indicated stress to that area. No further damage to the CRS was observed.

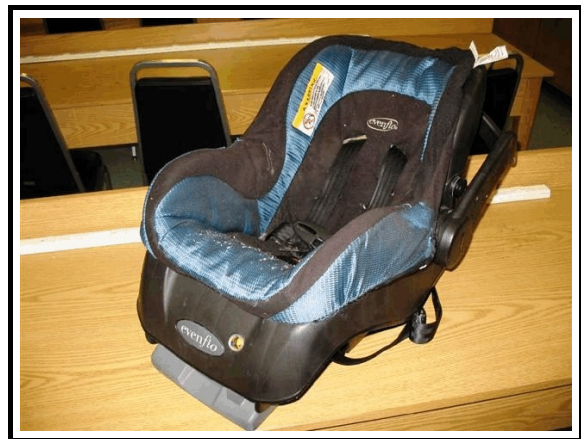
**Figure 9.** Evenflo Embrace CRS

The harness straps did not reveal any deformation due to contacts or loading. The occupant's safety belt webbing and latch plate exhibited loading evidence, but there was no corresponding damage to the CRS frame along the belt routing path. A 2 cm (0.8 in) scuff was located on the lower right side. There were no fractures or deformity present. The CRS exhibited a few dried liquid deposits that were consistent with food. No further damage to the CRS was observed.

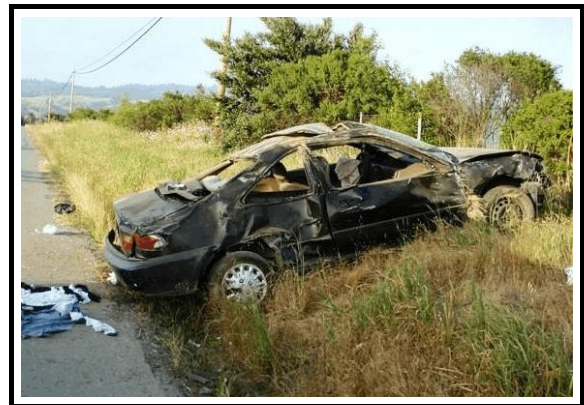
The Honda's exterior damage data was determined based on police photographs only (**Figure 10**). The vehicle sustained minor damage to the right side during the vehicle to vehicle impact (Event 1). The damage distribution was wide and comprised surface scratches; lateral crush was not determined but the overall damage was minor. For Event 1, the estimated Collision Deformation Classification (CDC) for the Honda was 02RBLW1.

**Figure 10.** 1993 Honda Civic, Police photo
