## ON-SITE SIDE IMPACT INFLATABLE OCCUPANT PROTECTION INVESTIGATION

CASE NUMBER - IN09023  
LOCATION - NEBRASKA  
VEHICLE - 2007 HONDA CIVIC Si  
CRASH DATE - May 2009

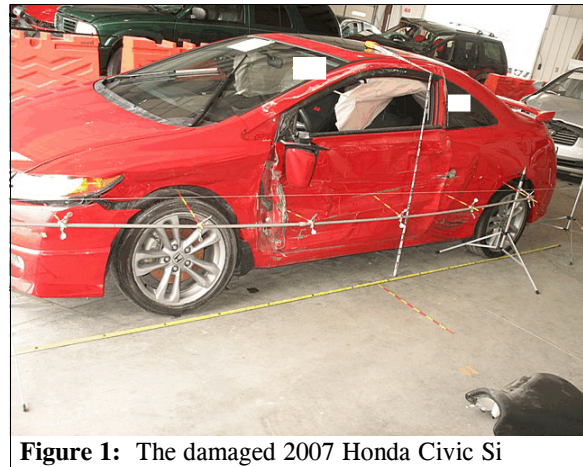
**Figure 1:** The damaged 2007 Honda Civic Si

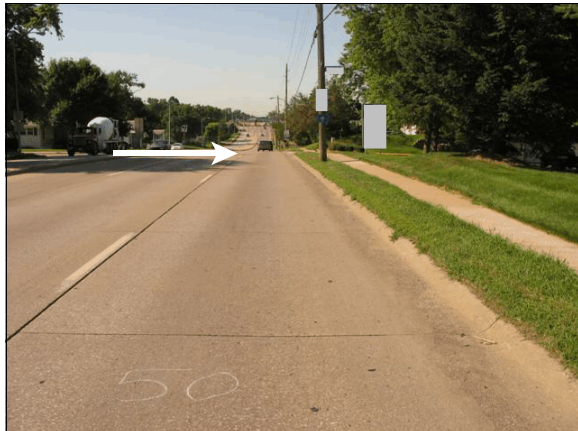
**Figure 2:** Approach of the Honda to the intersection; arrow shows approach of the Toyota

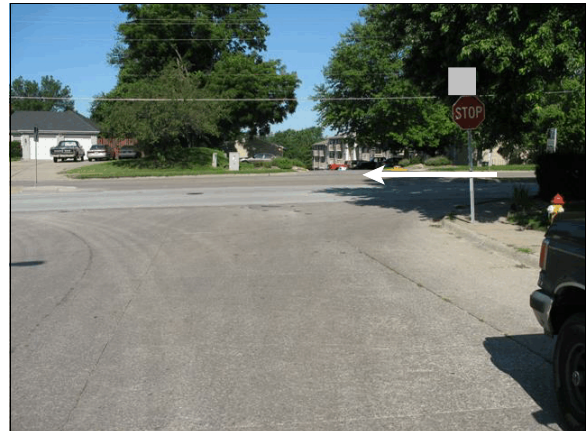
**Figure 3:** Approach of the Toyota; arrow shows the approach of the Honda

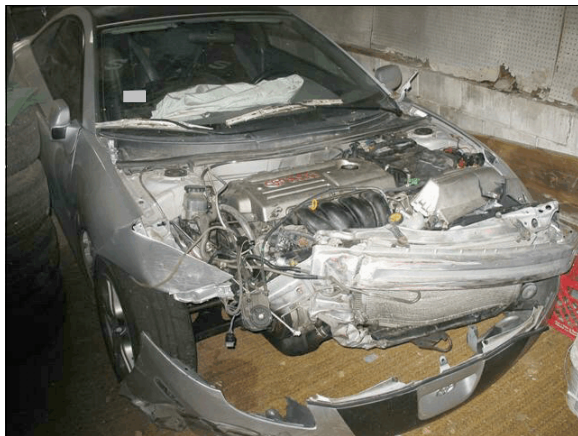
**Figure 4:** Damage on the front plane of the Toyota from the impact with the left side plane of the Honda

**Exterior Damage:** The impact with the Honda involved the Toyota’s front plane. The direct damage began at the front right bumper corner and extended across the full width of the bumper. The vehicle was located in a garage at the owner’s residence and due to the circumstances of the inspection, the damage was documented with photographs only.

**Damage Classification:** The CDC for the front impact with the Honda was **02-FDEW-2 (60 degrees)**. The Missing Vehicle algorithm of the WinSMASH program calculated the total Delta V as 20 km/h (12.4 mph). The longitudinal and lateral velocity changes were -10.0 km/h (-6.2 mph) and -17.3 km/h (10.8 mph), respectively. The results were based only on the Honda’s crush profile and should be considered as a borderline reconstruction of the Toyota’s Delta V.

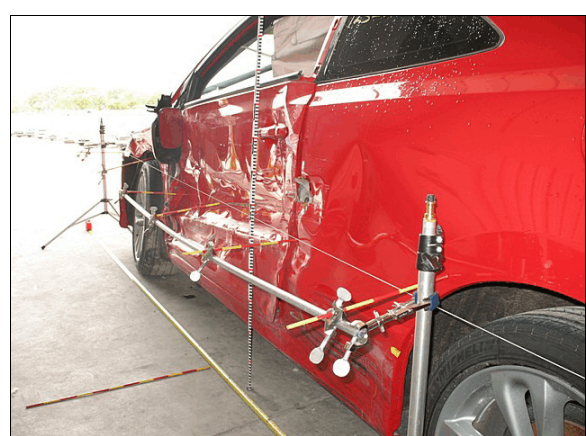
**Figure 5:** Damage on the left side lane of the Honda from the impact with the Toyota

**Exterior Damage:** The impact with the Toyota involved the left side plane of the Honda. The left fender, left front door and quarter panel were directly damaged. The direct damage began 36 cm (14.2 in) forward of the left rear axle and extended 291 cm (114.6 in) forward along the left side. The crush measurements were taken at the mid-door level and the residual maximum crush was 10 cm (3.9 in) occurring at both C<sub>4</sub> and C<sub>5</sub> (Figure 6). The height of the vehicle’s sill was 28 cm (11 in). The height of the maximum door crush was 49 cm (19.3 in) and the Door Sill Differential was 10 cm (3.9 in). The left side wheelbase was shortened 3 cm (1.2 in), while the right side wheelbase was extended 2 cm (0.8 in).

**Damage Classification:** The Collision Deformation Classification (CDC) was **11-LYEW-1 (340 degrees)** for the left side impact. The Missing Vehicle algorithm of the WinSMASH program calculated the vehicle’s total Delta V as 16 km/h (10 mph). The longitudinal and lateral velocity changes were -15.0 km/h (-9.0 mph) and 5.4 km/h (3.4 mph), respectively. The results were based only on the Honda’s crush profile and should be considered as a borderline reconstruction of the Delta V.

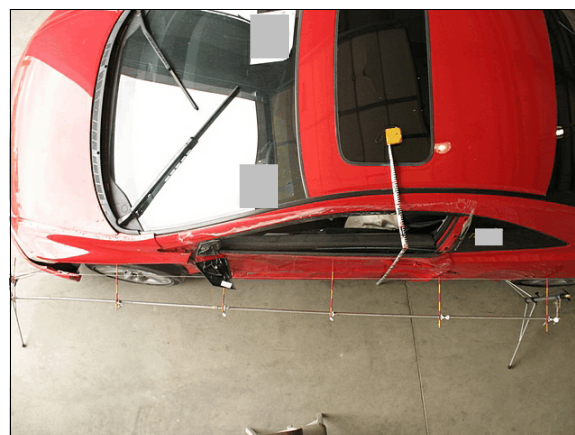
Figure 6: Top view of the crush on the left side plane of the Honda

The induced damage involved the front bumper fascia, left fender, and left quarter panel. The table below shows the left side crush profile.

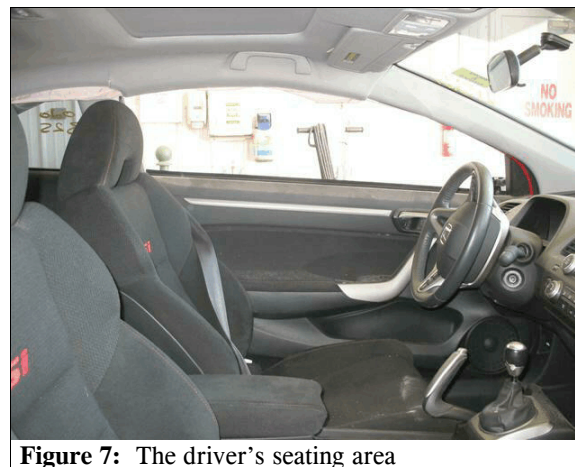
**Vehicle Interior:** The inspection of the Honda’s interior (**Figure 7**) revealed a possible occupant contact abrasion on the left front door armrest. No other discernable evidence of occupant contact was observed. There was no damage to the steering wheel and no compression of the energy absorbing steering column.

**Figure 7:** The driver’s seating area

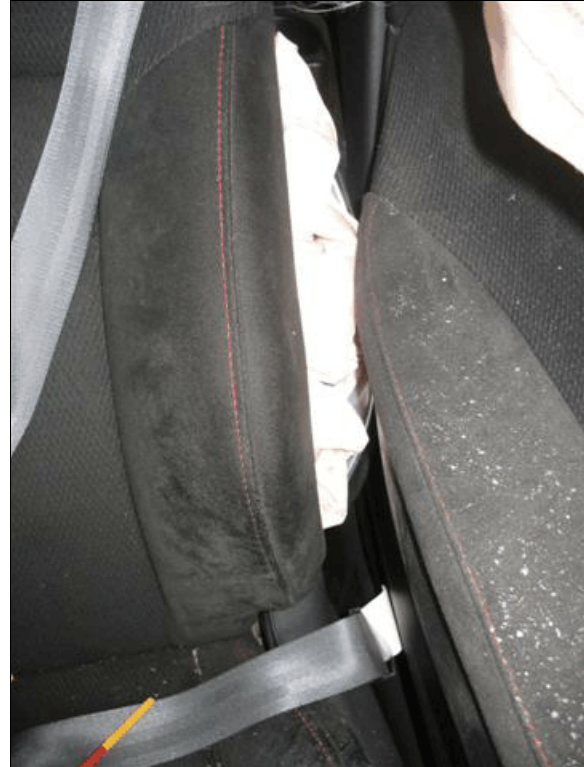
The driver's seat-mounted side impact air bag was located within the outboard side of the seat back (**Figure 8**) and deployed through a tear-seam. The air bag (**Figure 9**) was designed with one 3 cm (1.2 in) vent port located on the outboard side. The air bag had a single oval tether where both sides of the air bag were sewn together. The sewn area was 15 cm (5.9 in) in width and 9 cm (3.5 in) in height. The deployed air bag was 50 cm (19.7 in) in height and 36 cm (14.2 in) in width at its widest point. Inspection of the air bag revealed no discernable evidence of occupant contact and no damage. The front right seat-mounted side impact air bag was of the same construction and dimensions. It was not damaged and there was no discernable evidence of occupant contact.

**Figure 8:** The location of the front left seat-mounted side impact air bag

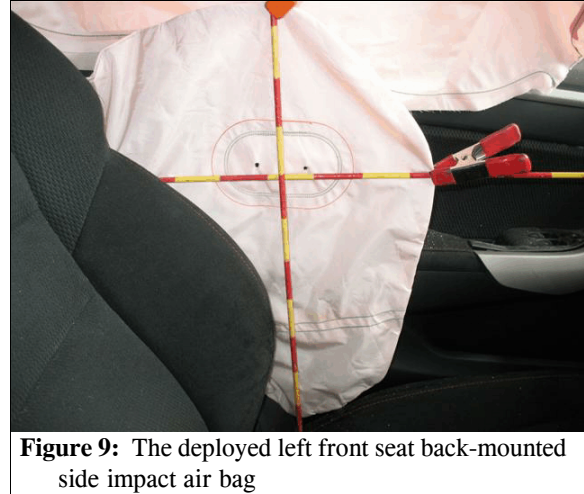
**Figure 9:** The deployed left front seat back-mounted side impact air bag

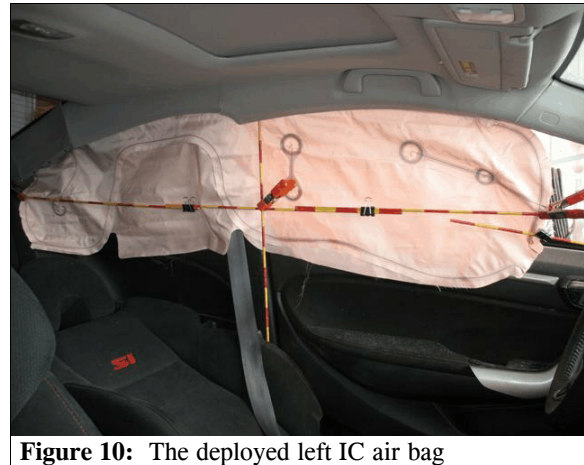
The left IC air bag was located along the roof side rail (**Figures 10**) inside the headliner and extended from the A-pillar to the C-pillar. The deployed IC air bag was 141 cm (55.5 in) in width, 35 cm (13.8 in) in height, and extended 8 cm (3.1 in) below the beltline. It was attached at the A-pillar by a cloth tether 27 cm (10.6 in) in length. The gap between the air bag and the A-pillar at the beltline was 39 cm (15.3 in). There was no visible tether at the C-pillar. There was what appeared to be a single vent port on the front edge of the air bag. The fold creases on the air bag indicated that it had been folded accordion fashion within the headliner. Inspection of

the air bag revealed no damage and no discernable evidence of occupant contact. The right IC air bag was of the same construction and dimensions. It was not damaged and there was no discernable evidence of occupant contact.

**Figure 10:** The deployed left IC air bag
