**CALSPAN ON-SITE CERTIFIED ADVANCED 208-COMPLIANT VEHICLE
CRASH INVESTIGATION**

SCI CASE NO.: CA09024

VEHICLE: 2008 HONDA CIVIC COUPE

CRASH DATE: SEPTEMBER 2008

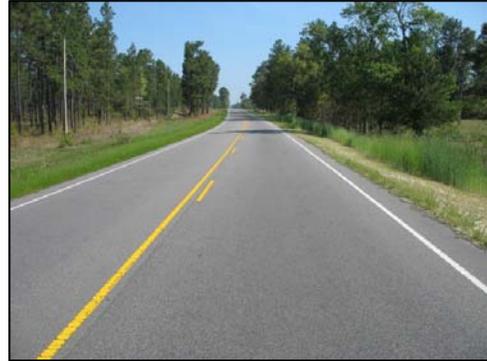
The restrained 29-year old female driver of the Honda was traveling north on the rural roadway, at a police estimated speed of 89 km/h (55 mph), negotiating a shallow left curve (**Figure 2**). As the curve transitioned back to a straight roadway, the driver continued her steering input to the left. Consequently, the vehicle initiated a northwest trajectory, crossed the center line and departed the left side of the road. The Civic continued its northwest trajectory across the grass shoulder onto the pine straw roadside and began to approach the pine trees.

Figure 2: Honda's pre-crash trajectory.

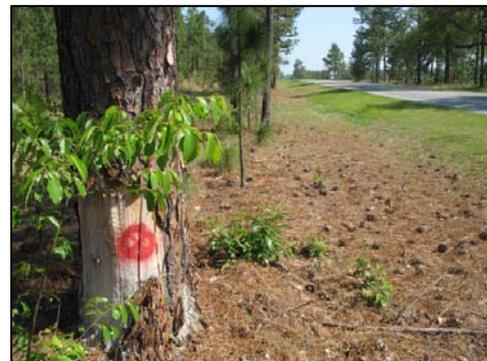
To the west of this grass shoulder, the surface transitioned to pine straw with small brush. A tree line was located 9.3 m (30.5 ft) west of the fog line. A 70 cm (27.6 in) diameter tree located within the tree line was the initial point of impact. A 35 cm (13.8 in) diameter tree located 13.5 m (44.3 ft) north of the initial impact was contacted by the Honda as it came to final rest. The posted speed limit was 89 km/h (55 mph).

Figure 3: Initial and subsequent impact pine trees.

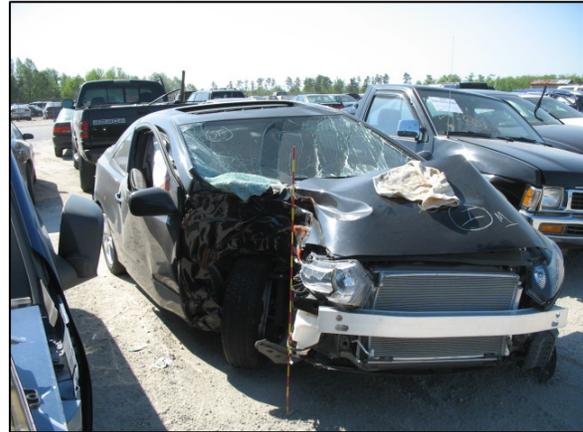
The exterior of the Honda sustained moderate severity damage to the right side plane as a result of this multiple impact crash. The Honda impacted the 70 cm (27.6 in) diameter tree (Event 1) with the forward aspect of the right plane (Figure 4). The direct contact damage began on the forward aspect of the right fender, 305 cm (120 in) forward of the right rear axle. The direct contact damage extended 86 cm (33.9 in) rearward forming a pocketed region of deformation at the right A-pillar area. The right front suspension and wheel deformed rearward into the lower A-pillar. The right wheelbase was reduced 51 cm (20 in). The force of the impact caused an outward buckling of the front right door. This induced damage began at the right B-pillar. The combined length of the induced and direct damage measured 230 cm (90.6 in). A crush profile was documented along the right plane at the mid-door elevation and was as follows: C1 = 0 cm, C2 = 0 cm, C3 = 0 cm, C4 = 28 cm (11 in), C5 = 47 cm (18.5 in), C6 = 3 cm (1.2 in). The induced damage at crush locations C1, C2 and C3 was displaced outboard, resulting in negative crush measurements at those locations. Negative crush measurements are taken to be zero. The maximum crush measured 51 cm (20.1 in) and was located 251 cm (98.8 in) forward of the right rear axle. The Collision Deformation Classification for this event was 02-RYEW4.

Figure 4: Right front corner damage.

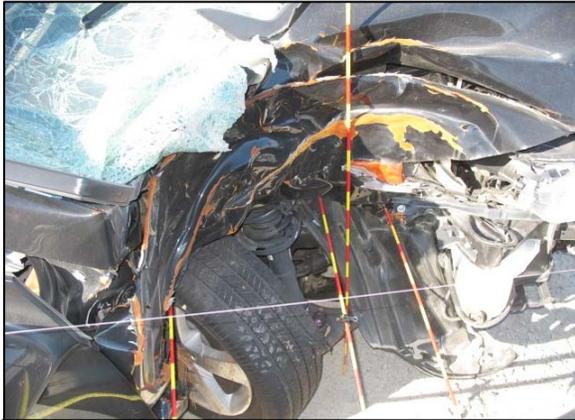
Figure 5 and 6 are close-up views of the deformation to the right fender area. The ACE frame structure was within the area of the deformation.

Figure 5: Right lateral view of the Event 1 impact damage.

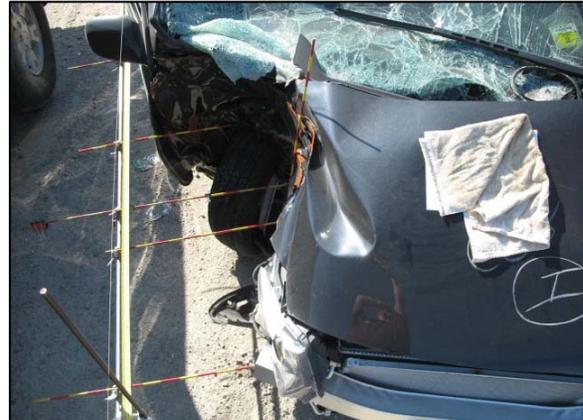
Figure 6: Longitudinal view of the Event 1 impact damage.

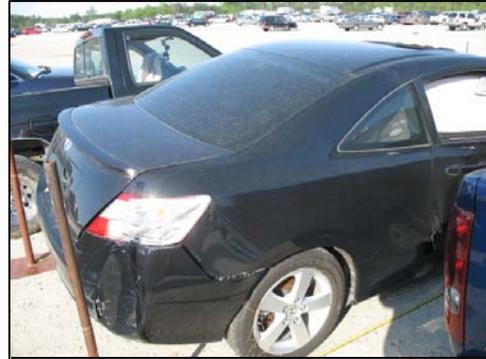
The impact with the 35 cm (13.8 in) diameter tree (Event 2) resulted in damage to the right rear corner of the Honda (**Figure 7**). The direct damage began 63 cm (24.8 in) rear of the right rear axle and extended rearward 10 cm (3.9 in). The induced damage began 17 cm (6.7 in) rear of the right rear axle and extended rearward 58 cm (22.8 in). The maximum crush was located at the right rear bumper corner and measured 14 cm (5.5 in). The CDC for this impact was 05-RBEE2.

Figure 7: Right rear corner damage.

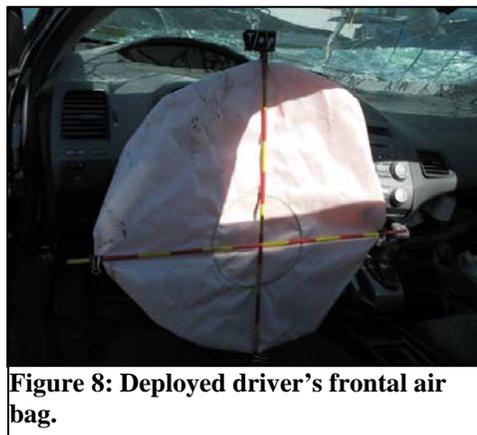
The driver's air bag was concealed within the center hub of a three-spoke steering wheel by a tri-flap design. The upper flap was 13 cm (5.1 in) in width at the horizontal tear seam and 7 cm (2.8 in) in height. The lower flaps dimensions were mirrored symmetrically, the upper aspects measuring 7 cm (2.8 in) in width at the horizontal tear seam, the outboard sides measuring 7 cm (2.8 in) in height vertically and the lower aspects measuring 3 cm (1.2 in) horizontally. The air bag (**Figure 8**) measured 60 cm (23.6 in) in diameter in its deflated state. The air bag was vented by two ports located at the eleven and one o'clock positions. The air bag was tethered by two straps located at the twelve and six o'clock positions on a 16 cm (6.3 in) circular seam sewn to the center of the face of the air bag. There were no occupant contacts to the driver's frontal air bag, but the upper left quadrant contained multiple droplets of an unidentified gritty substance. This substance was distributed in a semi-circular arc around the upper left quadrant, beginning 20 cm (7.9 in) and ending 30 cm (11.8 in) from the center of the air bag.

Figure 8: Deployed driver's frontal air bag.

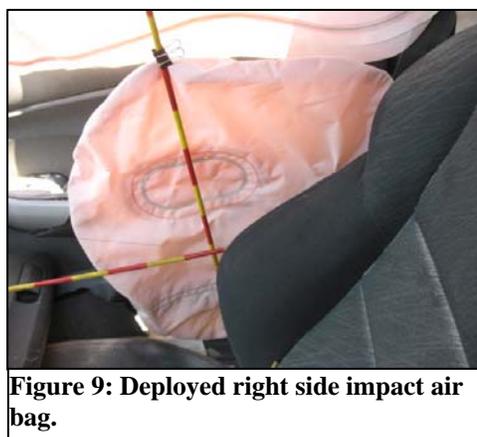
The Honda was equipped with front seat back-mounted side impact air bags and roof side rail-mounted curtain air bags. The right side impact air bag and the right curtain air bag deployed during this crash. The right side impact air bag (**Figure 9**) deployed from a 35 cm (13.8 in) long seam in the upper outboard aspect of the front right seat back. The air bag measured 52 cm (20.5 in) in height and 32 cm (12.6 in) in width. The air bag had one vent port on the outboard aspect at the three o'clock position. There was no contact evidence on the side air bag.

Figure 9: Deployed right side impact air bag.

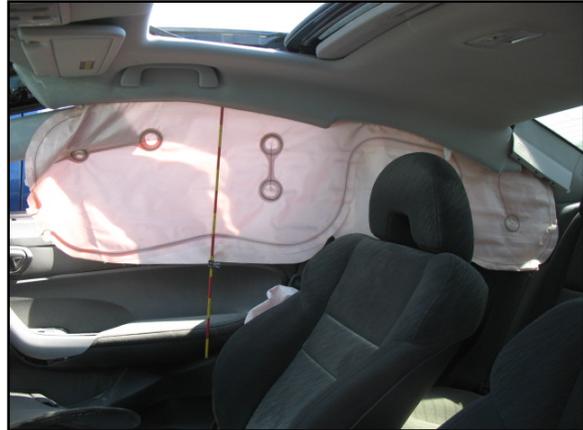
The right side curtain air bag deployed from the right roof side rail (**Figure 10**). The air bag measured 137 cm (53.9 in) in length and 41 cm (16.1 in) in height at the front seating position, including a 4 cm (1.6 in) non-inflating strip at the bottom of the fabric. In the rear seating position, the air bag measured 36 cm (14.2 in) in height. At the rear of the curtain, the inflatable section of the air bag measured 33 cm (13 in) in width and 34 cm (13.4 in) in height. Forward of this inflatable section was a non-inflated panel measuring 30 cm (11.8 in) in height and width. There was an inflatable tube connecting the front and rear inflatable sections of the curtain measuring 30 cm (11.8 in) in width and 6 cm (2.4 in) in height. The curtain was tethered to the A-pillar by a 28 cm (11 in) webbing strap. Vertically, the curtain air bag extended below the belt line at each outboard position approximately 5 cm (2 in). The curtain air bags provided head protection from the roof side rail to the belt line from the B-pillar forward 74 cm (29.1 in) and from the C-pillar forward 33 cm (13 in). There was an unprotected opening at A-pillar measuring 44 cm (17.3 in) in width and 24 cm (9.4 in) in height. The right curtain air bag was free from occupant contact points and damage.

Figure 10: Deployed right curtain air bag.

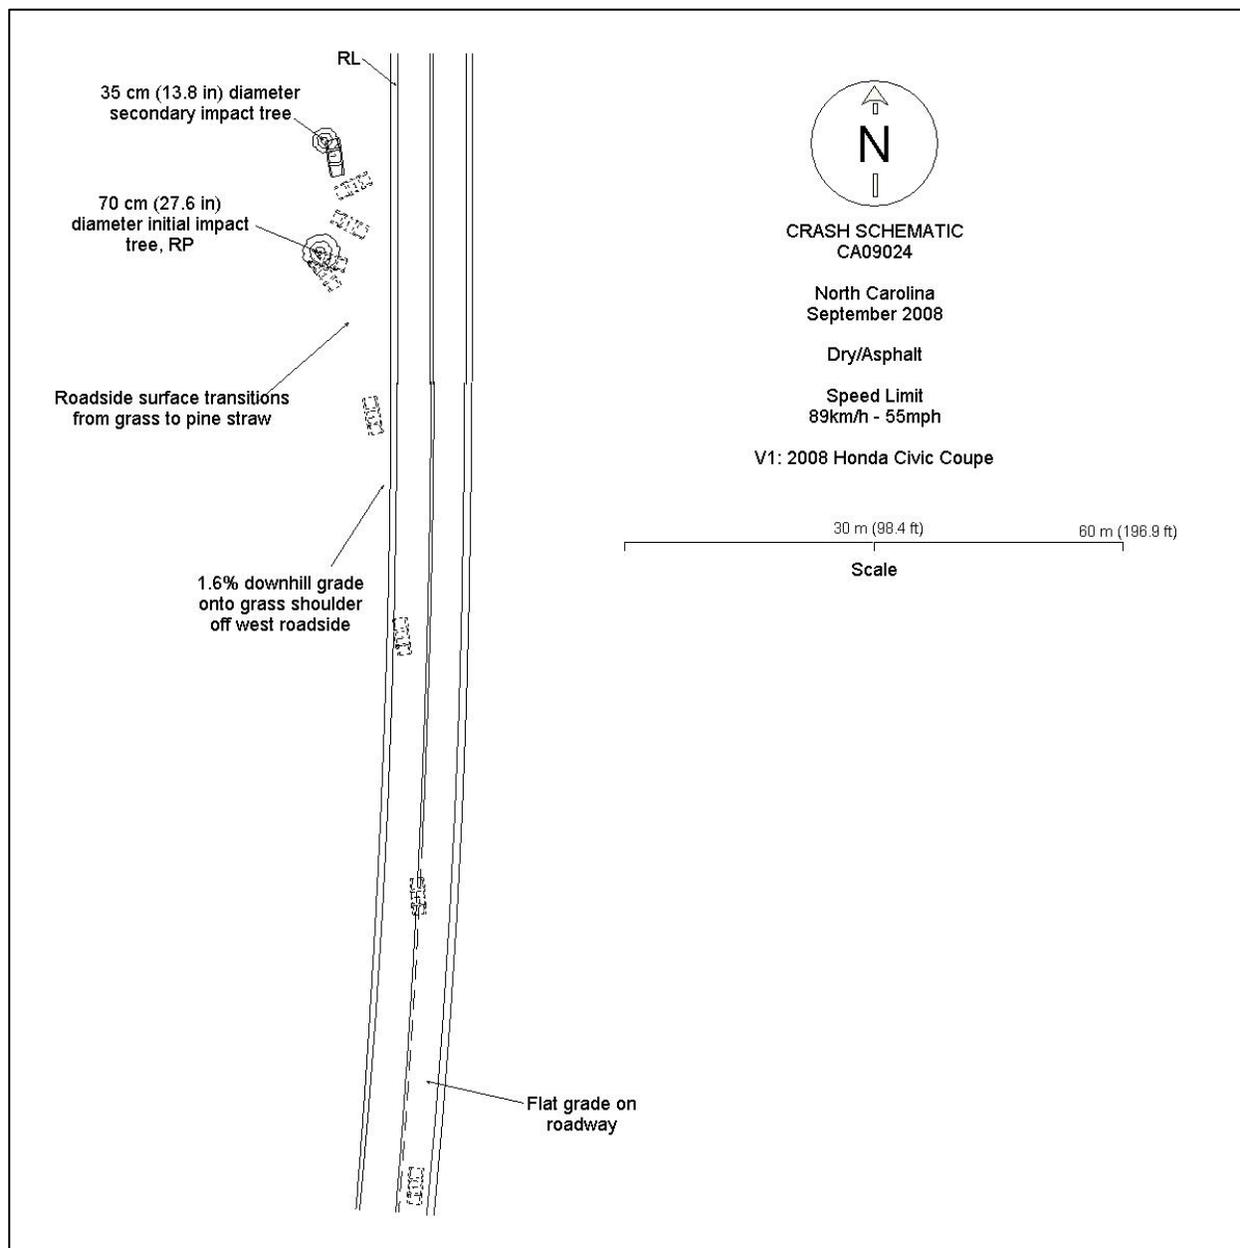
Figure 11: Scene Schematic

The angular impact force to the forward right side induced a counterclockwise rotation to the Honda. The vehicle rotated approximately 180 degrees within the off-road area and impacted the 35 cm (13.8 in) diameter tree with the right rear corner of the vehicle (Event 2). The direction of force for the minor secondary impact was within the five-o'clock sector. This impact resulted in minor damage. The vehicle came to rest in close proximity to the second tree facing south. **Figure 3** is an overall view of both trees involved. A schematic of the crash is included at the end of this report as **Figure 11**.
