CALSPAN ON-SITE ROLLOVER CRASH INVESTIGATION

SCI CASE NO.: CA09025

VEHICLE: 2009 FORD MUSTANG

CRASH DATE: MARCH 2009

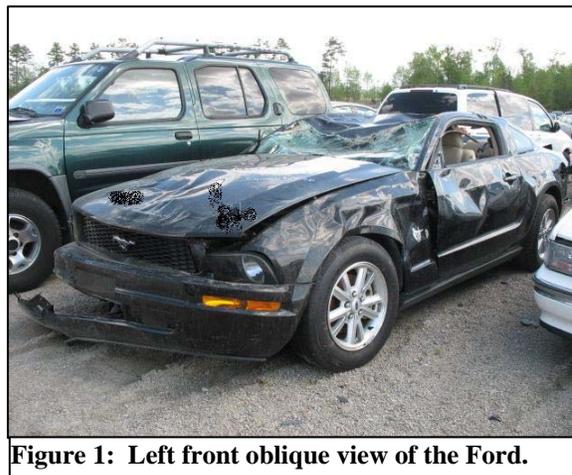
Figure 1: Left front oblique view of the Ford.

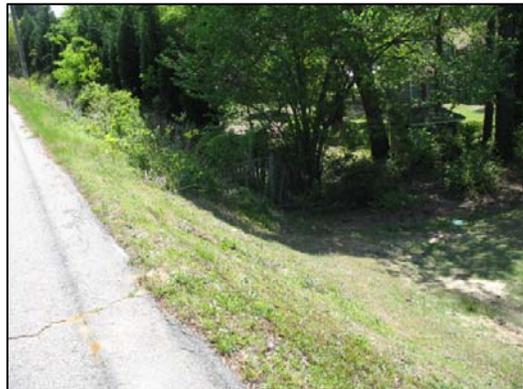
The Ford initiated a right side leading fall-over type rollover event down the embankment (**Figure 2**). As the Ford rolled two-quarter turns, the top plane of the hood impacted the wood split-rail fence. The impact fractured the fence as the vehicle continued to roll. The Ford rolled over four-quarter turns coming to rest on its wheels. The vehicle came to rest in a residential back yard.

Figure 2: Steep slope of the grass-surfaced embankment.

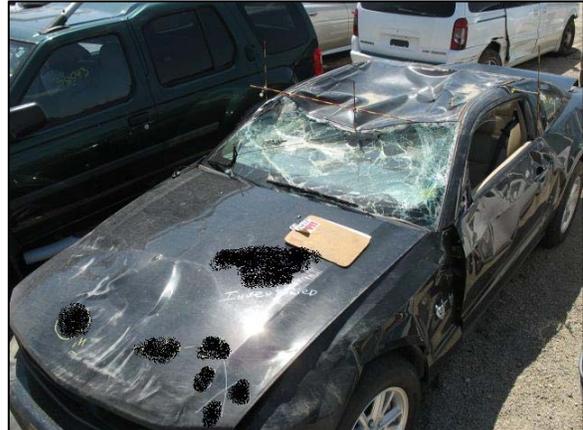
The exterior of the Ford sustained moderate severity damage to the right, top and left planes as a result of the rollover crash (**Figure 3**). The abrasions on the roof were longitudinally oriented indicating that the vehicle had rolled over one complete turn. The maximum vertical and lateral crush locations were separate. The maximum vertical crush was located on the windshield header, 56 cm (22 in) left of the junction of the right A-pillar and the right roof side rail (**Figure 4**). The resultant maximum vertical deformation was 20 cm (7.9 in). The direct damage to the top plane extended laterally from the left roof side rail to the right roof side rail. The lateral direct damage measured 115 cm (45.3 in). The direct damage to the top plane extended longitudinally from the front edge of the hood to the rear edge of the trunk lid and was 426 cm (167.7 in). The maximum lateral crush was located on the left roof side rail, 14 cm (5.5 in) forward of the B-pillar and measured 3 cm (1.2 in). The left and right door hinges were intact and remained attached to the A-pillars. Both door latches remained engaged as the doors remained closed during the crash. The windshield was cracked but remained in place. The left front and backlight glazing disintegrated during the ground contact. The left rear and right side glazing were not damaged. The Collision Deformation Classification (CDC) assigned for this rollover was 00TDDO4.

Figure 3: Rollover damage of the Ford Mustang from overhead left.

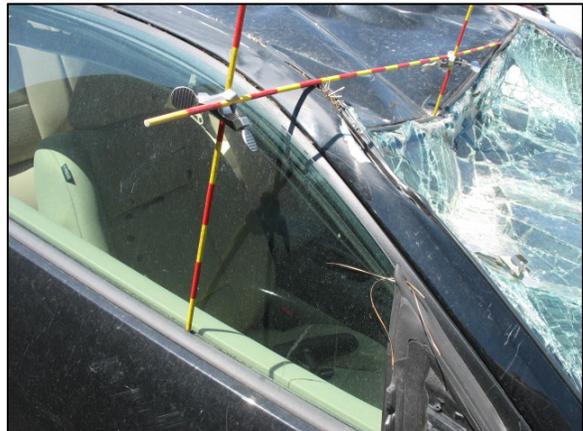
Figure 4: Maximum vertical crush of the roof of the Ford Mustang.

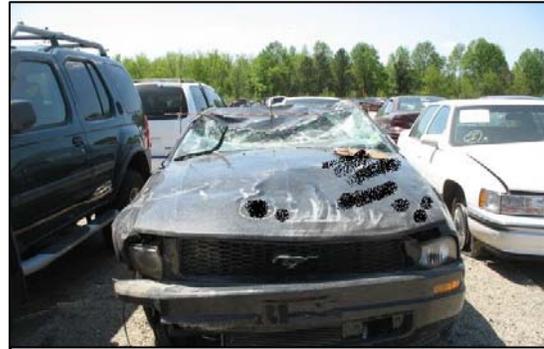
During the rollover event, the front aspect of the hood impacted the wood fence. The direct damage from the fence was identified by a subtle paint transfer and scratching to the vehicle. There was no crush to the hood. The direct damage measured 62 cm (24.4 in) longitudinally and began at the front edge of the hood, extending rearward (**Figure 5**). The CDC was 00TFDW1.

Figure 5: Secondary impact damage to the top of the hood of the Ford Mustang.

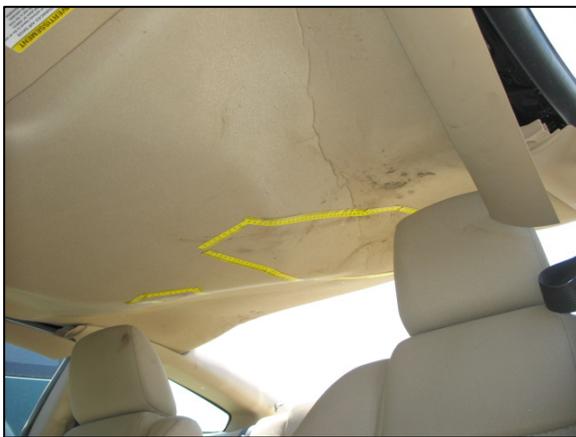
The interior of the Ford sustained damage attributed to occupant contact. There was a scuff mark on the headliner that began over the front left seating position. This scuff mark began 51 cm (20.1 in) aft of the windshield header and ended at the backlight header. Laterally this scuff mark was located from 20 cm (7.9 in) to 40 cm (15.7 in) inboard of the left roof side rail. This contact was attributed to the driver's head. There was a scuff mark on the forward aspect of the center armrest/console. This scuff resulted from contact with the driver's right hip. A scuff mark from the front right passenger's head was present on the roof over the front right seating position beginning 60 cm (23.6 in) rear of the windshield header and 55 cm (21.7 in) inboard of the right roof side rail. This contact terminated 68 cm (26.8 cm) rear of the windshield header and 63 cm (24.8 in) inboard of the right roof side rail. **Figures 6 and 7** depict the occupant contact damage to the interior of the Ford.

Figure 6: Head contacts to the headliner.

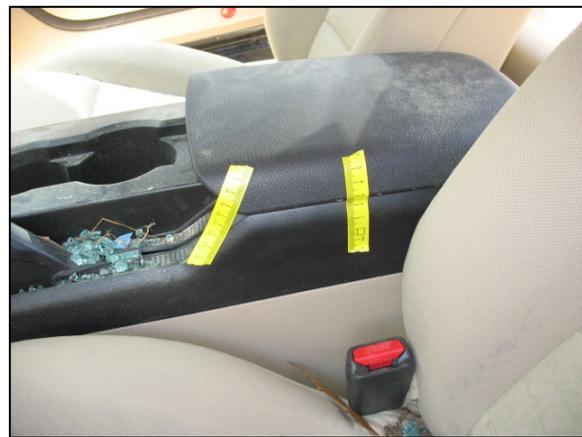
Figure 7: Hip contact to the center console.

The 33-year-old male driver was seated in a full-rear track position and was restrained by the manual three-point lap and shoulder belt system. During the Ford's rollover sequence to the right, the driver loaded the center console with his right hip. Although the console was scuffed, this contact did not result in injury. The driver loaded the manual safety belt system resulting in a contusion across his abdomen. The roof and headliner intruded into the passenger

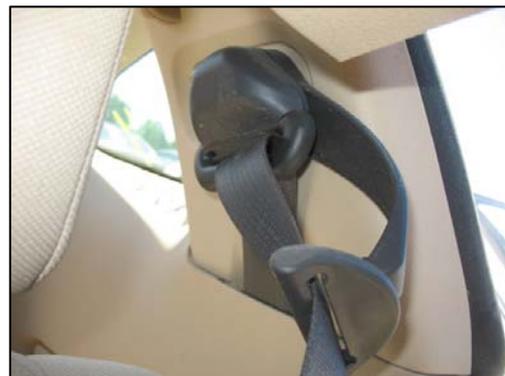
Figure 8: OEM belt positioning device.
