## ON-SITE SIDE IMPACT INFLATABLE OCCUPANT PROTECTION INVESTIGATION

CASE NUMBER - IN09025

LOCATION - NEBRASKA

VEHICLE - 2004 MAZDA TRIBUTE ES

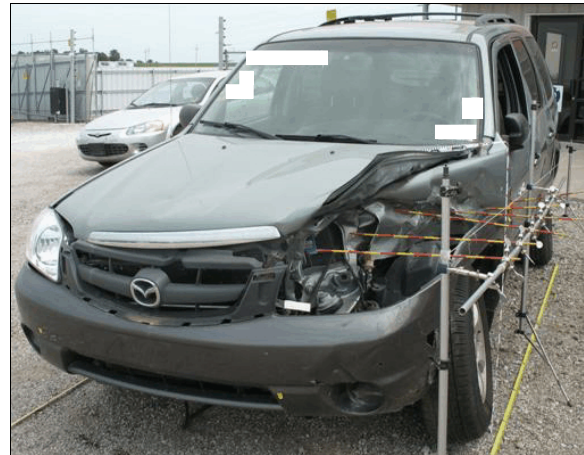
**Figure 1:** The damaged 2004 Mazda Tribute ES

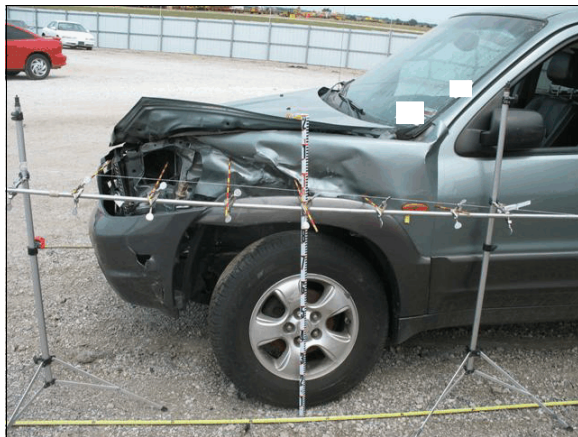
**Crash:** The front plane of the Ford impacted the Mazda's left fender (**Figure 4**, event 1). The direction of force on the Mazda was within the 11 o'clock sector, and the impact force was sufficient to trigger a deployment of the driver's seat-mounted side impact air bag. The impact caused the Mazda to rotate clockwise and the Ford rotated counterclockwise. The right quarter panel of the Ford impacted the left quarter panel of the Mazda (**Figure 5**, event 2). Both vehicles were redirected to the southwest (**Figure 6**) and entered a convenience store lot where the front of the Mazda (**Figure 7**) impacted the north wall of the convenience store (**Figure 6**, event 3). The Mazda's direction of force was within the 12 o'clock sector and the impact force was not sufficient to trigger deployment of the driver's frontal air bag. The Mazda rolled backward in a northerly direction across the street (**Figure 8**) and its back plane (**Figure 9**) impacted a metal fence (event 4) where the vehicle came to final rest heading southeast. The Ford came to final rest in the convenience store lot heading southwest.

**Figure 4:** Damage on the left fender of the Mazda from impact with the front of the Ford

**Exterior Damage:** The initial impact with the Ford involved the left side plane of the Mazda. The left fender, corner of the front bumper, and the left front wheel were directly damaged. The direct damage began 32 cm (12.6 in) rear of the left front axle and extended 112 cm (44.1 in) along the fender. The crush measurements were taken at the upper fender level and the residual maximum crush was 34 cm (13.4 in) occurring at C<sub>4</sub> (**Figure 10**). The induced damage involved the left front door and the left side wheelbase was reduced 3 cm (1.2 in). The table below shows the vehicle’s left side crush profile.

**Damage Classification:** The Collision Deformation Classifications (CDC) were **11-LFEW-3 (330 degrees)** for the left fender impact with the front plane of the Ford (event 1) and **09-LZEW-2 (270 degrees)** for the left quarter panel impact with the right quarter panel of the Ford (event 2). The CDC for the front plane impact with the convenience store (event 3) was **12-FDLW-1 (0 degrees)**, and **06-BZLN-1 (180 degrees)** for the back plane impact with the metal fence (event 4).

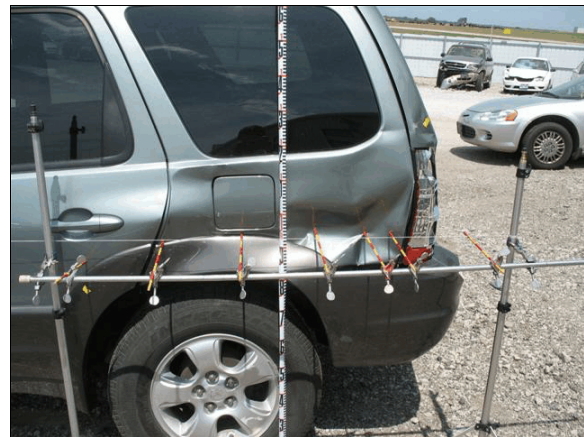
**Figure 5:** Damage on the left quarter panel of the Mazda from impact with the right quarter panel of the Ford

The second impact with the Ford also involved the left side plane of the Mazda. The left quarter panel and the side portion of the back bumper fascia were directly damaged. The direct damage began 34 cm (13.4 in) forward of the left rear axle and extended 116 cm (45.7 in) rearward along the quarter panel. The crush measurements were taken at the middle quarter panel level and the residual maximum crush was 12 cm (4.7 in) occurring 6 cm (2.4 in) forward of C<sub>3</sub> (**Figure 11**). The induced damage involved the left rear door. The table below shows the crush profile on the left quarter panel.

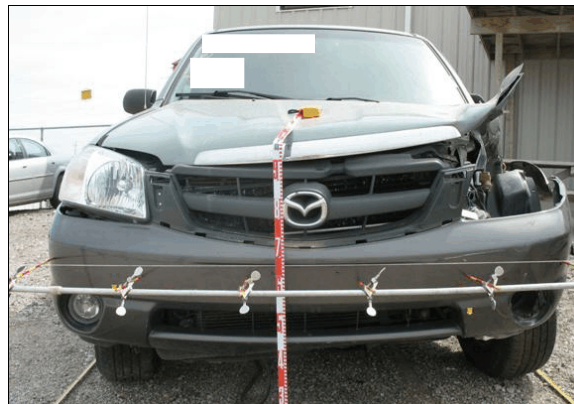
**Figure 7:** Damage to the Mazda's front plane from the impact with the wall of the convenience store

The Mazda's impact with the convenience store involved the front plane and the front bumper was directly damaged. The direct damage began 22 cm (8.7 in) left of the front right bumper corner and extended 100 cm (39.4 in) across the bumper. The front bumper sustained no residual crush due to this impact. The induced damage involved the bumper fascia.

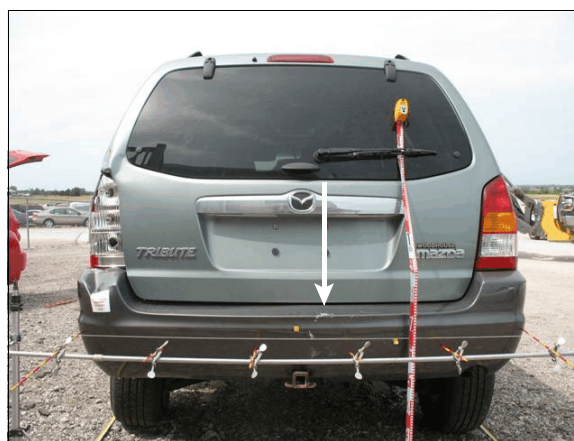
**Figure 9:** Arrow shows damage location on Mazda's back bumper from impact with the metal fence

The Mazda's impact with the fence involved the back plane and the back bumper was directly damaged. The direct damage began 51 cm (20.1 in) left of the back right bumper corner and extended 31 cm (12.2 in) across the bumper. The back bumper sustained no residual crush due to this impact. The induced damage involved the bumper fascia.

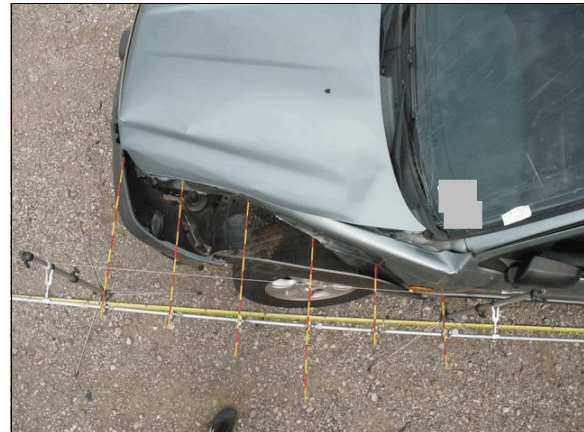
**Figure 10:** Top view of the crush on the left fender of the Mazda

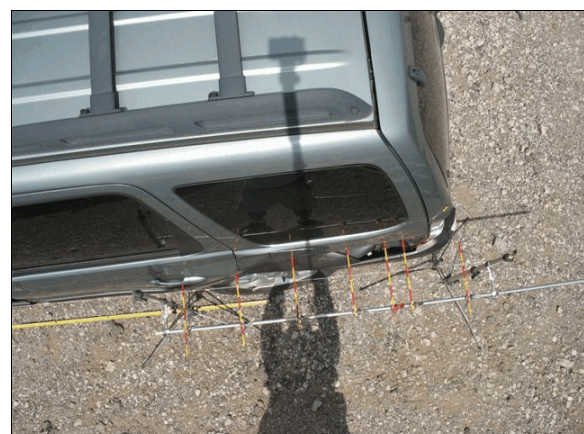
**Figure 11:** Top view of the crush on the left quarter panel of the Mazda

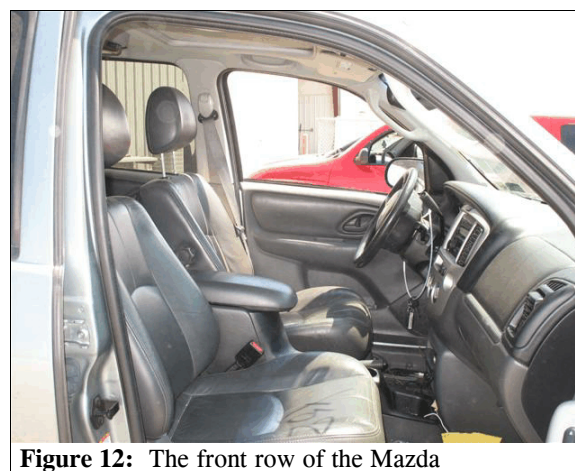
**Vehicle Interior:** The inspection of the Mazda's interior (**Figure 12**) revealed a possible skin transfer near the top of the driver's seat-mounted side impact air bag. The source of the transfer was possibly the left side of the driver's face. There was no other discernable occupant contact evidence and no steering rim deformation or compression of the energy absorbing steering column.

Figure 12: The front row of the Mazda

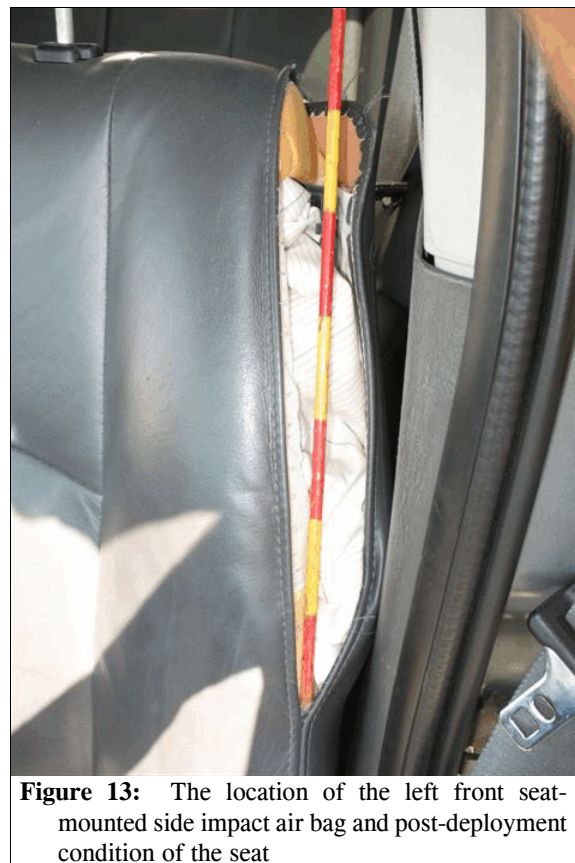
Figure 13: The location of the left front seat-mounted side impact air bag and post-deployment condition of the seat

The driver's seat-mounted side impact air bag was located in the outboard side of the driver's seat back and deployed through a tear seam (**Figure 13**). The deployed air bag (**Figure 14**) was 23 cm (9.1 in) in width and 65 cm (25.6 in) in height. There was one vent port located at

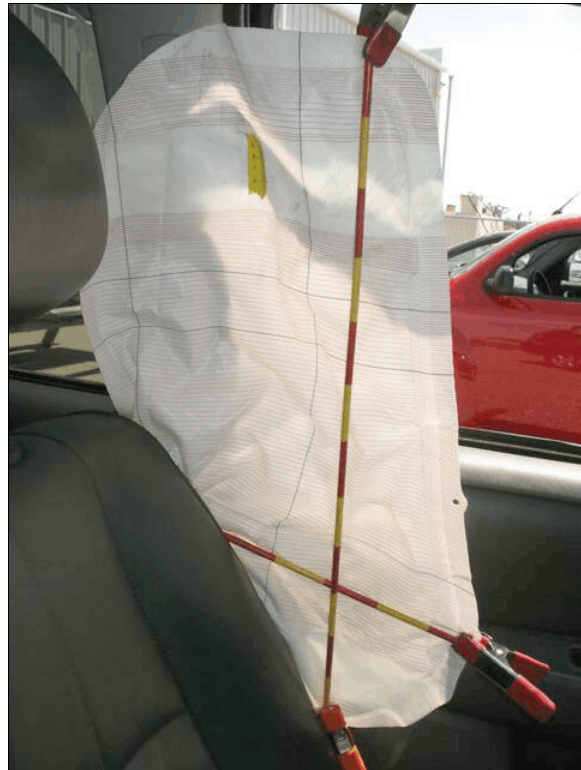
the bottom of the air bag. Inspection of the air bag revealed a possible skin transfer located 10 cm (4 in) from the top and 23 cm (9.1 in) from the front edge of the air bag. The transfer was possibly due to contact by the left side of the driver's face. There were no other discernable occupant contacts on the air bag and no damage.

**Figure 14:** The deployed left front seat back-mounted side impact air bag
