ODI Driver Air Bag Non-Deployment Investigation  
Dynamic Science, Inc. (DSI), Case Number DS09026  
2001 Honda Civic  
California  
June 2009

1. Report No. DS09026	2. Government Accession No.		3. Recipient Catalog No.	
4. Title and Subtitle  ODI Driver Air Bag Non-Deployment Investigation			5. Report Date December 4, 2009

**Dynamic Science, Inc.**  
**Crash Investigation**  
**Case Number: DS09026**

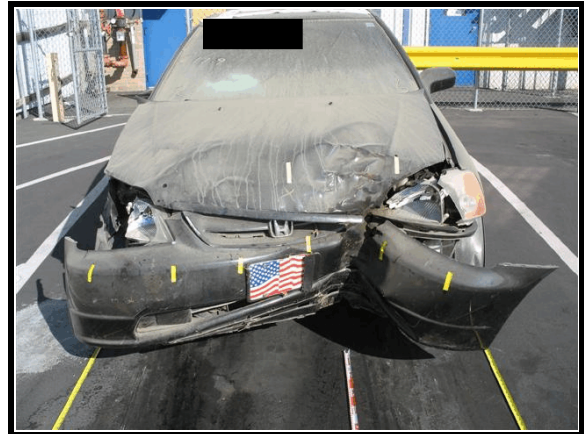
This on-site investigation focused on the non-deployment of the driver's frontal air bag in a 2001 Honda Civic (**Figure 1**). This single-vehicle crash occurred in June 2009 at 1520 hours in northern California. The 2001 Honda Civic was being driven by a restrained 71-year-old female. The Honda was subject to a driver air bag module recall, National Highway Traffic Safety Administration (NHTSA) Campaign ID Number 08V593000. According to the vehicle owner, several weeks prior to the crash the vehicle had been taken to a dealership for the recall remedy and the driver air bag module was replaced. The Honda was traveling northbound with the cruise control activated in the outboard lane of a 2-lane, divided US highway at a driver-reported speed of 100 km/h (62 mph). The roadway curved to the left and was bordered on the left by a dirt and grass covered center median and on the right by an asphalt shoulder leading to an asphalt curb and eventually to a tree and shrubbery-covered descending embankment. The driver reported to the police that she was sleepy and fatigued. She fell asleep at some point and the Honda traveled off the right side of the roadway. The Honda impacted an asphalt curb with its right rear tire, sustained undercarriage damage as it overrode the curb, impacted a plastic curve delineator, and then impacted a tree with its front end. At impact with the tree, the front row passenger air bag deployed and the driver's air bag did not. The Honda came to rest on top of the tree and facing north. The driver sustained a chest wall strain and contusion, contusions to the left shoulder and abdomen, and a laceration to her right foot. She was transported to a local hospital where she was treated and released. The Honda was towed from the scene due to damage and was later declared a total loss by the insurance company.

**Figure 1.** Subject vehicle, 2001 Honda Civic

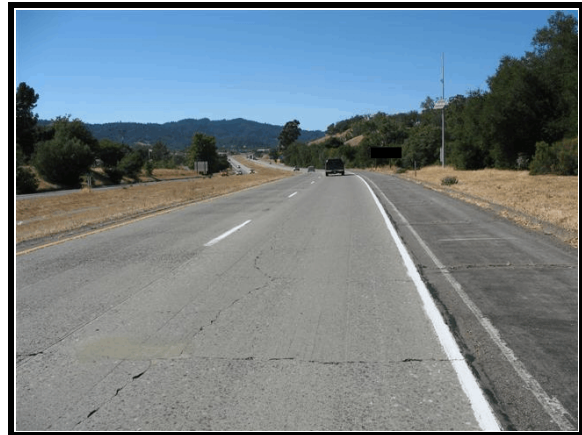
The crash site was a northbound, curved two-lane divided US highway (**Figure 2**). The roadway was of concrete composition and had a negative 1.6 percent grade. The roadway was dry and free of defects. The roadway was bordered on the west by a dirt and grass covered center median and on the east by a 2.4 m (8 ft) asphalt shoulder leading to an asphalt curb and eventually to a tree and shrubbery-covered descending embankment. The impacted tree was 28 cm (11 in) in diameter and was located 2.4 m (8 ft) west of the curb. The curb was 15 cm (5.9 in) in height. The speed limit was 105 km/h (65 mph).

**Figure 2.** Northbound approach

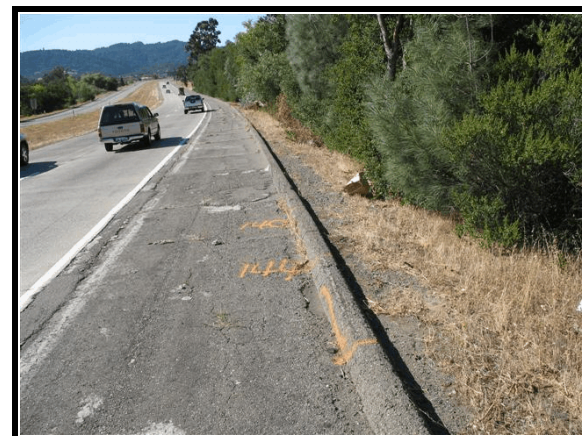
The Honda was traveling northbound with the cruise control activated in the outboard lane at a driver-reported speed of 100 km/h (62 mph). The driver reported to the police that she was sleepy and fatigued. She fell asleep at some point and the Honda traveled off the right side of the roadway (**Figure 3**).

**Figure 3.** Area of roadway departure and impacts with asphalt curb

As the vehicle departed the roadway, the right rear tire impacted the curb (Event 1). The vehicle overrode the curb and sustained undercarriage damage (Event 2). The Honda impacted shrubbery with its front end as it continued traveling north (Event 3). The Honda then struck a plastic curve delineator (Event 4) and a tree (Event 5). The total distance traveled from roadway departure to the impact with the tree was 44.5 m (146 ft).

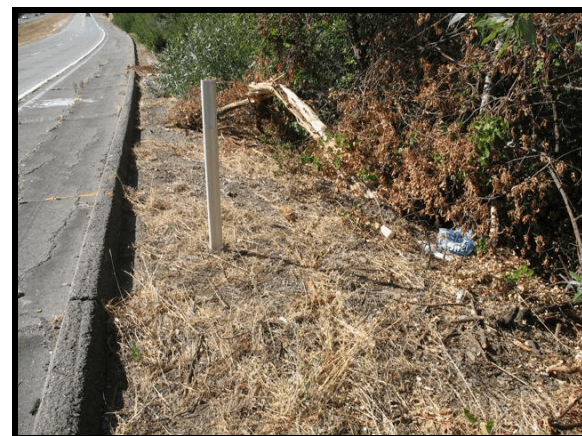
**Figure 4.** Area of impact to delineator and tree

At impact with the tree, the front passenger air bag deployed and the driver's seat belt retractor and buckle pretensioners actuated. The driver's frontal air bag did not deploy. The tree was knocked over and partially overridden by the Honda as the vehicle came to final rest (**Figure 4**). The WinSMASH program could not be used to

calculate a Delta-V because the tree yielded and invalidated the program. DSI calculated an Equivalent Barrier Speed (EBS) of 25.7 km/h (16.0 mph) based on the vehicle crush and stiffness values that were derived from New Car Assessment Program (NCAP) test #3456 (Attachment 2).

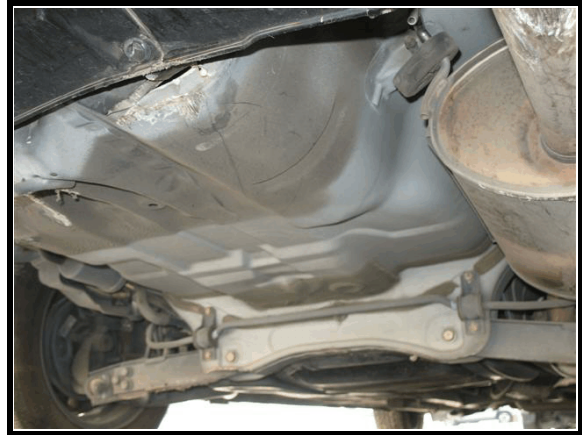
As the Honda overrode the curb, it traveled along the descending embankment, and the undercarriage impacted the top of the curb (Event 2). The undercarriage damage began at the rear axle, extended 86 cm (33.8 in) rearward, and ended at the rear bumper. The damage measured 110 cm (43.3 in) laterally along the bottom of the rear bumper fascia (**Figure 5**). The CDC for this impact was 00UBDS2.

**Figure 5.** Undercarriage damage

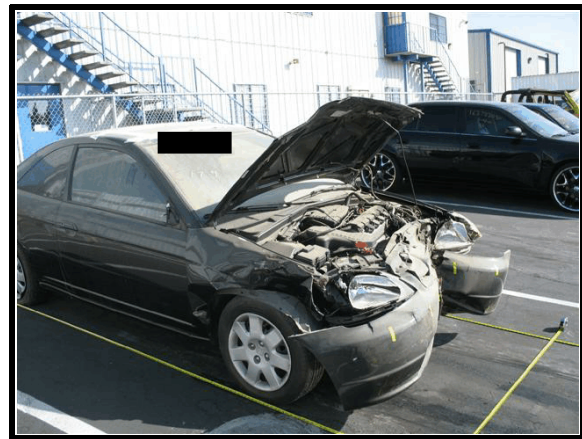
The Honda sustained minor frontal and right side damage as it contacted shrubbery along the east side of the embankment (Event 3). The direct damage began at the right front bumper corner and extended 40 cm (15.7 in) to the left. The direct damage extended 82 cm (32.3 in) longitudinally down the right side of the vehicle (**Figure 6**). The CDC for the impact with the shrubbery was 12FREE4.

**Figure 6.** Front and right side damage

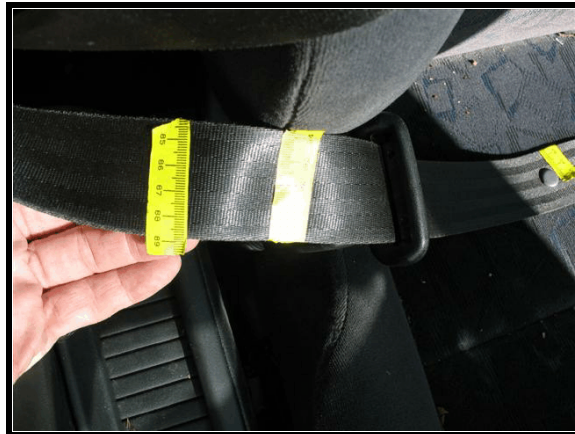
The Honda was equipped with 3-point manual lap and shoulder belts for all five seating positions. The front safety belts were equipped with retractor and buckle pretensioners. The driver's safety belt pretensioners actuated during the impact with the tree. The belt webbing was locked in the used position and the buckle stalk was compressed by 1 cm (0.4 in) as compared to the stalk on the right. The total spooled out belt webbing distance measured 193 cm (75.9 in). An area of belt loading that measured 5 cm (2.0 in) was located 74 cm (29.1 in) from the belt anchor (**Figure 7**). The driver's safety belt was configured with a sliding latch plate and an Emergency Locking Retractor (ELR). The remaining safety belts were configured with sliding latchplates and switchable ELR/Automatic Locking Retractors (ALR).

**Figure 7.** Driver safety belt loading

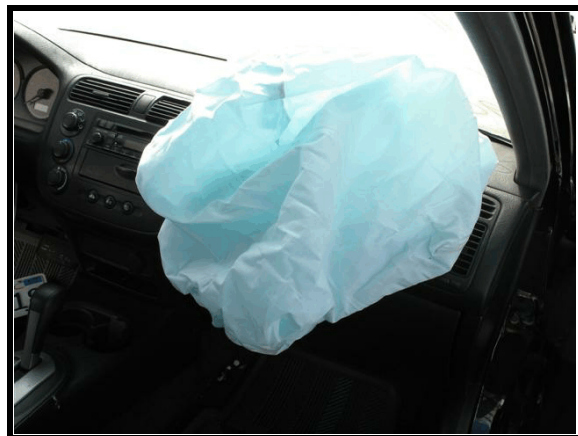
The front passenger air bag was a top mount module in the top instrument panel (**Figure 8**). The air bag deployed through a rectangular module cover flap that was hinged at the forward aspect and measured 22 cm (8.6 in) in width by 6 cm (2.4 in) in height. The air bag was rectangular in shape and measured 43 cm (16.9 in) in width and 58 cm (22.8 in) in height. Two circular vent ports were located on the side panel at the 3 and 9 o'clock positions. The air bag was not tethered internally. During the deployment, the front right air bag contacted and fractured the windshield above the module assembly.

**Figure 8.** Front passenger air bag
