## ON-SITE SIDE IMPACT INFLATABLE OCCUPANT PROTECTION INVESTIGATION

CASE NUMBER - IN09027

VEHICLE - 2007 KIA SPECTRA EX

CRASH DATE - May 2009

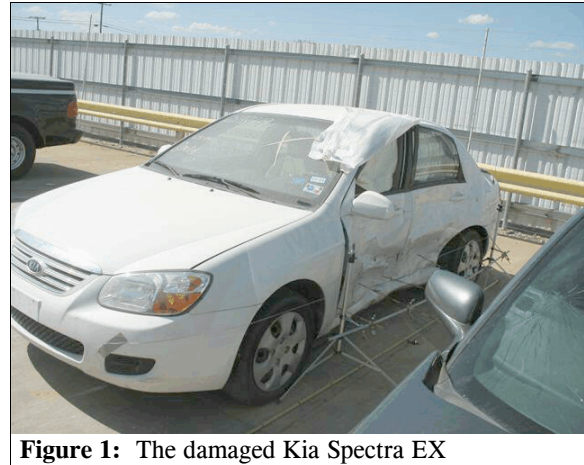
**Figure 1:** The damaged Kia Spectra EX

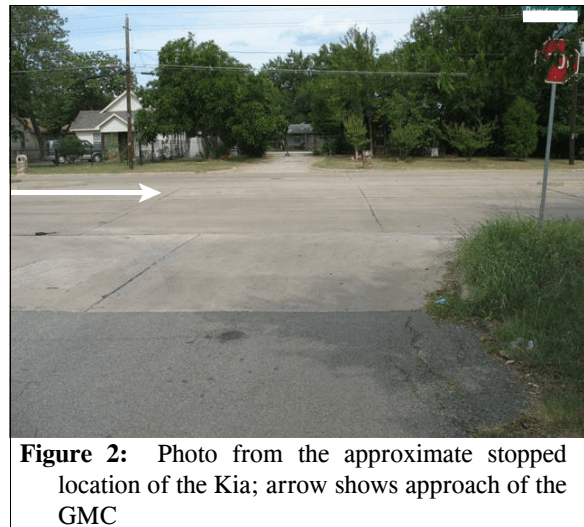
**Figure 2:** Photo from the approximate stopped location of the Kia; arrow shows approach of the GMC

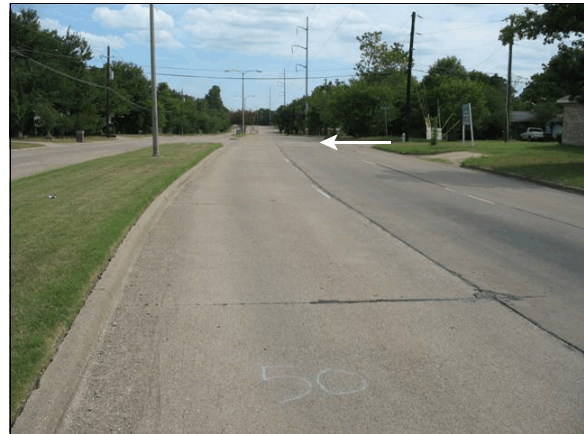
**Figure 3:** Approach of the GMC; number on pavement shows meters to impact area; arrow shows approach of Kia

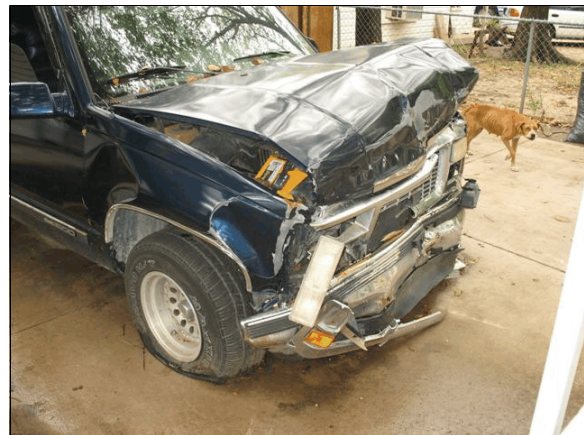
**Crash:** The front plane of the GMC (**Figure 4**) impacted the left side plane of the Kia (**Figure 5**). The direction of force on the Kia was within the 10 o'clock sector and the impact force was sufficient to trigger a deployment of the left side impact inflatable curtain (IC) air bag and the left front seat-mounted side impact air bag. The impact caused both vehicles to rotate counterclockwise. The Kia came to final rest within the intersection heading northeast. The GMC came to final rest within the intersection heading southeast.

**Figure 4:** Front damage on the GMC from the impact with the left side plane of the Kia

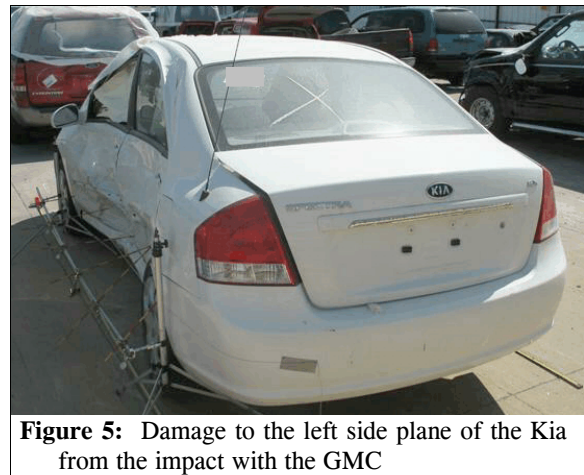
**Figure 5:** Damage to the left side plane of the Kia from the impact with the GMC

**Exterior Damage:** The impact with the GMC involved the left side plane of the Kia. The left front door, B-pillar, left rear door, and quarter panel were directly damaged. The direct damage began 81 cm (31.9 in) rear of the left front axle and extended 181 cm (71.3 in) rearward along the left side. The crush measurements were taken at the lower door level and the residual maximum crush was 26 cm (10.2 in) occurring at C<sub>4</sub> (**Figure 6**). The vehicle’s sill height was 31 cm (12.2 in) and the height of the maximum crush was 35 cm (13.8 in). The door sill differential was 1 cm (0.4 in). The vehicle’s left side wheelbase was reduced 1 cm (0.4 in). The induced damage involved the left quarter panel and C-pillar. The table below shows the vehicle’s right side crush profile.

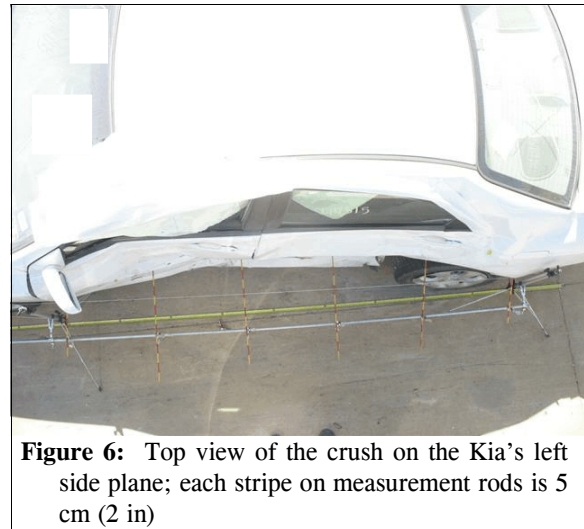
**Figure 6:** Top view of the crush on the Kia’s left side plane; each stripe on measurement rods is 5 cm (2 in)

**Damage Classification:** The Collision Deformation Classification (CDC) was **10LZAW2 (300 degrees)** for the left side plane impact with the GMC. The Missing Vehicle algorithm of the WinSMASH program calculated the Kia’s total Delta V as 31 km/h (19.3 mph). The longitudinal and lateral velocity changes were -15.5 km/h (-9.6 mph) and 26.8 km/h (16.7 mph), respectively. Based on the damage on both vehicles, the results appeared reasonable.

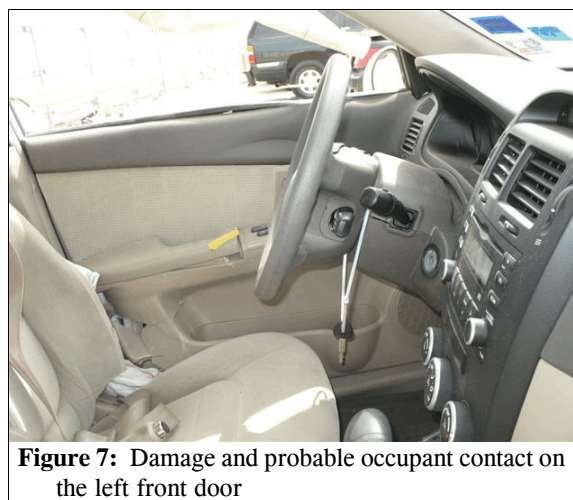
**Vehicle Interior:** The inspection of the Kia's interior revealed evidence of probable driver contact on the left front door (**Figure 7**). The arm rest was scuffed and displaced, probably from contact by the driver's left arm. The plastic on the rear lower quadrant of the door panel was cracked and broken, probably from contact by the driver's left hip. Some of the deformation on the rear lower door quadrant was also probably due to contact with the driver's seat as the door intruded during the crash. There was no deformation of the steering wheel or displacement of the energy absorbing steering column.

**Figure 7:** Damage and probable occupant contact on the left front door

The vehicle sustained 10 passenger compartment intrusions. The most severe intrusions in the driver's space involved the rear upper quadrant of the left front door (**Figure 7**), the driver's seat back, and the left instrument panel. These components intruded laterally 10 cm (3.9 in), 7 cm (2.8 in), and 3 cm (1.2 in), respectively.

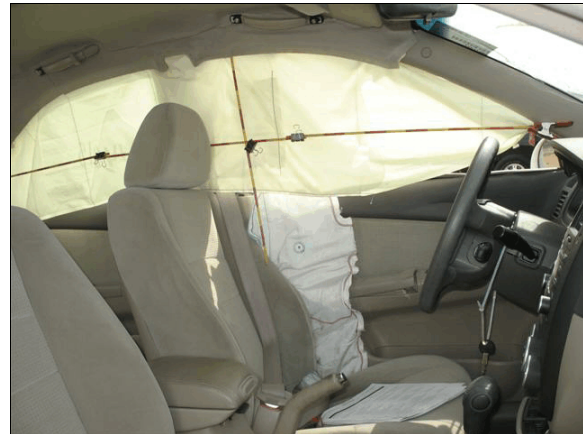
The left IC air bag was located along the left roof side rail inside the headliner and extended from the A-pillar to the C-pillar (**Figure 8**). The IC air bag was designed with inflation chambers adjacent to the outboard seating positions. What appeared to be 4 cm (1.6 in) vent port was located on the outboard side of the air bag 40 cm (15.7 in) rear of the front of the air bag. The deployed IC air bag was 174 cm (68.5 in) in width and 35 cm (13.8 in) in height. It was attached to the A-pillar by a 5 cm (2 in) nylon rope. The gap between the front of the IC air bag and the A-pillar was 8 cm (3.1 in). Adjacent to the left front seating position, the IC air bag extended vertically 2 cm (0.8 in) below the beltline and curved upward to 8 cm above the beltline at the front of the IC air bag. Adjacent to the second row left seating position, the IC air bag extended 2 cm (0.8 in) above the beltline near the B-pillar and 10 cm (4 in) below the beltline at the back of the air bag. Inspection of the deployed IC air bag revealed no discernable evidence of occupant contact. There was no damage on the inboard side of the IC air bag. On the outboard side of the IC air bag, glass fragments from the disintegrated left front window glazing caused a 15 cm (6 in) x 13 cm (5.1 in) area of abrasions located 20 cm (7.9 in) forward of the B-pillar and 25 cm (9.8 in) below the top of the IC air bag (**Figure 9**). The location was adjacent to the probable location of the driver's head.

**Figure 8:** The left side impact IC air bag and left front seat-mounted side impact air bag

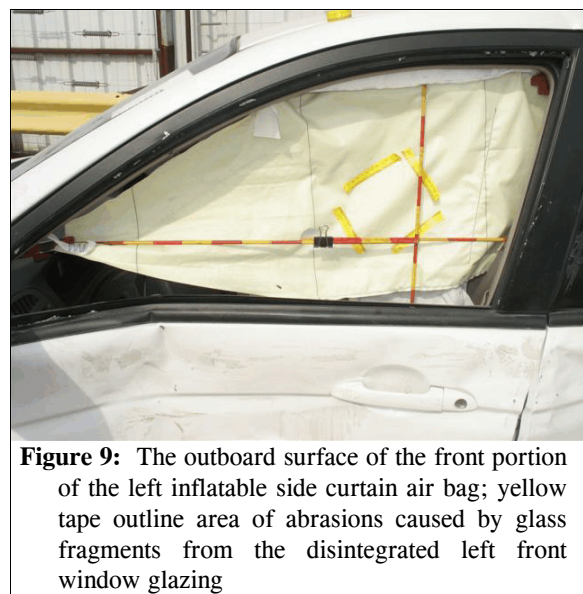
**Figure 9:** The outboard surface of the front portion of the left inflatable side curtain air bag; yellow tape outline area of abrasions caused by glass fragments from the disintegrated left front window glazing

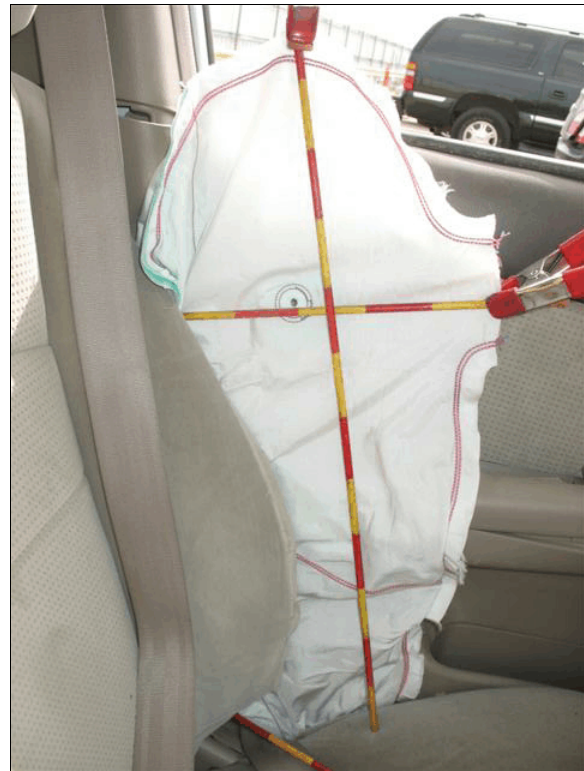
The driver's seat-mounted side impact air bag was located within the outboard side of the seat back and deployed through a tear-seam. The deployed air bag was 64 cm (25.2 inches) in height and 22 cm (11.8 in) in width (**Figure 10**). The air bag was designed with one vent port located on the front edge of the air bag. There was a single circular tether where both sides of the air bag were sewn together. The sewn area was 3 cm (1.2 in) in diameter. It was located 15 cm (5.9 in) from the front of the air bag and 20 cm (7.9 in) from the top. Inspection of the deployed air bag revealed no damage and no discernable evidence of occupant contact.

**Figure 10:** The left front seat-mounted side impact air bag

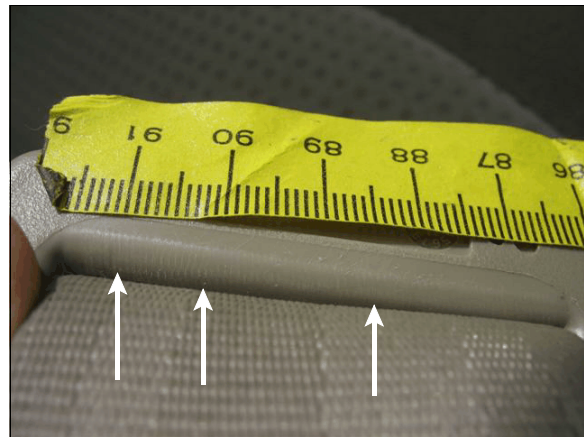
The inspection of the driver’s safety belt assembly revealed historical usage scratches on the latch plate. The belt webbing was slightly stretched and there were load abrasions from the belt webbing across the width of the latch plate belt guide (Figure 11). The retractor was also jammed with a length of belt webbing extended out of the retractor consistent with usage. This evidence indicated that the driver was restrained at the time of the crash. The remaining seat positions were unoccupied.

**Figure 11:** Load abrasions from the safety belt webbing on the driver’s latch plate belt guide

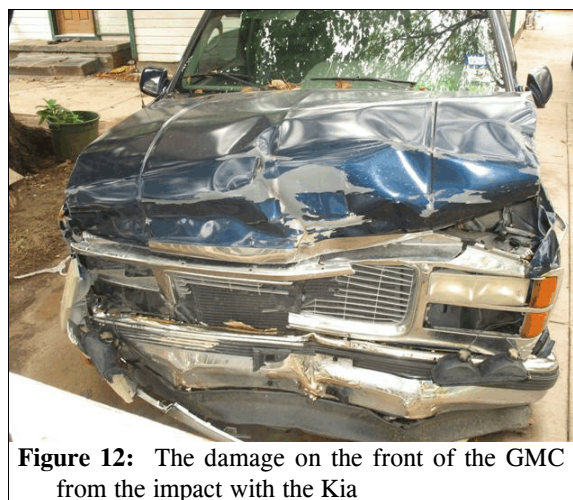
**Exterior Damage:** While this contractor had the owner's permission to inspect the vehicle, the owner was not at home and it was not possible to enter the area where the vehicle was stored due to the presence of the owner's dog. The vehicle was photographed and the CDC was based on the photographs. The visual inspection indicated that the GMC sustained direct damage across the full width of the front plane. The damage involved the bumper, hood, grille, and both headlamp/turn signal assemblies (**Figure 12**). The induced damaged involved both fenders and the hood.

**Figure 12:** The damage on the front of the GMC from the impact with the Kia

**Damage Classification:** The CDC for the impact with the Kia was **01FDEW1 (20 degrees)**. The Missing Vehicle algorithm of the WinSMASH program calculated the GMC's total Delta-V as 20 km/h (12.4 mph). The longitudinal and lateral velocity changes were -18.8 km/h (-11.7 mph) and -6.8 km/h (-4.2 mph), respectively. The results should be considered borderline since they are based only on the crush sustained by the Kia.
