CALSPAN ON-SITE FRONT OVER INVESTIGATION

SCI CASE NO: CA09027

VEHICLE: 2008 LEXUS RX350

INCIDENT DATE: APRIL 2009

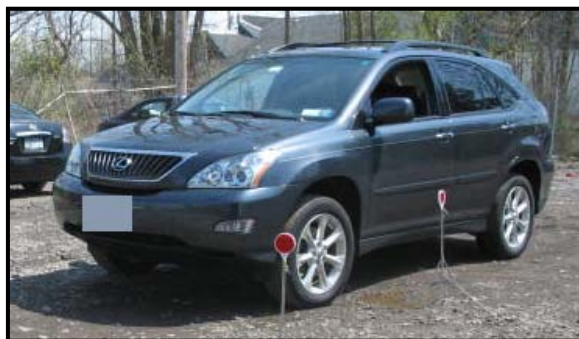
Figure 1: Front left oblique view of the Lexus RX350.

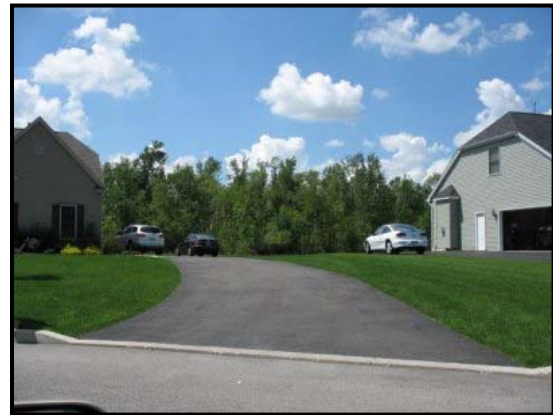
Figure 2: West view along the driveway

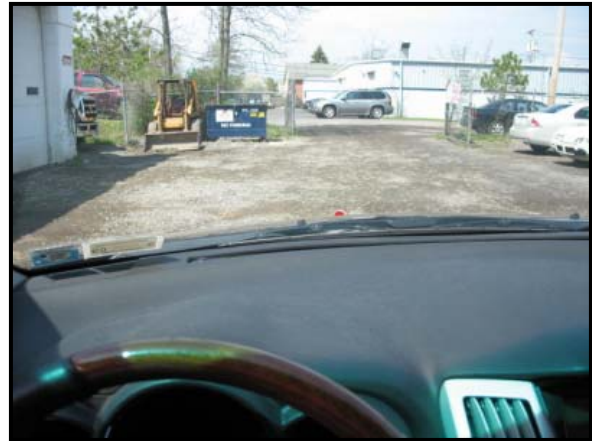
Figure 3: Driver interior view to the forward centerline target.

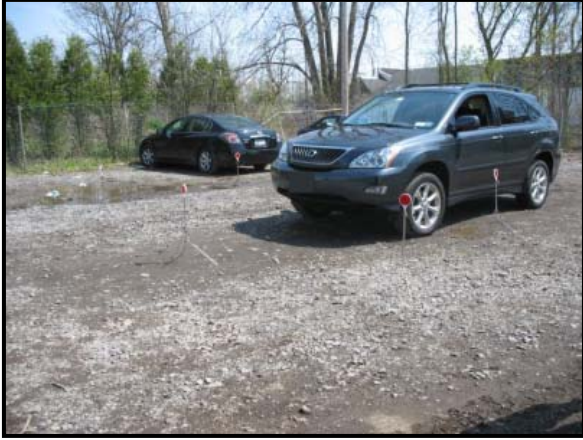
Figure 4: Front left oblique view of the Lexus and front visibility targets.

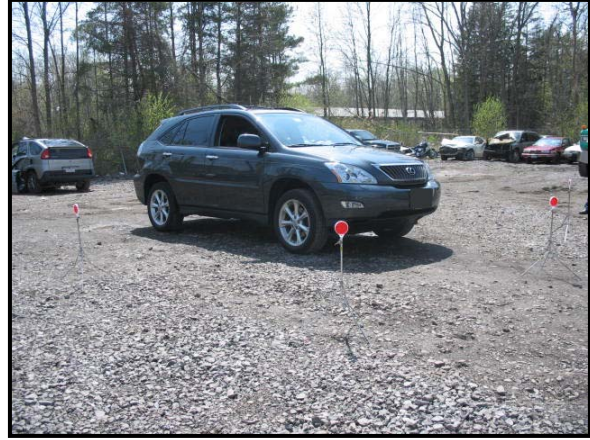
Figure 5: Front right oblique view of the Lexus and front visibility targets.

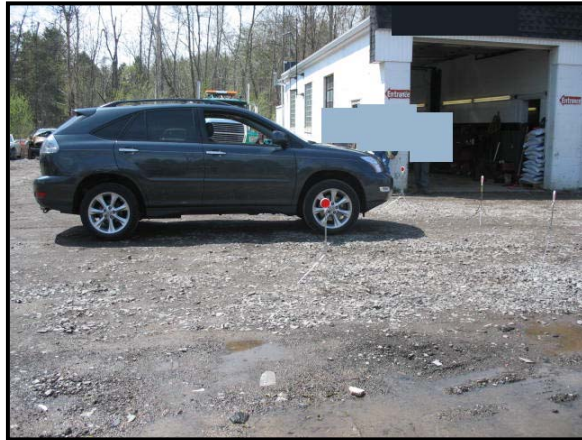
Figure 6: Right view of the Lexus and the target locations.

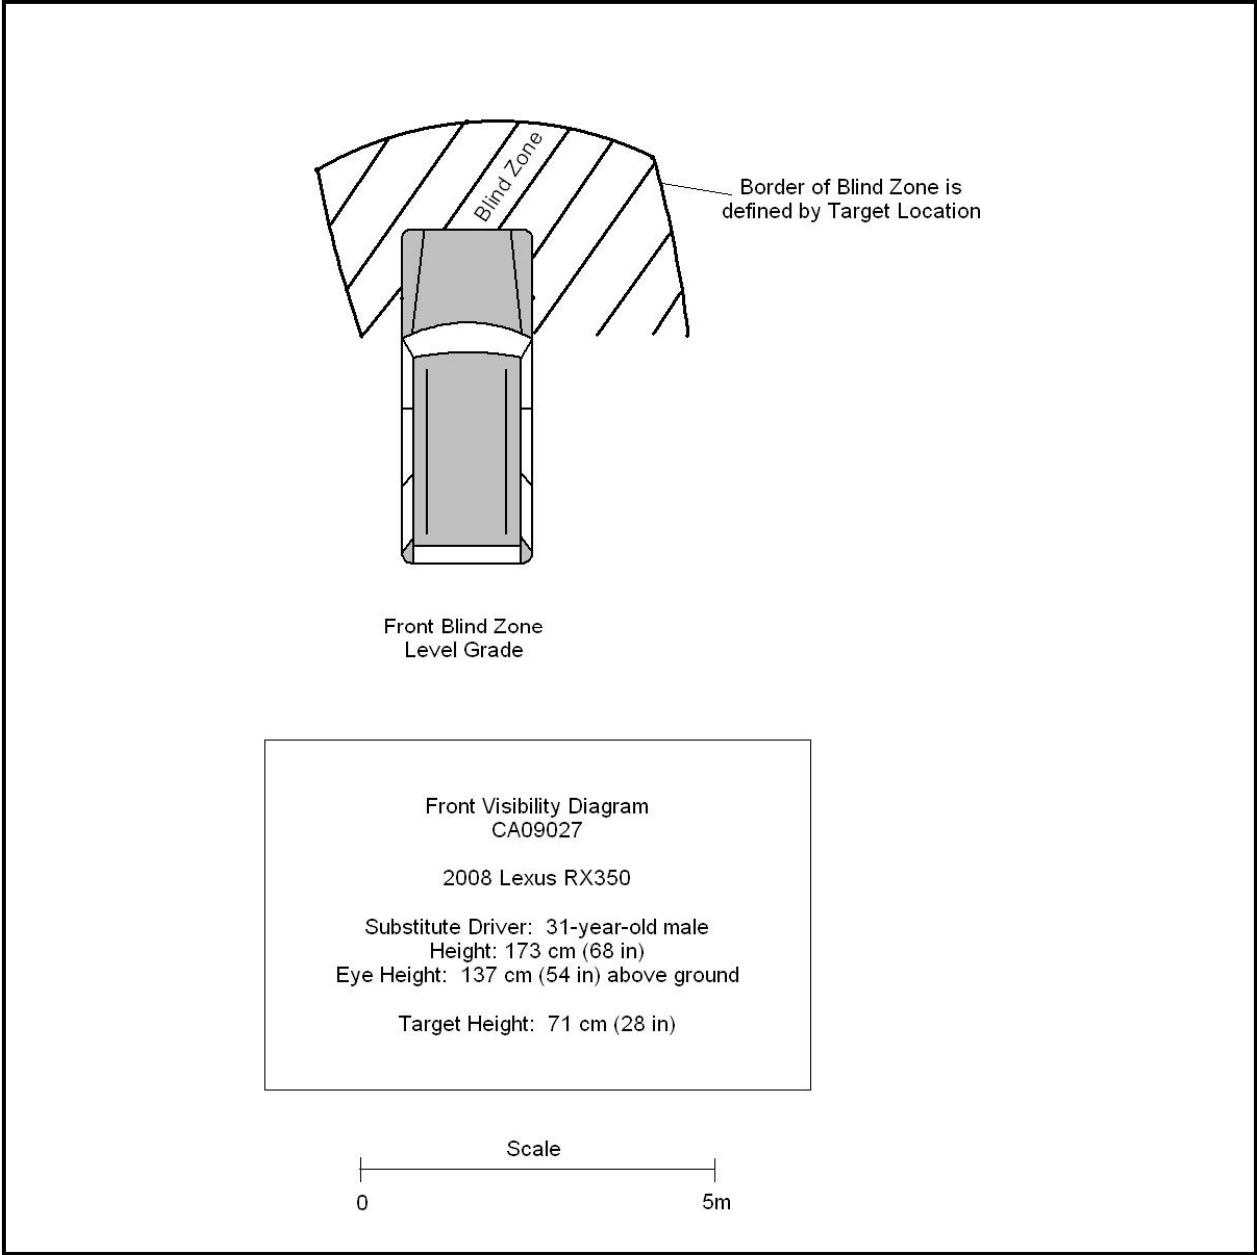
Figure 7: Front visibility diagram.

The front visibility of the vehicle was measured of a level surface using a substitute driver. The substitute driver had a seated eye height of 137 cm (54 in). The driver's eye height is unknown. Five 71 cm (28 in) tall red reflective targets were used to identify the location of the front blind zone around the vehicle. The targets were located outboard the left mirror, at the front left, the forward centerline, the front right, and outboard right mirror. The locations of the targets were adjusted outboard the vehicle, along the substitute driver's sight line, to a point where the driver indicated that he could first identify the target. The driver was asked to remain seated in a normal driving position. The target locations were then measured with respect to the vehicle. **Figure 3** is a driver view through the windshield to the centerline target. The longitudinal distance from the front bumper fascia to the centerline target in the figure measured 142 cm (56 in). **Figures 4 - 6** are exterior views depicting the locations of the forward blind zone targets around the Lexus. **Figure 7** attached to the end of this report is a scaled overhead visibility schematic depicting the blind zone forward of the vehicle. Cooperation with the driver could not be obtained. Details of the regarding the garage lighting and layout were not obtained.

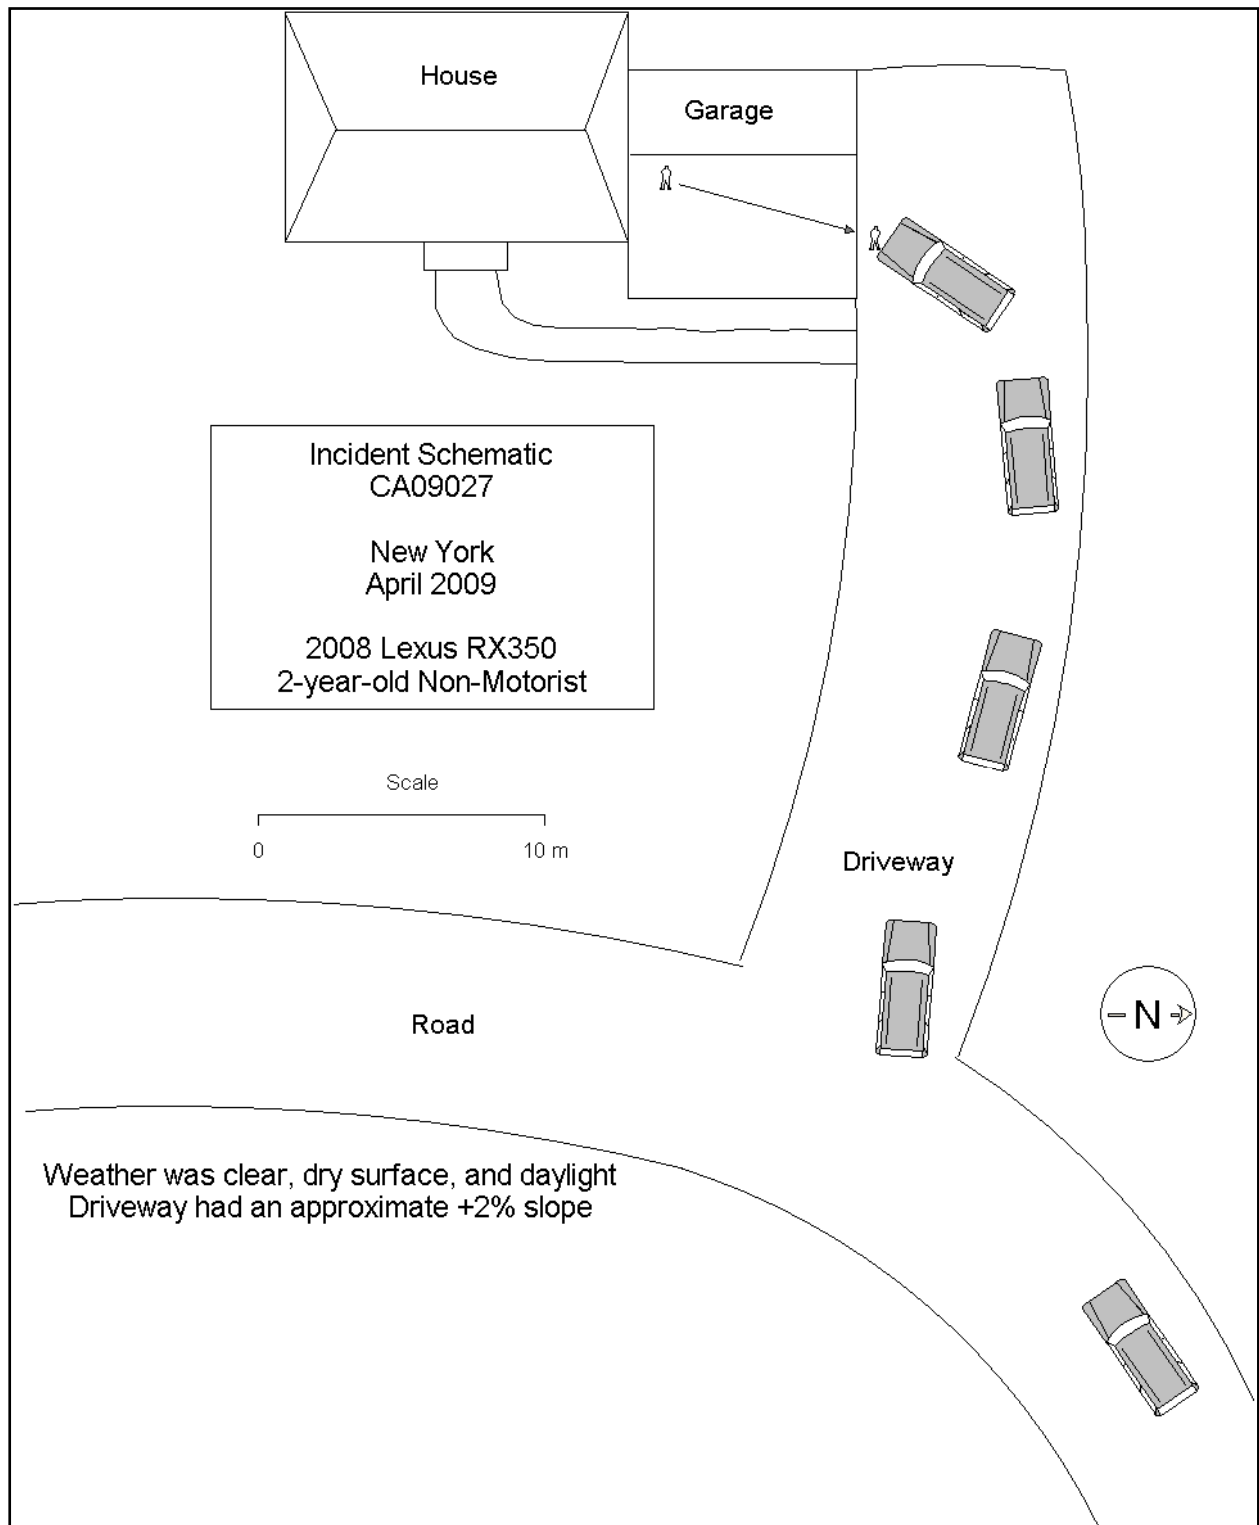
Figure 8: Incident Schematic

A schematic of the incident is attached to the end of this narrative report as **Figure 8**. Prior to the incident, the driver was conducting errands. The non-motorist was in the home under the supervision of his grandmother. When the driver returned and was approaching the garage, the driver activated the motorized garage door with the remote control located in the vehicle. The police investigator reported that the non-motorist heard the garage door opening, exited the home through an entry door and entered the garage. The driver was operating the Lexus westward along the driveway and initiated a left turn to enter the garage. She was unaware of the non-motorist's presence.

As the child emerged from the garage, the front left area of the vehicle struck and knocked the non-motorist to the ground. The vehicle continued forward and the left front tire ran over the child. The driver stated to the investigating police officer that she believed the vehicle had run over a toy. She stopped, placed the Lexus in reverse and began a backing maneuver. She subsequently ran over the non-motorist a second time with the front left tire.
