Certified Advanced 208-Compliant Investigation  
Dynamic Science, Inc. (DSI), Case Number DS09028  
2008 Honda Odyssey LX  
California  
July 2009

1. Report No. DS09028		2. Government Accession No.		3. Recipient Catalog No.	
4. Title and Subtitle Certified Advanced 208-Compliant Investigation				5. Report Date January 18, 2010

**Dynamic Science, Inc.  
Crash Investigation  
Case Number: DS09028**

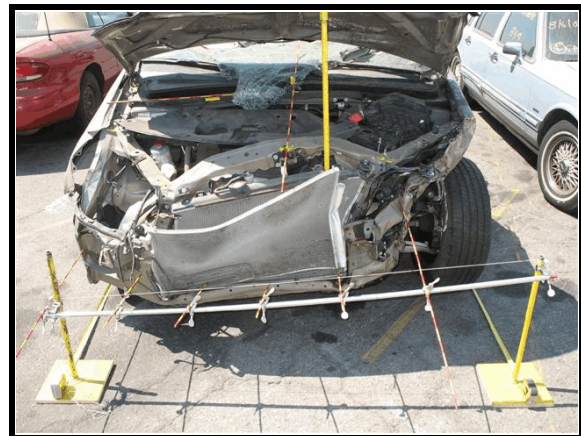
**Figure 4.** Frontal damage

The Honda sustained moderate front end damage as a result of the initial impact with the Chevrolet (**Figure 4**). The direct damage began at the front left right bumper corner and extended 42 cm (16.5 in) to the right. The bumper fascia and backing bar were displaced from the vehicle during the crash. Six crush measurements documented at the bumper mounts and lower radiator support as follows:  $C_1 = 12$  cm (4.7 in),  $C_2 = 5$  cm (2.0 in),  $C_3 = 5$  cm (2.0 in),  $C_4 = 4$  cm (1.6 in),  $C_5 = 10$  cm (3.9 in),  $C_6 = 2$  cm (0.8 in). The left mount was shifted 26 cm (10.2 in) to the right and the right was shifted 20 cm (7.9 in). The Collision Deformation Classification (CDC) for the frontal impact with the Chevrolet was 10FLEW1.

The impacts with the two sign posts were masked by the vehicle-to-vehicle impact. CDCs assigned to these events are 12F9999 and 12F9999.

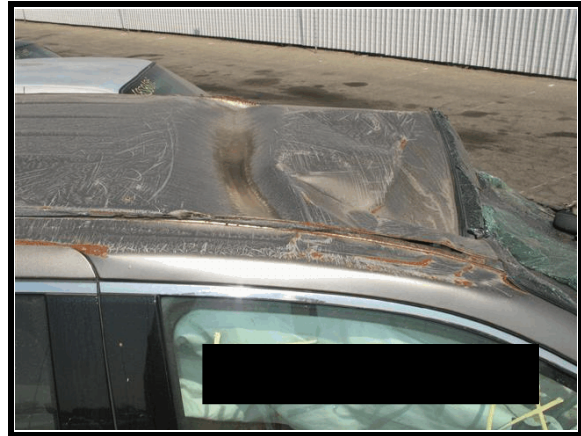
**Figure 5.** Roof damage

The Honda sustained moderate to the top plane during the rollover event (**Figure 5**). The direct damage to the top of the vehicle extended laterally from roof side rail to roof side rail and measured 129 cm (50.8 in). The damage extended from the windshield header rearward 206 cm (81.1 in). The maximum vertical crush was located on the windshield header 23 cm (9.0 in) left of the right side rail and measured 12 cm (4.7 in). The maximum lateral crush was located at the left A-pillar and measured 5 cm (1.9 in).

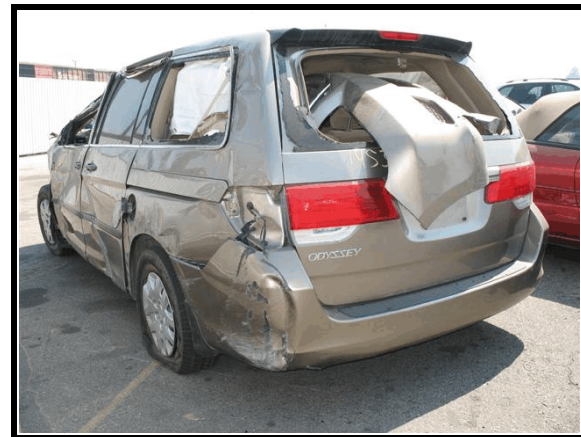
**Figure 6.** Left side damage

The direct damage to the left side began at the back left bumper corner and extended forward 397 cm (156.2 in) (**Figure 6**). The damage began at the sill and extended 154 cm (60.6 in) up to the roof side rail. There was a 7 cm (2.8 in) wide scrape that began 94 cm (37.0 in) forward of the rear axle at the sill and ended 149 cm (58.6 in) forward of the rear axle 65 cm (25.5 in) above the sill. This damage was caused by the curb on the west side of the roadway. The damage to the right side consisted of minor scratches at the right rear bumper and a deformed right rear tire rim. The CDC for the rollover was 00TDDO2.

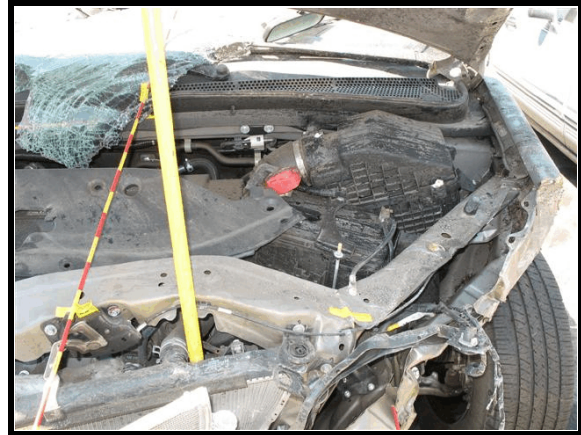
**Figure 8.** Left upper bulkhead frame

Measurements were documented to compare the upper bulkhead frame to an undamaged frame (**Figure 8**). The left side of frame was shifted to the right 12 cm (4.7 in) and deformed rearward 4 cm (1.6 in).

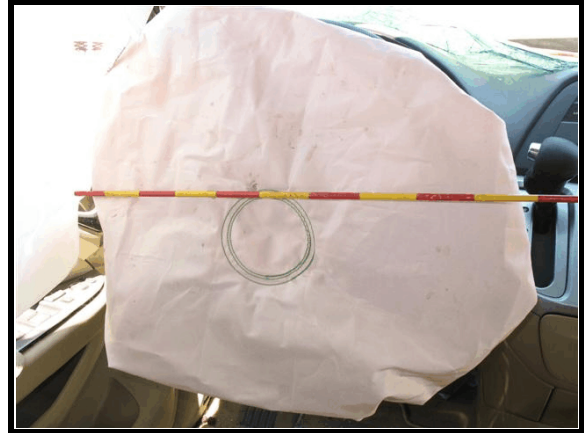
**Figure 9.** Driver's air bag

The driver's frontal air bag deployed from the center of the steering wheel hub through H-configuration module cover flaps (**Figure 9**). The top flap measured 15 cm (6.7 in) in width and 13 cm (5.1 in) in height; the lower flap measured 15 cm (6.7 in) in width and 10 cm (3.9 in) in height. The deployed air bag measured 56 cm (22.0 in) in width in its deflated state. The air bag was tethered by a single internal strap. The tether was attached to a stitched 10 cm (3.9 in) diameter circle in the center of the front panel. Two vent ports that measured 5 cm (1.9 in) in diameter were located at the 11 and 1 o'clock aspects on the rear panel. There was a 53 x 20 cm (20.8 x 7.9 in) area of blood drops across the right upper, right lower, and left lower quadrants.

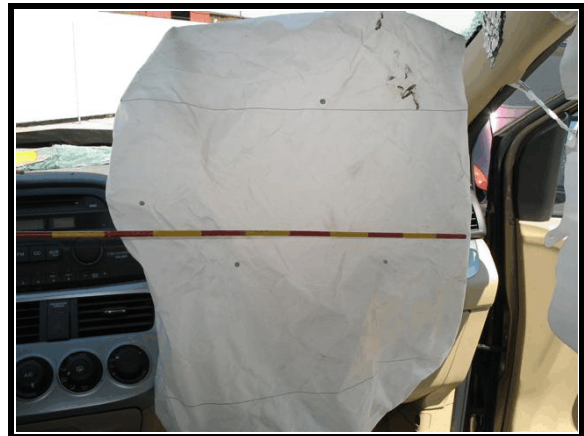
**Figure 10.** Front right passenger air bag

The front right passenger's frontal air bag deployed from the top of the instrument panel through H-configuration module cover flaps (**Figure 10**). The top flap measured 23 cm (9.0 in) in width and 6 cm (2.4 in) in height; the lower flap measured 23 cm (9.0 in) in width and 4 cm (1.6 in) in height. The deployed air bag measured 60 cm (23.6 in) in height and 34 cm (13.3 in) in width with a maximum excursion of 50 cm (19.6 in). Two 7 cm (2.8 in) vent ports were located on the side air bag panels at the 3 and 9 o'clock positions. There were areas of grease located on the right upper quadrant that was deposited by vehicle components that had been placed in the vehicle after the crash.

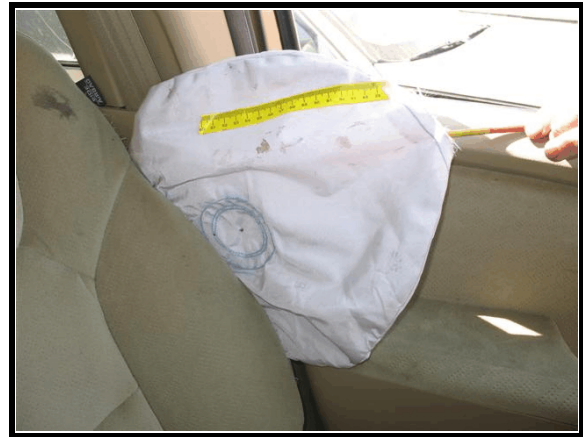
**Figure 11.** Driver's side air bag

The driver's seat-mounted side air bag deployed from the seat back (**Figure 11**). The air bag was configured in a semi-circular shape and measured 30 cm (11.8 in) in height and 32 cm (12.5 in) in width. The air bag was configured on both sides with an 8 cm (3.1 in) circular area of stitching surrounding a circular vent port. A 9 cm (3.5 in) vent port was located at the leading edge of the air bag. On the inboard aspect of the air bag panel, there was a 10 x 4 cm (3.9 x 1.6 in) area of blood

transfers. On the outboard aspect, there was a 9 x 8 cm (3.5 x 3.1 in) dark-colored splatter mark located on the bottom of the air bag and a 3 cm (1.2 in) scuff on the upper portion.

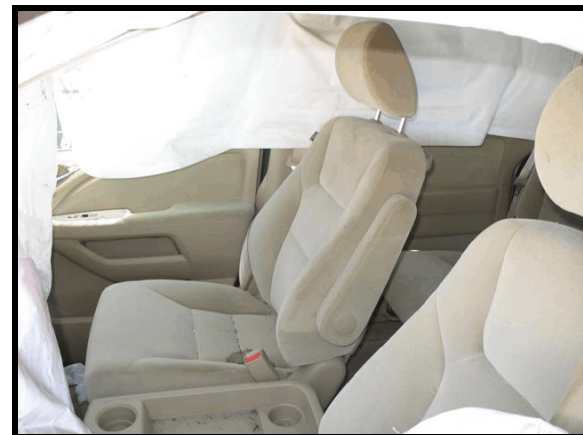
**Figure 12.** Right IC air bag

The side IC air bags deployed through the roof rail cladding from a module located at the roof side rail (**Figure 12**). The air bag was generally rectangular and measured 250 cm (98.4 in) in length and 44 cm (17.3 in) in width. The forward aspect of the bags were attached to the A-pillar by tethers that measured 27 cm (10.6 in) in length; the rear aspect of the bags were attached to the D-pillar. The longitudinal area of coverage began near the A-pillar and extended to the D-pillar. The bag's vertical coverage began at the roof rail and extended to downward 44 cm (17.3 in). A 17 x 13 cm (6.7 x 5.1 in) smear was documented at the forward end of the outboard facing portion of the air bag.
