## **ON-SITE CERTIFIED ADVANCED 208-COMPLIANT VEHICLE INVESTIGATION**

CASE NUMBER - IN09029

VEHICLE - 2005 HONDA ODYSSEY TOURING

CRASH DATE - May 2009

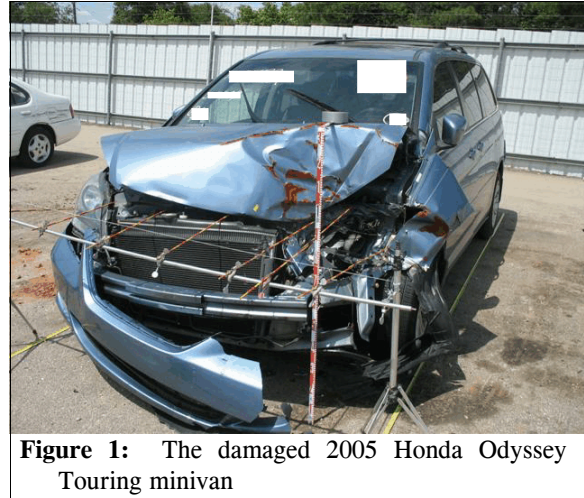
**Figure 1:** The damaged 2005 Honda Odyssey Touring minivan

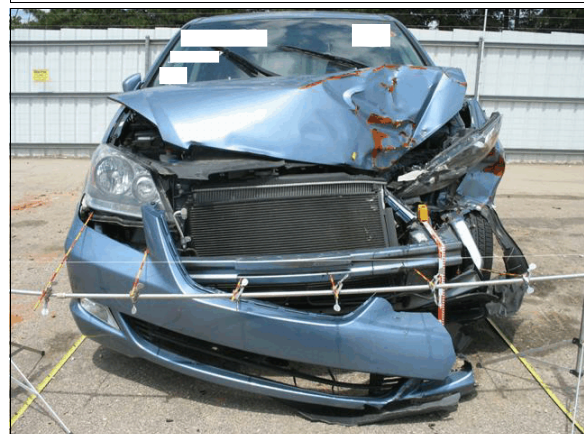
Figure 4: Front plane damage on the Honda from the impact with the back plane of the Ford

**Exterior Damage:** The impact with the Ford involved the front plane of the Honda. The left portion of the front bumper, hood, and the left fender were directly damaged. The direct damage began at the front left bumper corner and extended 56 cm (22 in) across the front plane. Due to the underride of the back of the Ford, the crush measurements were taken at the bumper level and upper radiator support level on the Honda. The maximum residual crush at the bumper level was 13 cm (5.1 in) occurring at C<sub>1</sub>. The maximum residual crush at the upper radiator support level (**Figure 7**) was 44 cm (17.3 in), occurring 19 cm (7.5 in) left of C<sub>1</sub>. The table below shows the crush profile, which reflects the average crush of the two levels.

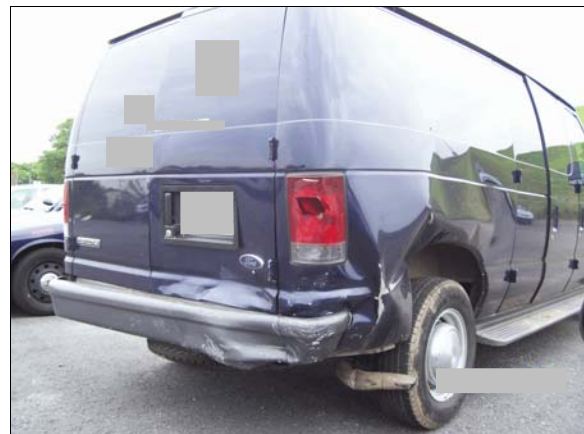
Figure 5: Damage on the back plane of the Ford from the impact with the Honda

**Vehicle Exterior:** The Ford had been repaired and was not inspected. Based on photographs of the damaged vehicle, the CDC was **06-BZEW-2 (170 degrees)**.

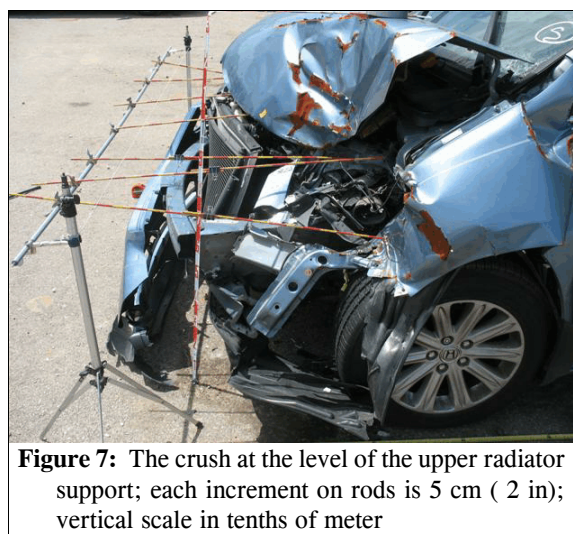
**Figure 7:** The crush at the level of the upper radiator support; each increment on rods is 5 cm ( 2 in); vertical scale in tenths of meter

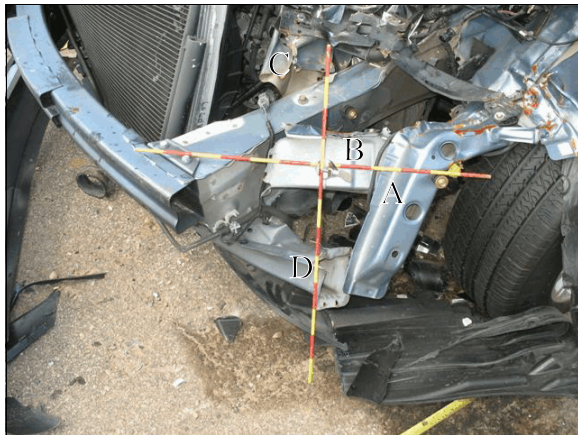
Four of the ACE components on the front left sustained damage and were displaced. The components are identified in **Figure 8** as A, B, C, and D. Component A was displaced 9 cm (3.5 in) right and 20 cm (7.9 in) rearward. Components B, C, and D were displaced rearward 12 cm (4.7 in), 20 cm (7.9 in), and 4 cm (1.6 in), respectively. The undamaged components on the front right are shown in **Figure 9**. A left side view of the damaged components is shown in **Figure 10** and the front undercarriage in **Figure 11**. There was no displacement of the lower left A-pillar and no passenger compartment intrusion.

**Figure 8:** Damage to the front left ACE components identified as A, B, C, and D

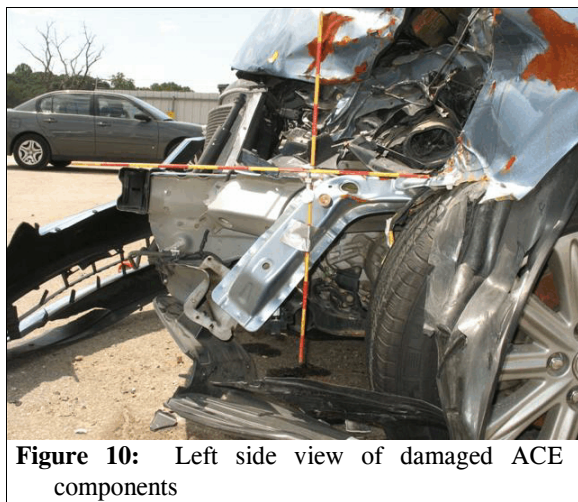
**Figure 10:** Left side view of damaged ACE components

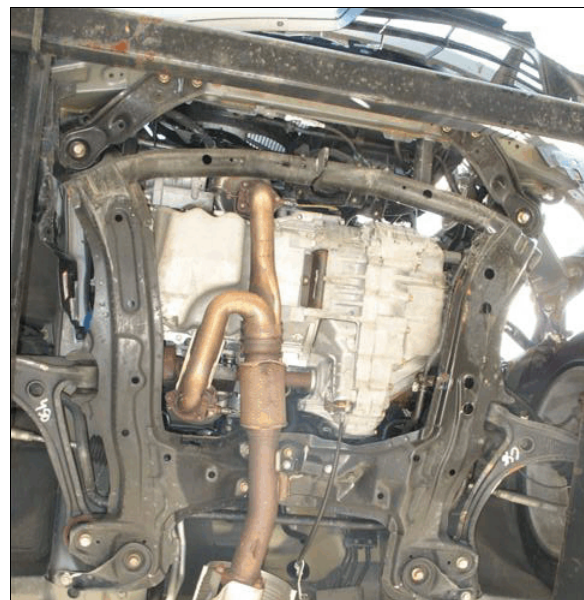
**Figure 11:** Undercarriage view of the left front wheel, suspensions components, engine, and stub frame

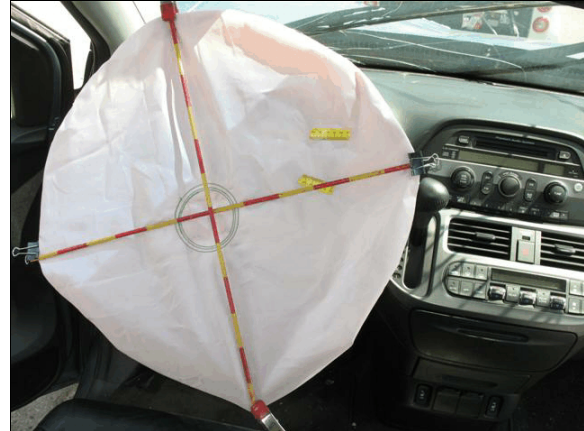
The driver's frontal air bag was located within the steering wheel hub and the module cover was a two flap configuration constructed of pliable vinyl. Each cover flap was 15 cm (5.9 in) in width at the horizontal tear seam. The top flap was 7 cm (2.8 in) in height, while the bottom flap was 10 cm (3.9 in) in height. The flaps opened at the designated tear points and were undamaged. The deployed air bag (**Figure 14**) was 60 cm (23.6 in) in diameter and was designed with two 4.5 cm (1.8 in) diameter vent ports located on the back of the air bag at the 10 and 2 o'clock positions. There were also three internal tethers, each 7 cm (2.8 in) in width. Inspection of the air bag revealed no damage and one possible occupant contact scuff, which was located within the upper right quadrant 7 cm (2.8 in) above and 19 cm (7.5 in) to the right of the center of the air bag.

**Figure 14:** The driver's frontal air bag, yellow tape shows area of possible occupant contact

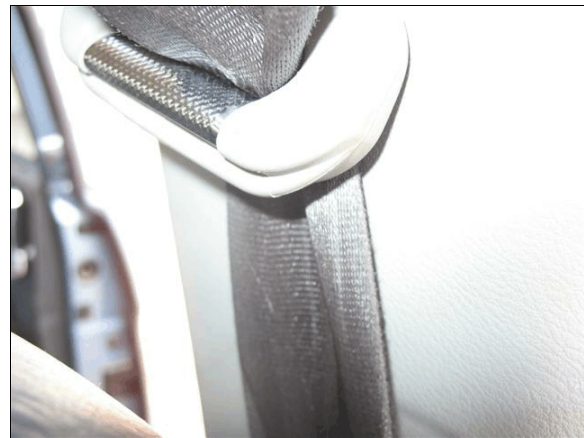
The inspection of the driver's safety belt assembly revealed heavy historical usage scratches on the latch plate. The safety belt webbing was entrapped in the forward corner of the D-ring (**Figure 15**) and the retractor-mounted pretensioner actuated. The length of belt webbing that was extended out of the retractor was 137 cm (53.9 in) in length. There were also light load abrasions on the latch plate belt guide (**Figure 16**). This

**Figure 15:** The driver's safety belt webbing was entrapped in the forward corner of the D-ring

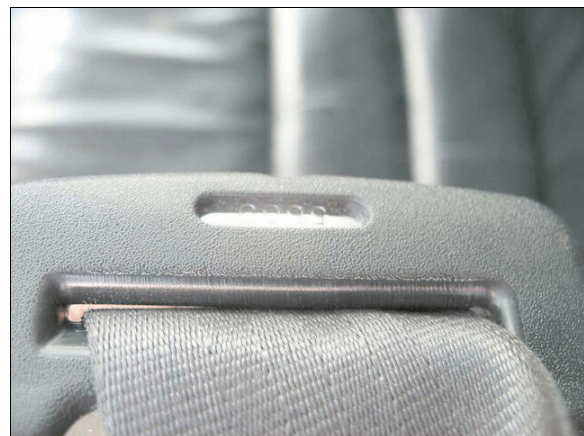
**Figure 16:** Light load abrasions on the driver's latch plate belt guide

evidence indicated that the driver was restrained by the lap-and-shoulder belt at the time of the crash.
