On-Site Side Air Bag Investigation
Dynamic Science, Inc. (DSI), Case Number DS09030
2009 Ford Focus
Washington
August 2009

1. Report No. DS09030		2. Government Accession No.		3. Recipient Catalog No.	
4. Title and Subtitle On-Site Side Air Bag Investigation				5. Report Date May 5, 2010

14. Sponsoring Agency Code	
15. Supplemental Notes					
16. Abstract <p>This on-site investigation focused on the air bag deployments in a 2009 Ford Focus involved in a single-vehicle crash and subsequent rollover. The crash occurred in August 2009 in the state of Washington. The subject vehicle was being driven by a 17-year-old male and a 16-year-old female occupied the front right seat. The crash site was an undivided two-lane, north/south roadway. The Ford was traveling northbound and as the driver negotiated a left curve the vehicle departed the roadway on the right side. The right side of the vehicle impacted a fire hydrant and four small trees, and the front end impacted a telephone utility marker. During those impacts the vehicle initiated a clockwise rotation, then it initiated a left side leading trip rollover. The vehicle came to rest on its roof in a private driveway.</p> <p>The Ford wa

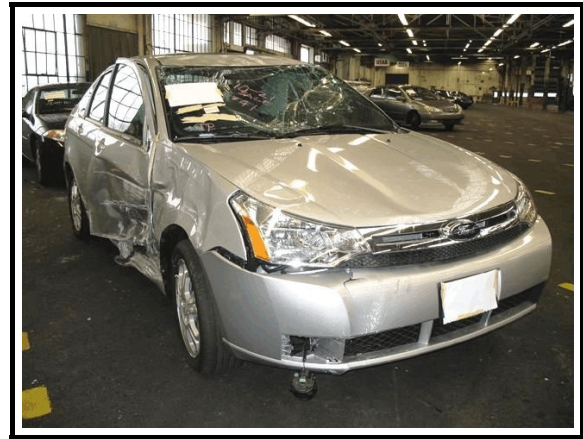
Figure 1. Subject vehicle, 2009 Ford Focus

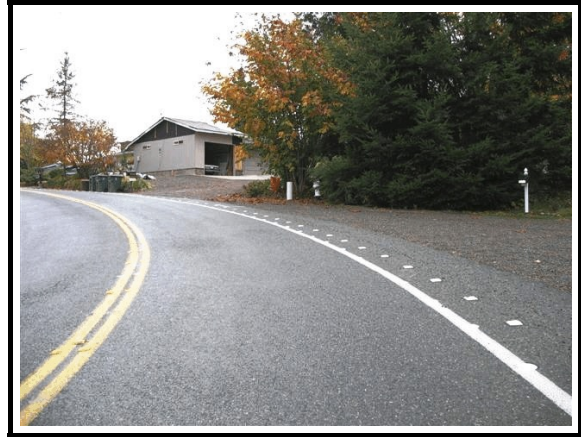
The crash site consisted of an undivided two-lane north/south roadway that curved left (**Figure 2**). The roadway was configured with paved shoulders; outboard of the paved shoulder were gravel shoulders followed by unpaved ground. Outboard of the east shoulder was a gravel shoulder and driveway, followed by grass, trees and shrubbery. The north- and southbound lanes measured 3.2 m (10.5 ft) in width; the east and west shoulder measured 1.4 m (4.5 ft) and 0.9 m (3.0 ft) in width,

Figure 2. Crash site

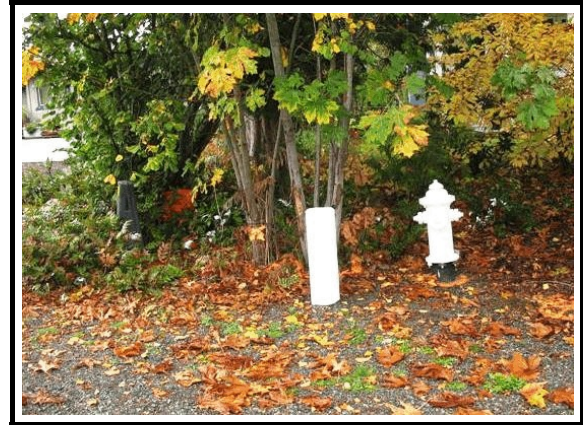
The crash sequence included seven events. The right side of the Ford impacted the fire hydrant (Events 1) (**Figure 3**). The fire hydrant was made of cast iron, measured 38.0 cm (15.0 in) at its

maximum width and 91.0 cm (36.0 in) in height, and was bolted to a steel base. The impact to the fire hydrant displaced it from its base. According to the local water district's office, a new fire hydrant was installed in place of the damaged one, and a concrete post was installed between the roadway and the fire hydrant to act as a protective barrier. There was no post installed prior to the crash. The EDR reported the vehicle's frontal and side air bags deployed between 51.5 milliseconds (msec) and 89.0 msec after AE. Based on the EDR, it was determined that all the air bags deployed at impact with the fire hydrant.

Figure 3. Impacted objects including fire hydrant, trees, and utility marker

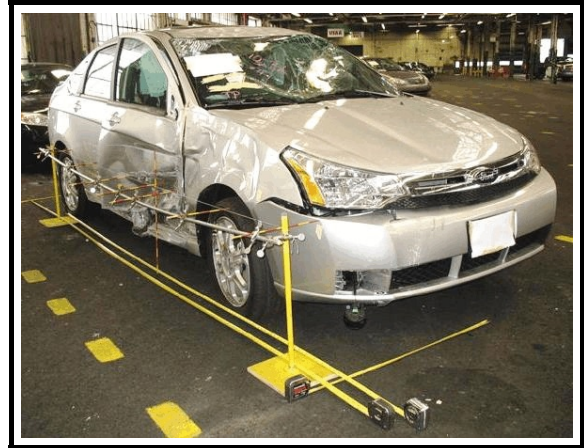
The impacts with the four trees (Events 2-5) resulted in overlapping the damage and the impacts could not be separated. The direct damage began 75.0 cm (29.5) aft of the front right axle, extended 102.0 cm (40.2 in) forward, and ended 27.0 cm (10.6 in) forward of the right front axle. The direct damage extended 30.0 cm (11.8 in) above the belt line and included the window frame of the front right door panel. The Field L began 75.0 cm (29.5) aft of the front right axle, extended 137.0 cm (53.9 in) forward, and ended at the right front bumper corner. In addition to the sheet metal crush, the tree impacts fractured and displaced the right side-view mirror. The estimated crush measurements for the tree impacts at upper door level was as follows: $C_1 = 0$ cm, $C_2 = 3.0$ cm (1.2 in), $C_3 = 4.0$ cm (1.6 in), $C_4 = 5.0$ cm (2.0 in), $C_5 = 2.0$ cm (0.8 in), $C_6 = 1.0$ cm (0.4 in). Maximum crush was located at C_4 . The CDC for the tree impacts was 01RYHW2.

Figure 4. Right side crush measurement

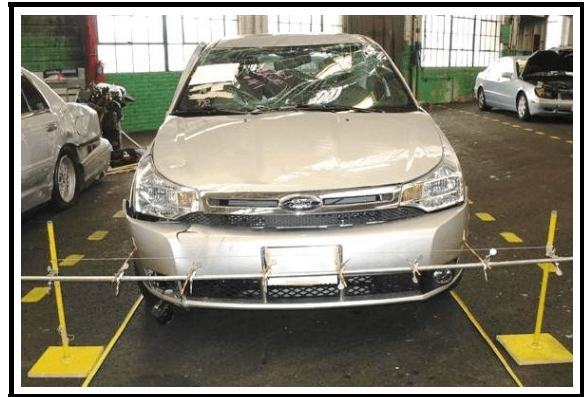
Figure 5. Front end crush measurement

Following the tree impacts, the front end of the Ford impacted a telephone utility marker (Event 6). The direct damage to the front bumper began 17.0 cm (6.7 in) to the left of the front right bumper corner, extended 30.0 cm (11.8 in) left, and ended 47.0 cm (18.5 in) left of the front right bumper corner. The Field L extended from bumper corner to bumper corner and measured 146.0 cm (57.5 in) (**Figure 5**). Vertically, the direct damage extended from the bumper to the hood. Six crush measurements were taken at bumper level as follows: $C_1 = 0$ cm, $C_2 = 0$ cm, $C_3 = 0$ cm, $C_4 = 3.0$ cm (1.2 in), $C_5 = 6.0$ cm (2.4 in), $C_6 = 5.0$ cm (2.0 in). Maximum crush to the front bumper was located 29.0 cm (11.4 in) right of the front right bumper corner at C_5 . The CDC for Event 6 was 12FREN1.

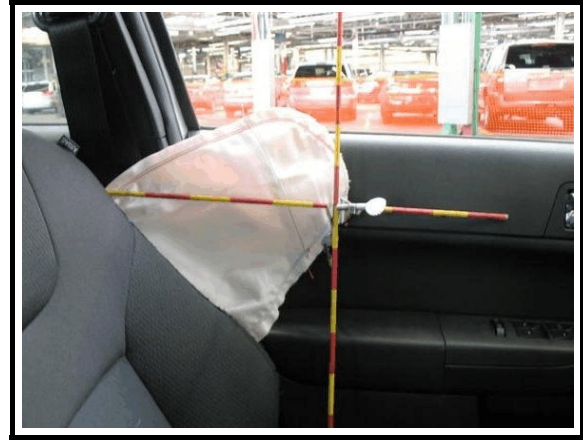
Figure 6. Left seat-mounted side air bag

The left seat-mounted side air bag deployed from the left seat-back. The air bag was triangular in shape and round at the leading edge. It measured 28.0 x 28.0 cm (11.0 x 11.0 in) in size and covered most of the upper rear quadrant of the left door panel (**Figure 6**). Vertically, the air bag covered the area of the left door panel from the bottom of the side glass to the upper aspect of the arm rest. The air bag was configured without tethers or vent ports.

The outboard panel of the air bag exhibited two scuffs measuring 2.0 cm (0.8 in) and 7.0 cm (2.8 in) indicating contact from the left door panel. The scuffs were in the upper aspect of the air bag and their color was consistent with the padded grey vinyl covering just below the bottom of the side glass. The air bag was probably loaded by the driver during the first quarter-turn of the rollover, and in turn the air bag loaded the door panel resulting in the transfers. At the lower aspect of the outboard panel was a dirt deposit measuring 5.0 cm (2.0 in) that occurred during post-crash salvage activities. The inboard panel of the left seat-mounted side air bag revealed no damage or evidence of occupant loading.

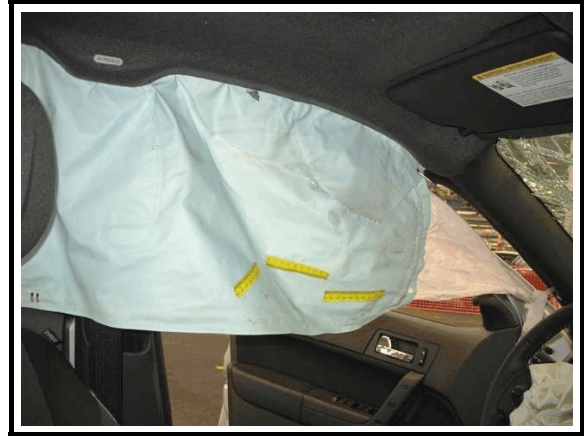
The left IC air bag deployed from the left roof side rail over the front and second rows. The IC air bag measured 170.0 cm (66.9 in) in length and 32.0 cm (12.6 in) in height. It was configured with a triangular sail at the forward aspect and 10.0 cm (3.9 in) tethers at the forward and rearward aspects. The forward aspect of the inboard panel revealed striations from the roof cladding, dirt deposits, and scuffs (**Figure 7**). The dirt deposits were located within an area measuring 9.0 x 25.0 cm (3.5 x 9.8 in) that began at the forward lower corner and extended upward and rearward. The front left window glazing pre-crash status was closed but then disintegrated during the rollover event. The dirt was deposited either during the rollover or post-crash salvage activities. Within the area of dirt deposit was a group of three scuffs measuring 1.0 cm (0.4 in) each that suggested the IC air bag contacted the ground during the rollover. The left side window was closed prior to the crash and disintegrated during the rollover, exposing the left IC air bag to the ground. The vehicle initiated a left side leading rollover and while it is probable the driver contacted the left IC air bag, during the interview he did not recall contacting the air bag and did not sustain air bag related injuries. The outboard panel of the IC air bag revealed several areas of contact with the ground resulting in dirt deposits and scuffs. During post-impact salvage activities, the left IC air bag was cut in order to allow easier access to the front row.

Figure 7. Left IC air bag
