**CALSPAN ON-SITE HYBRID VEHICLE CRASH INVESTIGATION**  
**SCI CASE NO: CA09033**

**VEHICLE: 2009 TOYOTA PRIUS**

**LOCATION: PENNSYLVANIA**

**CRASH DATE: APRIL, 2009**

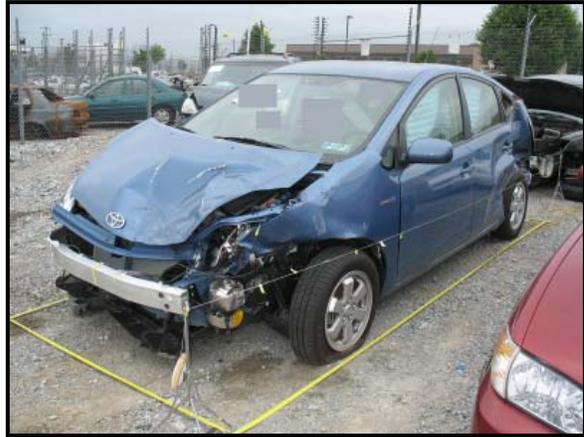
**Figure 1: 2009 Toyota Prius**

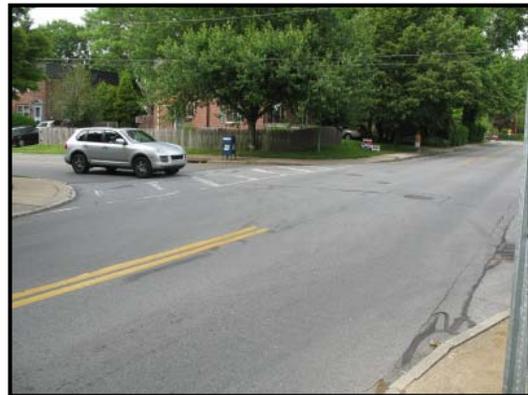
The cash occurred during the evening hours of April 2009. At the time of the crash, it was raining and the roads were wet. The area was illuminated by overhead street lighting. The crash occurred at the four-leg intersection of a two-lane north/south road and a two-lane east/west road. The east/west traffic was controlled by stop signs. **Figure 2** is a northward view of the intersection from the southeast quadrant. The speed limit in the area of the crash was 40 km/h (25 mph). A street sign was located in the southeast quadrant of the intersection and was struck by the Ford Explorer as it traveled to

**Figure 2: Northwest view of the intersection.**

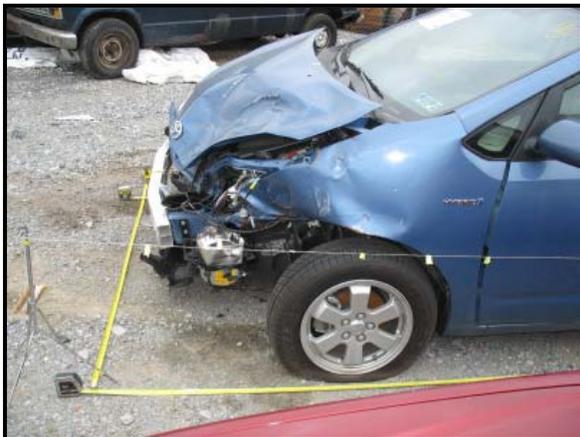
The Toyota Prius sustained left side damage consistent with the multiple event crash sequence, **Figures 3 and 4**. The primary impact damage (Event 1) was located on the left fender. The total length of the direct and induced damage measured 116.8 cm (46.0 in). The induced damage began at the trailing edge of the fender and left front door seam that was located 39 cm (15.4 in) aft of the left front axle. The direct damage measured 54.1 cm (21.3 in) in length. The direct

contact damage began at the left front corner and ended 23.1 cm (9.1 in) forward of the left front axle. The force of the impact crushed the front structure approximately 14 cm (5.5 in) to the right. The residual crush profile along the mid door elevation was as follows: C1 = 0, C2 = 2.0 cm (0.8 in), C3 = 5.0 cm (2.0 in), C4 = 7.0 cm (2.8 in), C5 = 35.0 cm (13.8 in), C6 = 28.0 cm (11.0 in). There was a 51 cm x 71 cm (20 in x 28 in) area of direct contact to the forward left aspect of the hood. The left wheelbase was reduced 1.0 cm (0.4 in). The right wheelbase was unchanged. The windshield was not fractured. All the side glazing was intact, except the disintegrated left rear quarter window. The Collision Deformation Classification (CDC) was 10LFEW3.

Figure 3: Left fender damage.

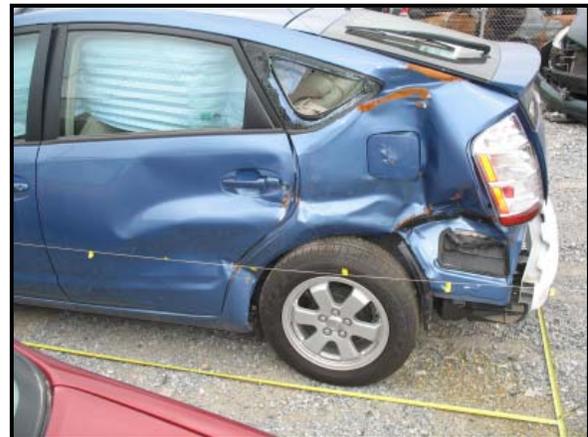
The side slap impact damage (Event 2) was located on the left quarterpanel and extended to the mid aspect of the left rear door panel. The combined length of the direct and induced damage measured 170 cm (66.9 in). The induced damage began 96 cm (37.8) forward of the left rear axle and ended at the left rear bumper corner. The direct contact damage measured 117 cm (46.0 in), began 43 cm (16.9 in) forward the left rear axle and ended at the left rear corner. The residual profile along the mid-door elevation was as follows: C1 = 8.0 cm (3.1 in), C2 = 20.0 cm (7.9 in), C3 = 17.0 cm (6.7 in), C4 = 11.0 cm (4.3 in), C5 = 5.0 cm (2.0 in), C6 = 0. The maximum crush was located 8.0 cm (3.1 in) forward of C2 and measured 21.0 cm (8.3 in). The CDC of this impact was 09LZAW3.

Figure 4: Left quarterpanel damage.

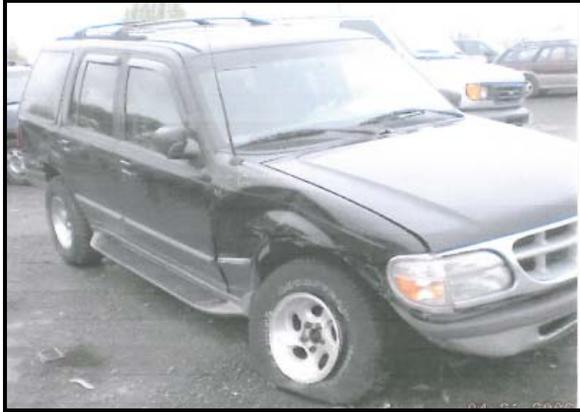
The Ford Explorer was sold prior to SCI involvement in this investigation and was not inspected. Insurance company images were obtained and reviewed. **Figures 5 and 6** are a front right oblique and a right rear oblique view of the Ford, respectively. The Ford Explorer sustained frontal and right side damage as a result of the intersection crash. The direct contract damage from the initial impact (Event 1) began at the front right corner and extended rearward along the right fender to the leading edge of the front right door. The maximum crush of the fender was located over the front right tire and was an estimated 13 cm (5 in). The front right tire was involved in the impact and was deboned. The frontal air bags in the Explorer deployed. The CDC of this impact was 01FREE5.

**Figure 5: Right front oblique view of the Ford supplied by the insurance carrier.**

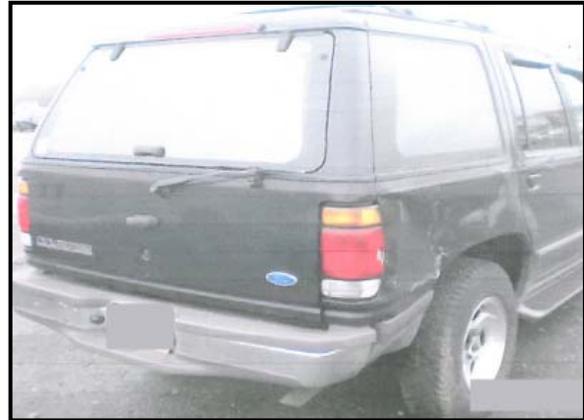
The right quarterpanel of the Explorer sustained an area of damage that began at the trailing edge of the right rear door extending to the right rear bumper corner as a result of the side slap impact (Event 2). The maximum crush was an estimated 5 cm (2 in) and was located approximately 10 cm (4 in) rearward of the right rear axle. The CDC of the impact was 03-RBEW1.

**Figure 6: Right rear oblique view of the Ford supplied by the insurance carrier.**

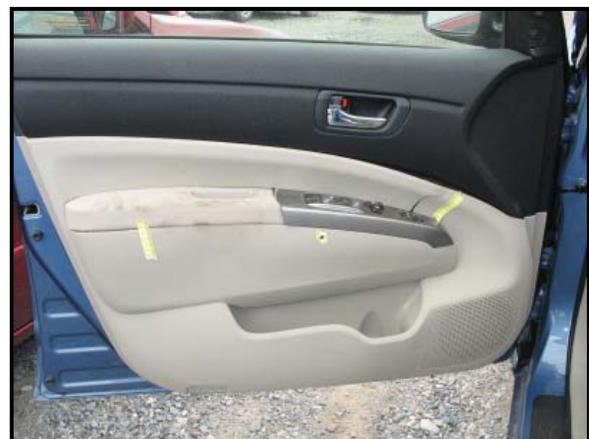
The driver's left hip contacted the door panel evidenced by a compression displacement of the arm rest. The displaced area measured 23 cm x 5 cm (9 in x 2 in) and was located in the upper rear quadrant of the door panel. There was an induced fracture of the forward aspect of the plastic panel. **Figure 7** is a view of the door panel.

**Figure 7: Left door panel**

At the initial impact with the Ford Explorer, the left IC air bag deployed. The driver responded to the 10 o'clock direction of force by initiating a left lateral and slightly forward trajectory. Her left flank/hip area impacted the left door panel and armrest area. The contact compressed the plastic panel resulting in a partial separation of the armrest from the panel. No apparent injury resulted from this contact.

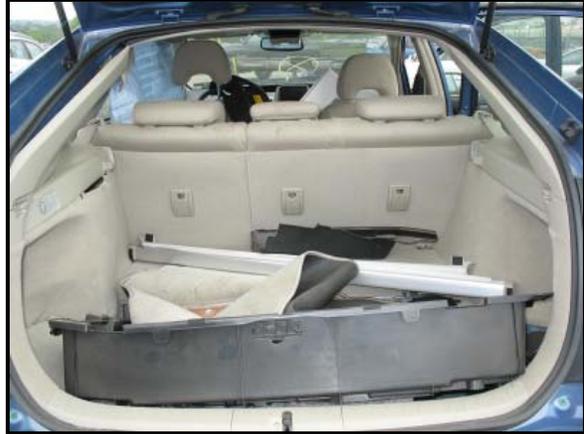
As a result of the side slap impact, the cargo area behind the second row seats sustained approximately 8 cm (3 in) of intrusion damage. The intrusion was located 46 cm (18 in) forward of the hatch opening on the left side plane, approximately 24 cm (9.5 in) aft of the hybrid battery compartment. Upon initial inspection, the OEM plastic storage container positioned over the spare tire well was found displaced and ajar, **Figure 8**. The cargo area was bell-shaped. At the rear seat back, the area measured 97 cm x 43 cm (38 in x 17 in) width by length. The cargo space then expanded to 140 cm (55 in) wide over an additional 46 cm (18 in). The total length from the seat back to the rear hatch opening measured 89 cm (35 in).

**Figure 8: View of the cargo area.**

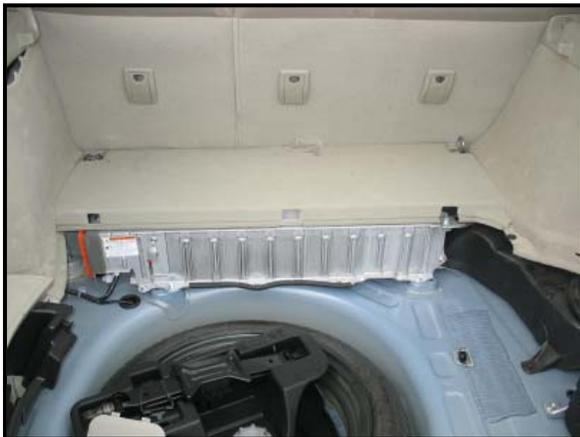
The hybrid battery compartment measured 30 cm x 76 cm x 15 cm (12 in x 30 in x 6 in) length x width x height. The battery compartment was located approximately over the rear axle, 70 cm (27.5 in) forward of the hatch opening [81 cm (32 in) forward of the rear bumper]. It was mounted to the floor of the cargo space, forward and above the 66 cm (26 in) diameter spare tire well. Heating, ventilation, and cooling (HVAC) duct work was located along the right side of the cargo area. There was no damage to, or leakage from, the hybrid battery compartment. **Figures 9 and 10** are additional views of the cargo area and hybrid battery. The battery appeared to be in compliance with Federal Motor Vehicle Safety Standard (FMVSS) No: 305.

**Figure 9: Cargo area and hybrid battery location.**

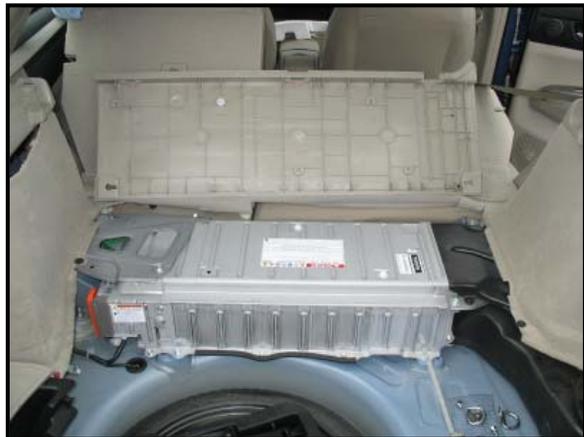
**Figure 10: Hybrid battery location.**

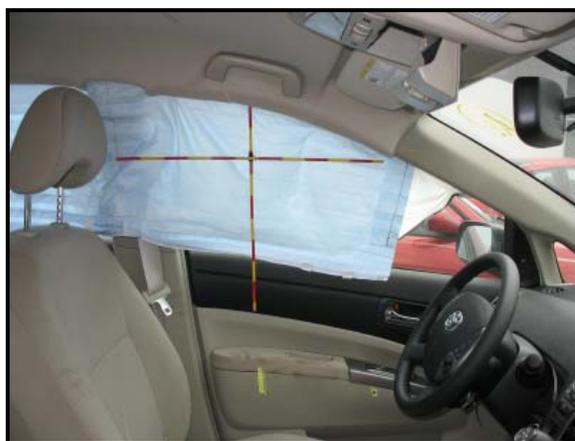
The left IC air bag deployed from the left roof side rail as a result of the crash, **Figure 11**. The curtain provided coverage from the A- to C-pillars. The membrane was rectangular in shape and measured 163 cm x 38 cm (64 in x 15 in). The curtain provided 66 cm (26 in) of coverage forward of the left B-pillar and provided full vertical coverage of the side glazing to the belt line in both rows. A 30 cm x 32 cm (12 in x 12.5 in) area forward of the curtain's leading edge at the A-pillar junction was not covered by the membrane. This area was partially covered by an 18 cm x 18 cm (7 in x 7 in) triangular sail panel that was attached to the leading aspect of the curtain. No occupant contacts were observed on the deployed curtain.

**Figure 11: Deployed left inflatable curtain.**

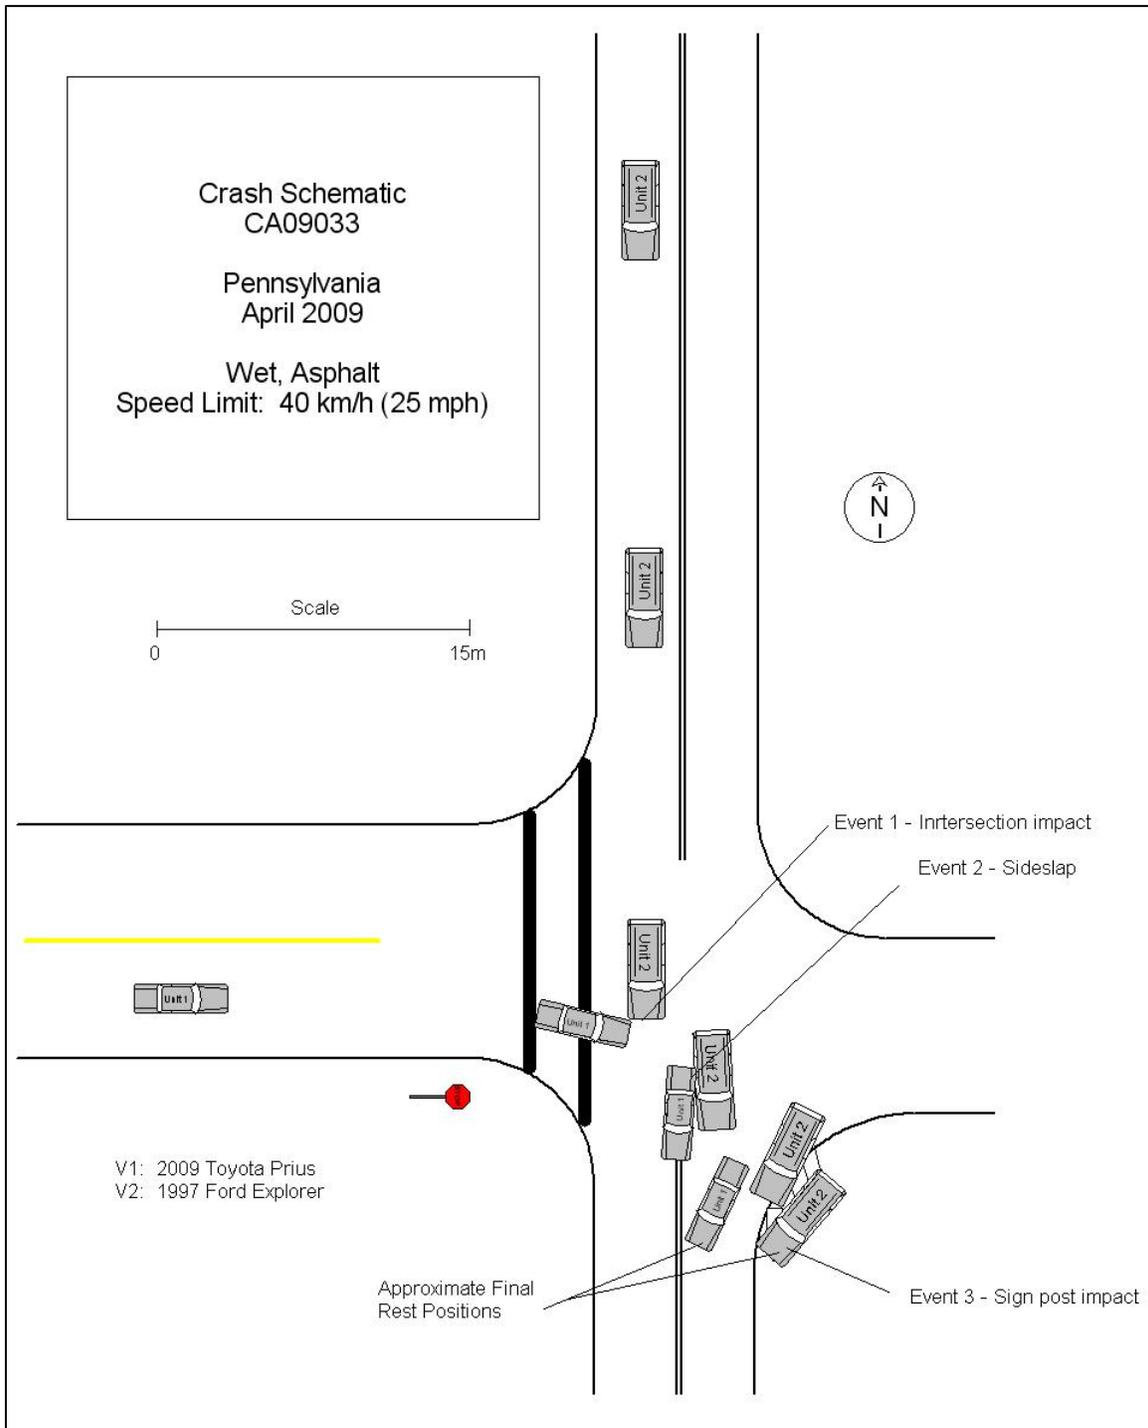
Figure 12: Crash Schematic.

final rest. Tire marks were observed on the sidewalk immediately north of the road sign and were attributed to the Explorer. A schematic of the crash is attached to the end of this report as **Figure 12**.
