INDIANA UNIVERSITY

ON-SITE CERTIFIED ADVANCED 208-COMPLIANT VEHICLE INVESTIGATION

CASE NUMBER - IN09033
LOCATION - MISSOURI
VEHICLE - 2009 MAZDA 3i
CRASH DATE - September 2009

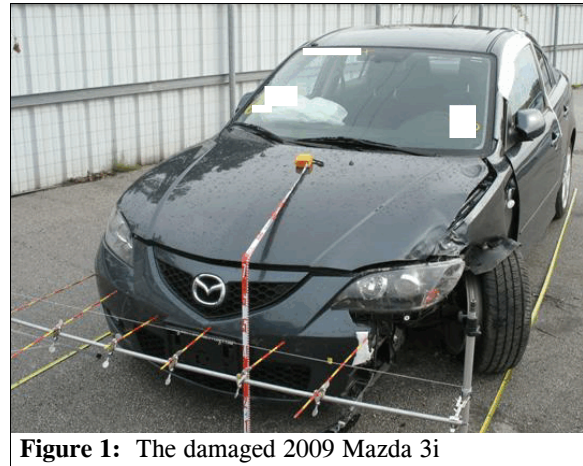
Figure 1: The damaged 2009 Mazda 3i

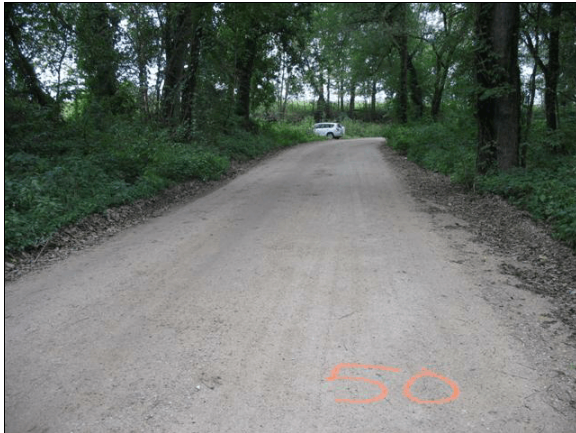
Figure 2: Approach of the Mazda to the curve and location of the crash; number on roadway shows meters to area of impact

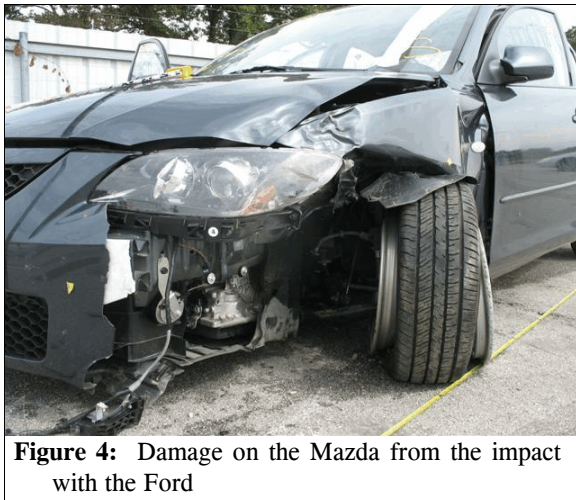
Figure 4: Damage on the Mazda from the impact with the Ford

Exterior Damage: The impact with the Ford involved the front plane of the Mazda. The front bumper fascia, left headlamp/turn signal assembly, hood, left fender, and left front wheel were directly damaged. The direct damage began at the left corner of the front bumper fascia and extended 36 cm (14.1 in) across the bumper fascia. The crush measurements were taken at the bumper level and C₁ was taken on the left end of the bumper bar. The maximum residual crush at this point was 5 cm (2 in). The vehicle’s left side wheelbase was reduced 20 cm (7.9 in) while the right side wheelbase was unchanged. The induced damage involved the left fender, hood, and left front door. The table below shows the vehicle’s front crush profile.

Damage Classification: The Mazda’s Collision Deformation Classification (CDC) for the front impact was **12-FLEE-4** (10 degrees). The Damage algorithm of the WinSMASH program calculated the Mazda’s total Delta V as 12.0 km/h (7.5 mph). The longitudinal and lateral velocity changes were -11.8 km/h (-7.3 mph) and -2.1 km/h (-1.3 mph), respectively. The results appeared low. The impact did not engage and bumper bar or left frame rail, which resulted in a shallow front crush profile. On this vehicle, the bumper bar did not extend beyond the frame rail (**Figure 6**). The left front wheel (**Figure 7**) was engaged and displaced rearward 20 cm (7.9 in). Displacement of a wheel is outside the scope of the crush measurement protocol and the WinSMASH program.

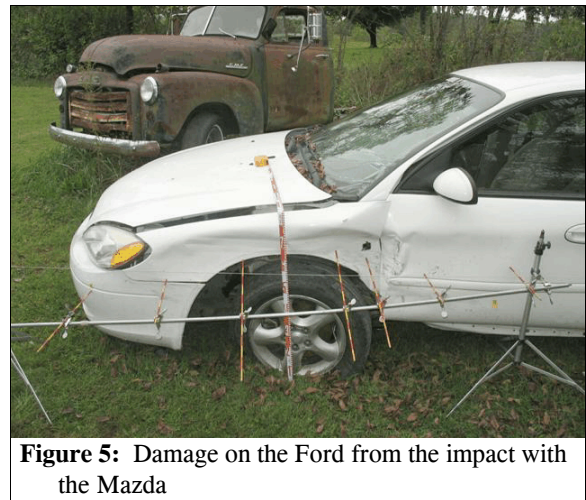
Figure 5: Damage on the Ford from the impact with the Mazda

Exterior Damage: The impact with the Mazda involved the left side plane of the Ford. The left fender, front wheel, and front door were directly damaged. The direct damage began 175 cm (68.9 in) forward of the left rear axle and extended 180 cm (70.9 in) along the left front door and left fender. The crush measurements were taken at the mid-door level and the maximum residual crush was 15 cm (5.9 in) occurring 13 cm (5.1 in) rear of C₃. The vehicle's left side wheelbase was reduced 18 cm (7.1 in) while the right side wheelbase was unchanged. The induced damage involved the hood, left front door, and windshield. The table below shows the vehicle's left side crush profile.

Damage Classification: The CDC for the left side plane impact with the Mazda was **11-LYEW-1 (240 degrees)**. The Damage algorithm of the WinSMASH program calculated the Ford's total Delta-V as 11 km/h (6.8 mph). The longitudinal and lateral velocity changes were -10.3 km/h (-6.4 mph) and 3.8 km/h (2.4 mph), respectively. Based on the displacement of both vehicle's left front wheels, the results appeared low.

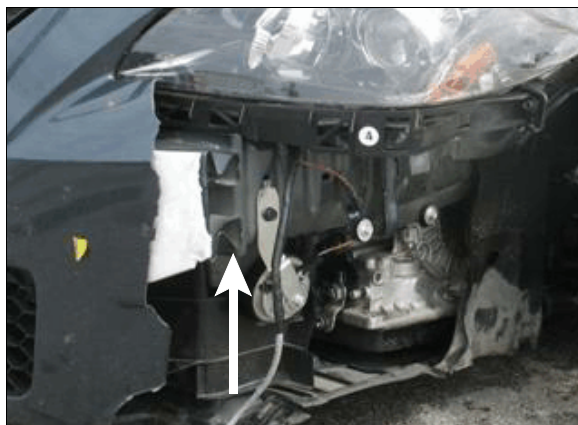
Figure 6: Arrow shows the left end of the bumper bar on the Mazda; the bumper bar did not extend beyond the left frame rail

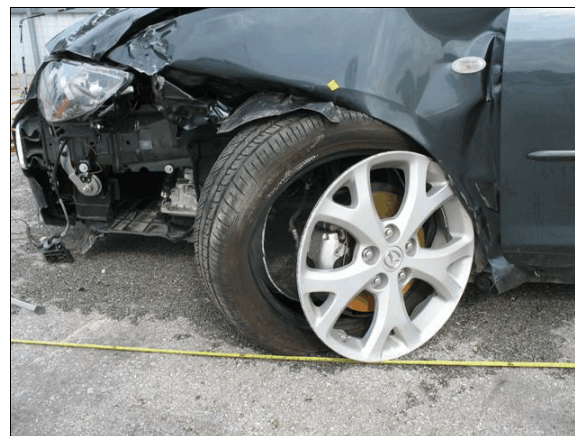
Figure 7: The impact displaced the Mazda's left front wheel rearward 20 cm (7.8 in)

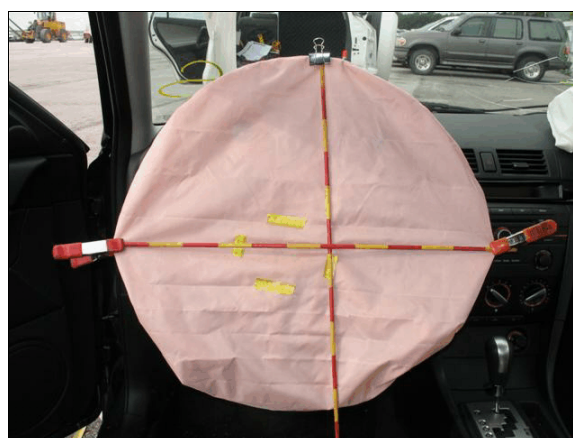
The driver's frontal air bag was located within the steering wheel hub and the module cover was a three flap configuration constructed of pliable vinyl. The top flap was 11.5 cm (4.5 in) in width and 9 cm (3.5 in) in height. Each bottom flap was 6 cm (2.4 in) in width and height as measured along the tear seams. An inspection of the air bag module cover flaps revealed that they opened at the designated tear points and were undamaged. The deployed air bag (**Figure 8**) was 58 cm (22.8 in) in diameter and had two 4 cm (1.6 in) diameter vent ports and no tethers. The vent ports were located on the back of the air bag at the 11 and 1 o'clock positions. Inspection of the air bag revealed what appeared to be a makeup transfer (**Figure 9**) located 3 cm (1.2 in) left of the center of the air bag. The air bag was not damaged during the deployment.

Figure 8: The Mazda driver's frontal air bag

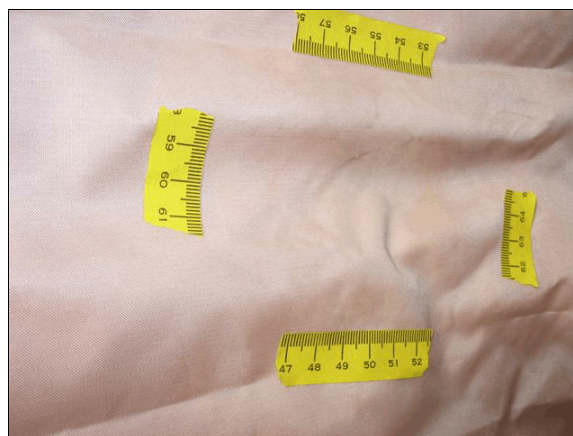
Vehicle Interior: The inspection of the Mazda's interior revealed a makeup transfer on the driver's frontal air bag from the driver's face. A scuff mark was also present the glove box door from contact by the front passenger's right knee. There was no discernable evidence of occupant contact in the second row.

Figure 9: Tape outlines area of make-up transfer on the driver's frontal air bag

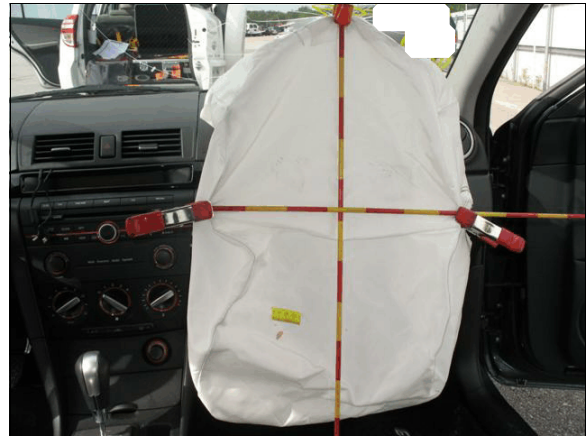
The front passenger's frontal air bag was located within the top of the instrument panel and the module cover consisted of a single flap constructed of medium gauge vinyl. The flap measured 24 cm (9.4 in) in width and 14 cm (5.5 in) in height. The module cover flap opened at the designated tear points and was undamaged. The deployed air bag (**Figure 10**) was rectangular with a width of 33 cm (13 in) and a height of 58 cm (22.8 in) and had two 6 cm (2.4 in) diameter vent ports and no tethers. The vent ports were located on the side of the air bag at the 3 and 9 o'clock positions. Inspection of the air bag revealed a small blood transfer located 7 cm (2.8 in)

to the left and 17 cm (6.7 in) below the center of the air bag. The air bag was not damaged during the deployment.

Figure 10: The front passenger's frontal air bag

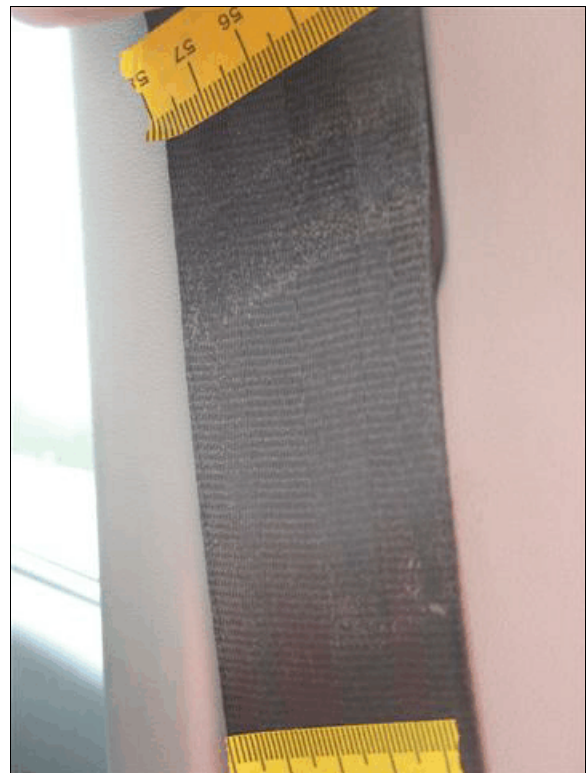
The inspection of the driver's safety belt assembly revealed a scuff from the latch plate on the safety belt webbing located 33 cm (13 in) above the stop button. A friction abrasion from the D-ring was also present on the belt webbing (**Figure 11**) located 92 cm (36.2 in) above the stop button. Abrasions from the safety belt webbing were also present on the latch plate belt guide and the D-ring. This evidence indicated that the driver was restrained in this crash.

Figure 11: Abrasion on the belt webbing of the Mazda's driver

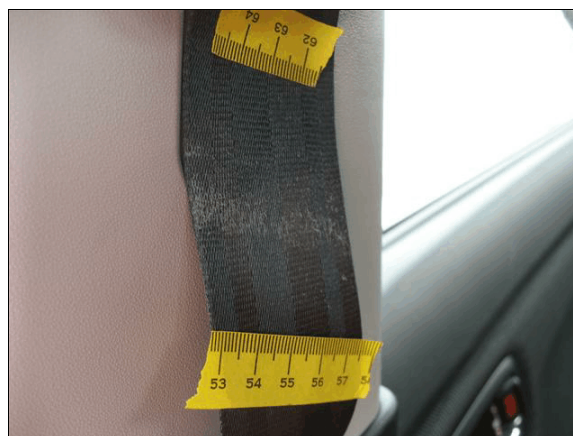
Inspection of the front passenger's safety belt assembly revealed a friction abrasion from the D-ring on the belt webbing (**Figure 12**) located 106 cm (41.7 in) above the stop button. There were also abrasions on the latch plate belt guide. This evidence indicated that the front passenger was restrained in this crash.

Figure 12: Friction abrasion on the belt webbing of the Mazda’s front passenger
