ON-SITE SIDE IMPACT INFLATABLE OCCUPANT PROTECTION INVESTIGATION

CASE NUMBER - IN09034

VEHICLE - 2007 CHRYSLER SEBRING LX

CRASH DATE - September 2009

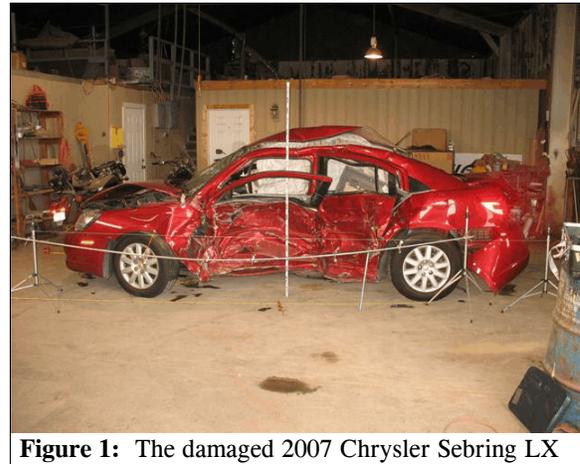
Figure 1: The damaged 2007 Chrysler Sebring LX

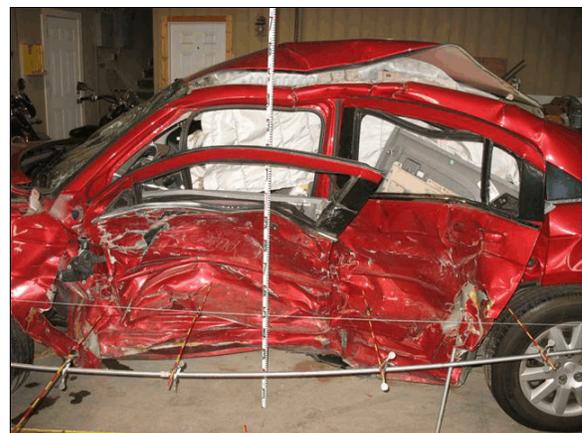
Crash: The left side plane of the Chrysler (Figure 4) was impacted by the front plane of the Ford (Figure 5). The direction of force on the Chrysler was within the 10 o'clock sector and the impact force was sufficient to trigger the deployment of the left IC air bag and the driver's seat-mounted side impact air bag. The impact also triggered the deployment of the driver's and front passenger's frontal air bags. The Chrysler was redirected to the northwest and rotated counterclockwise approximately 295 degrees as it traversed a distance of 24 m (78.7 ft) to its final rest position on the outside southeastbound lane heading west (Figure 6). The Ford was also redirected to the northwest. The vehicle rotated approximately 120 degrees as it traveled along a curved path and separated from the Chrysler. It continued backward in a northeast direction down the negative 3.3% cross grade of the roadway and came to final rest in the center northwestbound lane heading southwest (Figure 6). The Ford traversed a distance of 35 m (114.8 ft) from the impact to the final rest position.

Figure 4: Location of the impact on the Chrysler

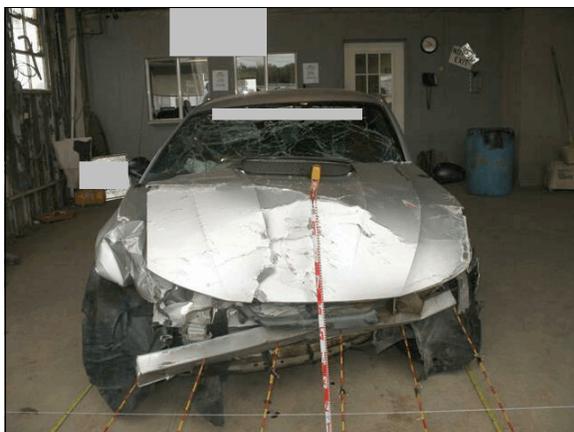
Figure 5: Damage on the front of the Ford from the impact with the Chrysler

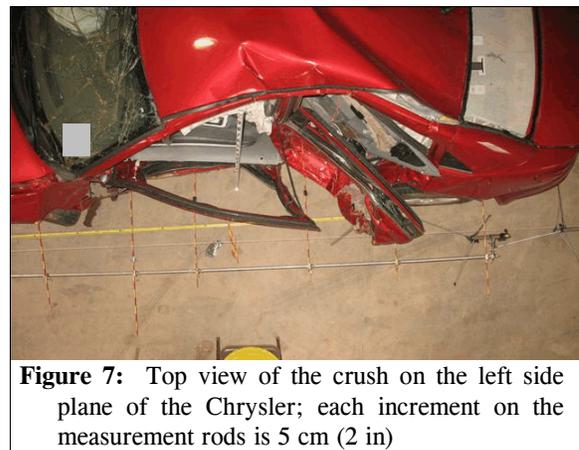
Exterior Damage: The impact by the front of the Ford involved the left side plane of the Chrysler. The fender, A-pillar, front door, B-pillar, and rear door were directly damaged. The direct damage began 44 cm (17.3 in) forward of the left rear axle and extended 203 cm (80 in) forward along the left side. The crush measurements were taken at the mid-door level and the residual maximum crush was 59 cm (23.2 in) occurring at C₄ (Figure 7). Since the left side doors had been forced open by rescue personnel, it was necessary to force them back in place and tie them shut. The damaged doors could not be forced fully back into their damaged position, so an adjustment factor of 10 cm (4 in) was added to the crush measurements at C₃ and C₄ based on measurements on the doors. The vehicle's sill height was 36 cm (14.2 in) and the height of the maximum crush was 72 cm (28.3 in). The Door Sill Differential was 23 cm (9.1 in). The induced damage involved the hood, windshield, left A-pillar, left roof side rail, roof, left quarter panel, and rear bumper cover. The table below shows the vehicle's right side crush profile.

Figure 7: Top view of the crush on the left side plane of the Chrysler; each increment on the measurement rods is 5 cm (2 in)

Damage Classification: The Collision Deformation Classification (CDC) was **10-LYAW-4 (300 degrees)** for the left side plane impact. The Damage algorithm of the WinSMASH program calculated the total Delta V for the Chrysler as 64 km/h (39.7 mph). The longitudinal and lateral velocity changes were -32.0 km/h (-19.9 mph) and 55.4 km/h (34.4 mph), respectively. Based on the damage sustained by both vehicles, the results appeared reasonable.

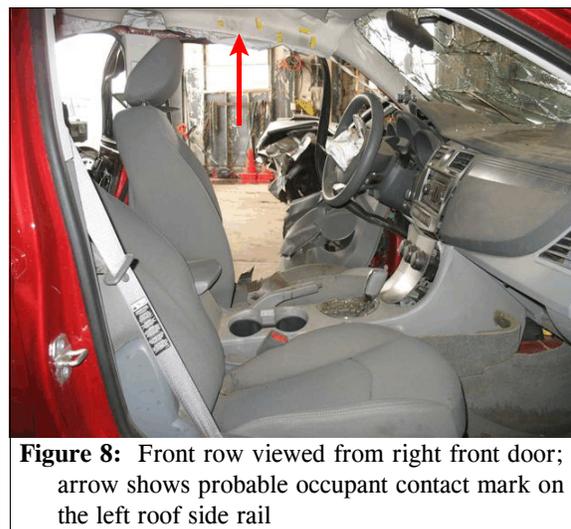
Vehicle Interior: The interior inspection of the Chrysler revealed an area of scuffing on the left roof side rail (**Figure 8**), possibly related to contact by the driver’s head. The left front door arm rest was scuffed and deformed (**Figure 9**). Much of the deformation on the interior door panel was also related to the impact and probably rescue activities. There were no occupant scuff marks or tissue transfer on the left IC air bag, left front seat-mounted side impact air bag, or driver’s frontal air bag. However, a significant amount of blood transfer was present on the driver’s frontal air bag and the outboard surface of the left front seat-mounted side impact air bag.

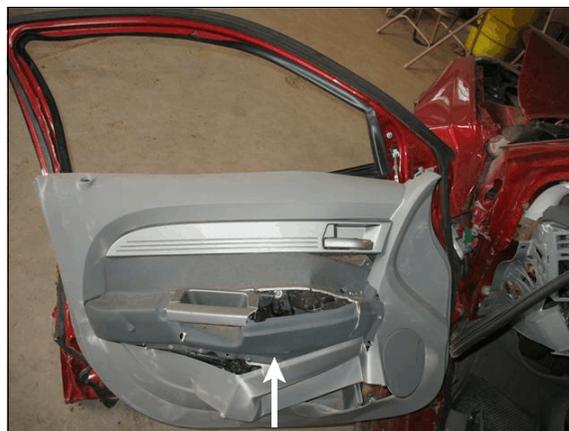
Figure 9: The left front door; arrow shows area of probable occupant contact

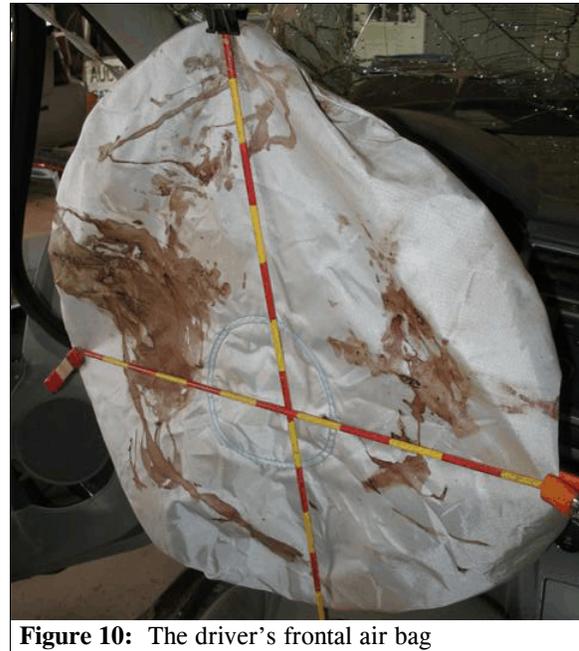
The driver's frontal air bag was located within the steering wheel hub and the module cover was a horizontal two-flap configuration constructed of pliable vinyl. The top cover flap was 16 cm (6.3 in) in width and 6 cm (2.4 in) in height. The bottom cover flap was 16 cm (6.3 in) in width and 9 cm in height (3.5 in). The flaps opened at the designated tear points and were undamaged. The deployed air bag (**Figure 10**) was 63 cm (24.8 in) in diameter and was designed with two 8 cm (3.1 in) wide tethers and two 3 cm (1.2 in) diameter vent ports, which were located at the 10 and 1 o'clock positions. Inspection of the air bag revealed no damage or occupant contact, but there was an extensive amount of blood transfer on the front of the air bag.

Figure 10: The driver's frontal air bag

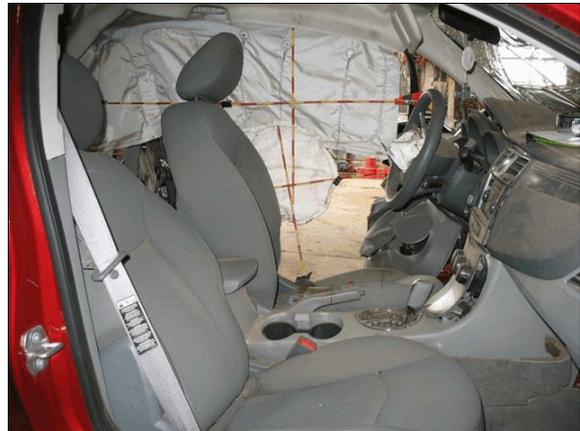
The IC air bags were located along the roof side rails inside the headliner and extended from the A-pillar to the C-pillar. There were no external vent ports. The deployed left IC air bag (**Figure 11**) was 148 cm (58.3 in) in width and 45 cm (17.7 in) in height. It was attached to the A-pillar by a 42 cm (16.5 in) nylon rope. The gap between the front of the IC air bag and the A-pillar was also 42 cm (16.5 in) at the bottom of the IC air bag. There was no gap between the back of the IC air bag and the C-pillar. The distance the IC air bag extended vertically below the beltline could not be determined since there was significant deformation of the side structure due to the impact and the left side doors would not close. The left IC air bag was not damaged and there was no discernable evidence of occupant contact.

Figure 11: The deployed left IC air bag and left front seat mounted side impact air bag

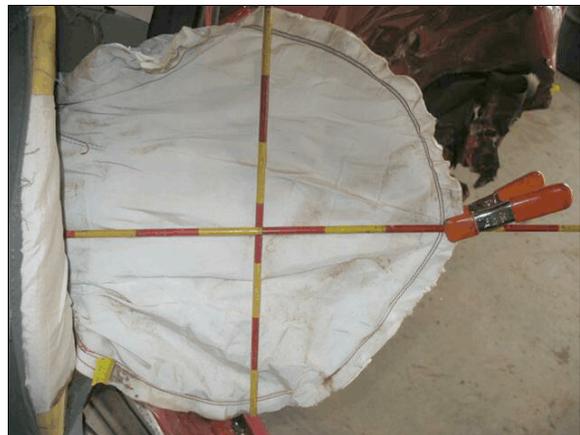
The driver's seat-mounted side impact air bag was located in the outboard side of the seat back and deployed through a tear-seam. The deployed air bag (Figure 12) was 35 cm (13.8 in) in height and 32 cm (12.6 in) in width. Inspection of the air bag revealed no discernable evidence of occupant contact. There was a significant amount of blood transfer on the outboard side of the air bag. The air bag sustained damage on the outboard surface (Figure 13) from glass fragments from the disintegrated left front window glazing. The damage consisted of an area of small holes and abrasions located approximately 15 cm (5.9 in) below the top of the air bag and 7 cm (2.8 in) forward of the center of the air bag.

Figure 12: The inboard side of the left front seat-mounted side impact air bag

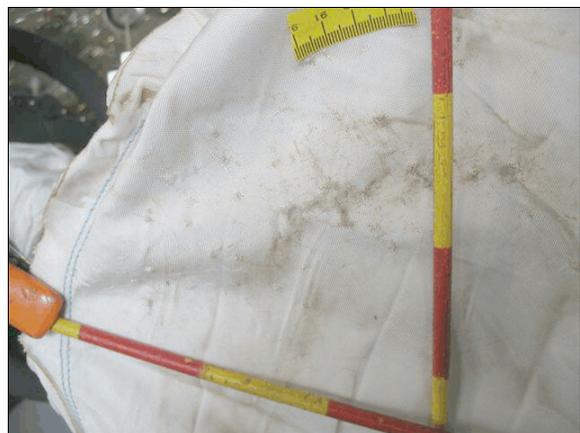
Figure 13: Abrasions and small holes on the forward upper quadrant of the left seat-mounted side impact air bag due to contact by glass fragments from the disintegrated left front window glazing

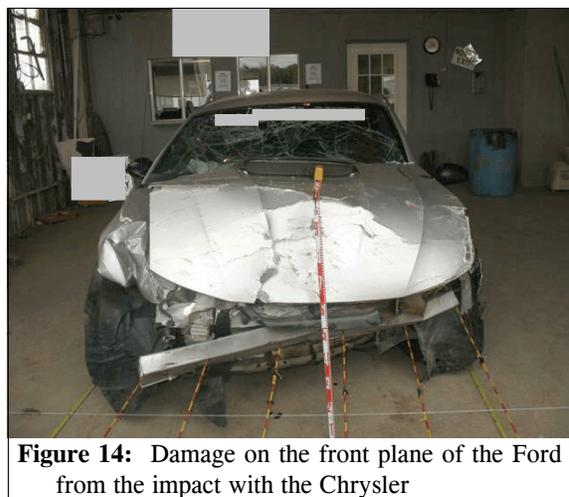
Exterior Damage: The impact with the Chrysler involved the front plane of the Ford (**Figures 14 and 15**). The front bumper, grille, hood, both fenders, and both headlamp/turn signal assemblies were directly damaged. The direct damage began at the front left bumper corner and extended across the full width of the front plane. The crush measurements were taken at the bumper level and the residual maximum crush was 74 cm (46 in) occurring at C₁ (**Figure 16**). The left side wheelbase was reduced 37 cm (14.6 in), while the right side wheelbase was extended 1 cm (0.4 in). The induced damage involved the hood and both fenders. The table below shows the front crush profile.

Figure 14: Damage on the front plane of the Ford from the impact with the Chrysler

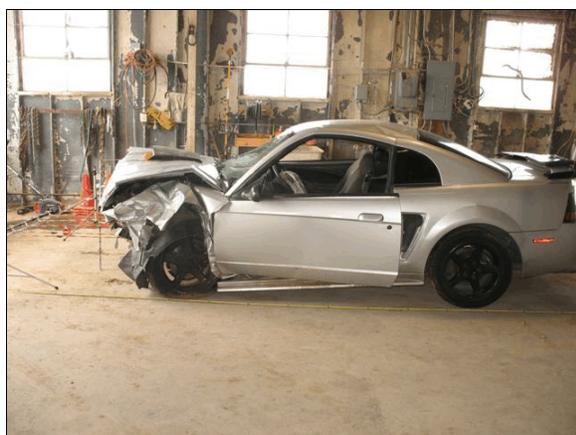
Figure 15: Left side view of the front plane damage on the Ford

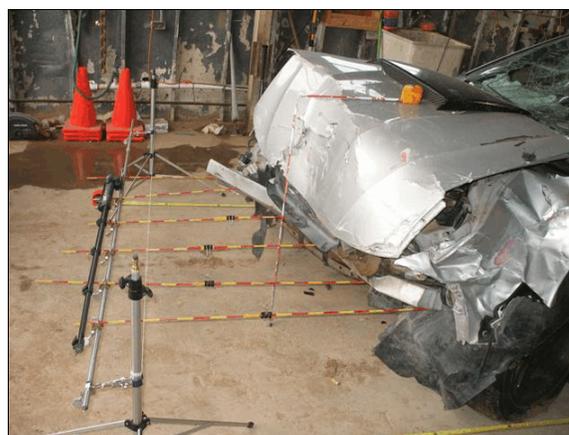
Figure 16: Left side view of the front plane crush on the Ford

Damage Classification: The CDC for the front impact with the Chrysler was **12-FDEW-3 (10 degrees)**. The Damage algorithm of the WinSMASH program calculated the Ford’s total Delta-V as 65 km/h (40.4 mph). The longitudinal and lateral velocity changes were -64.0 km/h (-39.8 mph) and -11.3 km/h (7.0 mph), respectively. Based on the damage on both vehicles, the results appeared reasonable.
