**CALSPAN ON-SITE SIDE IMPACT INFLATABLE OCCUPANT PROTECTION  
SYSTEM CRASH INVESTIGATION**

**SCI CASE NO: CA09034**

**VEHICLE: 2000 JAGUAR S-TYPE**

**CRASH DATE: APRIL 2009**

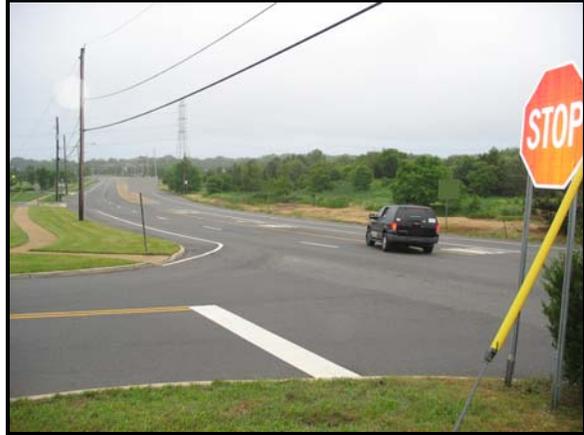
This two-vehicle crash occurred during the daylight hours of April 2009. At the time of the crash, it was raining and the asphalt road surface was wet. The crash occurred at the three-leg intersection of a two lane north/south road and a four lane east/west road. A stop sign for southbound traffic controlled the intersection. The north/south road measured 10.2 m (33.5 ft) in total width. The total width of east/west road measured 17.2 m (56.4 ft) and was configured with two traffic lanes in the respective travel directions. At the time of the SCI scene inspection, there were no apparent obstructions that would have obscured driver visibility to intersecting traffic. The speed limit for the north/south roadway was 40 km/h (25 mph). The posted speed limit for the east/west roadway was 64 km/h (40 mph). **Figure 2** is a southeast view of the intersection.

**Figure 2: Southeast ward of the intersection, the perspective of the Jaguar driver.**

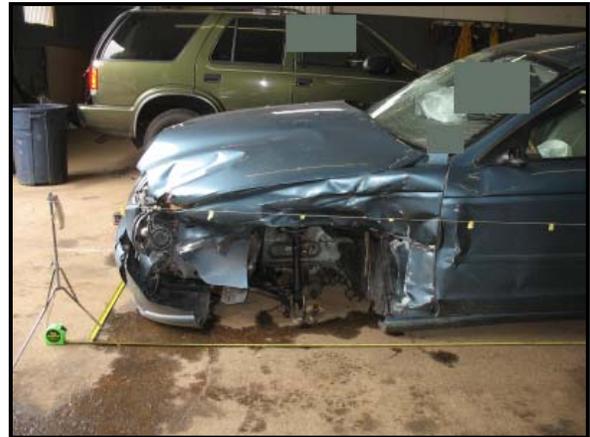
**Figures 3 and 4** are left side views of the damaged Jaguar. The exterior of the Jaguar sustained moderate severity left fender damage as a result of the intersection crash (Event 1). The direct contact damage for the initial impact with the Honda measured 154 cm (60.6 in) in length. The damage began at the front left corner of the vehicle and extended rearward to a point 314 cm (124 in) forward of the back plane. The induced damage began 296 cm (116.5 in) forward of the back plane. The maximum crush measured 38 cm (15.0 in) and was located at the forward aspect of the left fender. The impact involved the left front tire and wheel causing the left front wheel to separate due to a fractured lower suspension. The residual crush profile documented along the left fender was as follows: C1 = 1 cm (0.4 in), C2 = 2 cm (0.8 in), C3 = 16 cm (6.3 in), C4 = 19 cm (7.5 in), C5 = 38 cm (15.0 in), C6 = 21 cm (8.3 in). The Collision Deformation Classification (CDC) for this impact was 10-LYEW3.

**Figure 3: Jaguar left fender deformation.**

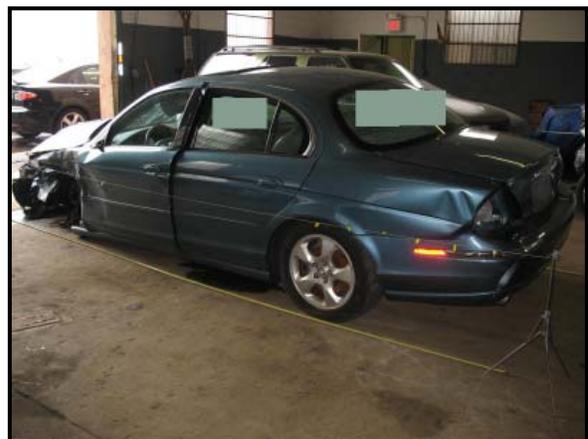
The side slap (Event 2) resulted in minor severity damage to the left rear aspect of the Jaguar. The direct contact damage measured 26 cm (10.2 in) and began 12 cm (4.7 in) forward of the back plane. The combined length of the direct and induced damage (Field L) measured 97 cm (38 in). The crush profile along the left quarterpanel of the Jaguar was as follows: C1 = 6 cm (2.4 in), C2 = 15 cm (5.9 in), C3 = 10 cm (3.9 in), C4 = 4 cm (1.6 in), C5 = 4 cm (1.6 in), C6 = 0 cm. The CDC assigned to this impact was 09-LBEN2.

**Figure 4: Left quarterpanel damage.**

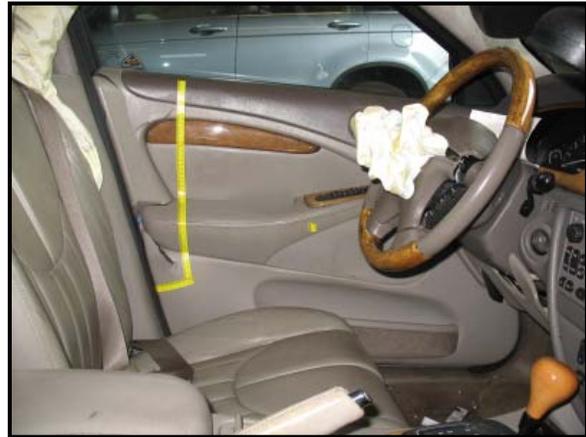
Inspection of the passenger compartment revealed a single occupant contact point. This contact consisted of the driver's left hip/flank loading through the side impact air bag and fracturing the rear aspect of the left front door panel. The contact measured 36 cm x 13 cm (14 in x 5 in) height x width and encompassed the rear upper and lower quadrants of the door panel, (**Figure 5**). There was no intrusion of the passenger compartment.

**Figure 5: Left front door panel contact.**

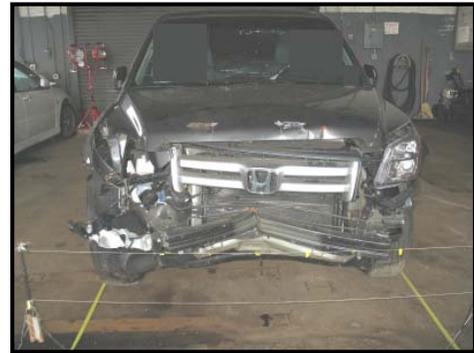
The 2007 Honda Pilot sustained moderate frontal damage as a result of the impact with the Jaguar (Event 1). The direct contact damage began 55 cm (21.5 in) left of center and extended to the right front bumper corner. The combined width of the direct and induced damage extended across the 165 cm (65 in) front end width. The maximum crush measured 41 cm (16.1 in) and was located immediately right of the centerline. The forward termination of the right frame was deformed inboard 18 cm (7 in). The residual crush profile documented along the bumper reinforcement beam of the Pilot was as follows: C1 = 0 cm, C2 = 13 cm (5.1 in), C3 = 26 cm (10.2 in), C4 = 41 cm (16.1 in), C5 = 20 cm (7.9 in), C6 = 4 cm (1.6 in). The CDC for this impact was 01-FZEW2.

**Figure 6: Honda frontal damage.**

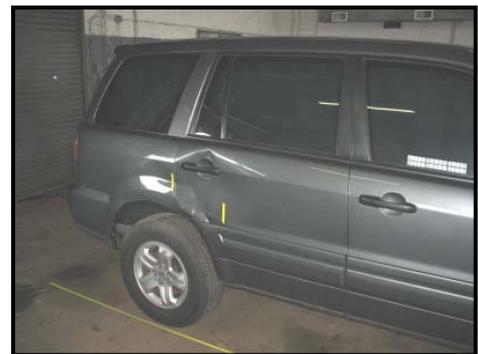
The Honda sustained minor deformation to the right rear door and quarter panel from the secondary impact with the Jaguar (Event 2). The direct contact damage was 34 cm (13.3 in) in length and began 124 cm (48.8 in) forward of the rear plane. The maximum deformation was 3 cm (1.2 in) located on the right rear door. The residual crush profile documented at the mid-door elevation was: C1 = 0 cm, C2 = 1 cm (0.4 in), C3 = 2 cm (0.8 in), C4 = 2 cm (0.8 in), C5 = 1 cm (0.4 in), C6 = 0 cm. The CDC for this impact was 09-RPEN1.

**Figure 7: Right side slap damage.**

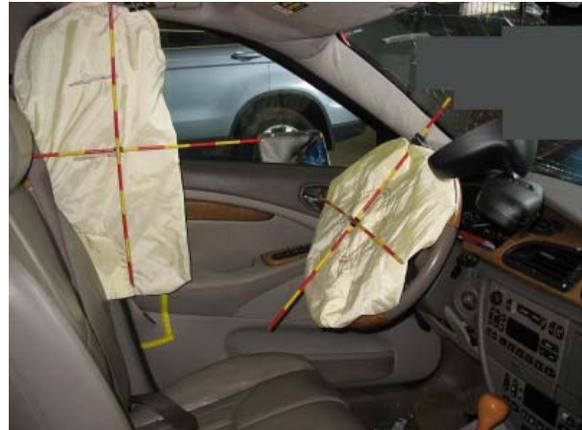
The 2000 Jaguar S-Type was equipped with front seat back-mounted side impact air bags. The left seat back-mounted air bag deployed during Event 1 of the crash sequence (**Figure 8**). The air bag was designed to offer protection to the upper torso and head in side impact crashes and was concealed within the outboard aspect of the seat back. The air bag deployed through a 43 cm (17 in) tear seam at the forward aspect of the seat back. The air bag measured 61 cm (24 in) in height and 23 cm (9 in) in width and was comprised of two panels sewn together at the forward edge. Two 9 cm (3.5 in) wide tethers were sewn to the air bag at the center and upper third aspects. The air bag extended vertically over the side glazing to the headliner. The air bag did not provide full coverage across the entire left front glazing. With the air bag membrane placed in the deployed position, a triangular shaped void was present at the left front glazing adjacent to the A-pillar. The dimensions of the void were 76 cm (30 in) in length and 34 cm (13.5 in) in maximum height. There was no damage or occupant contact points to the seat back-mounted side air bag.

**Figure 8: Right lateral view of the deployed side air bag.**

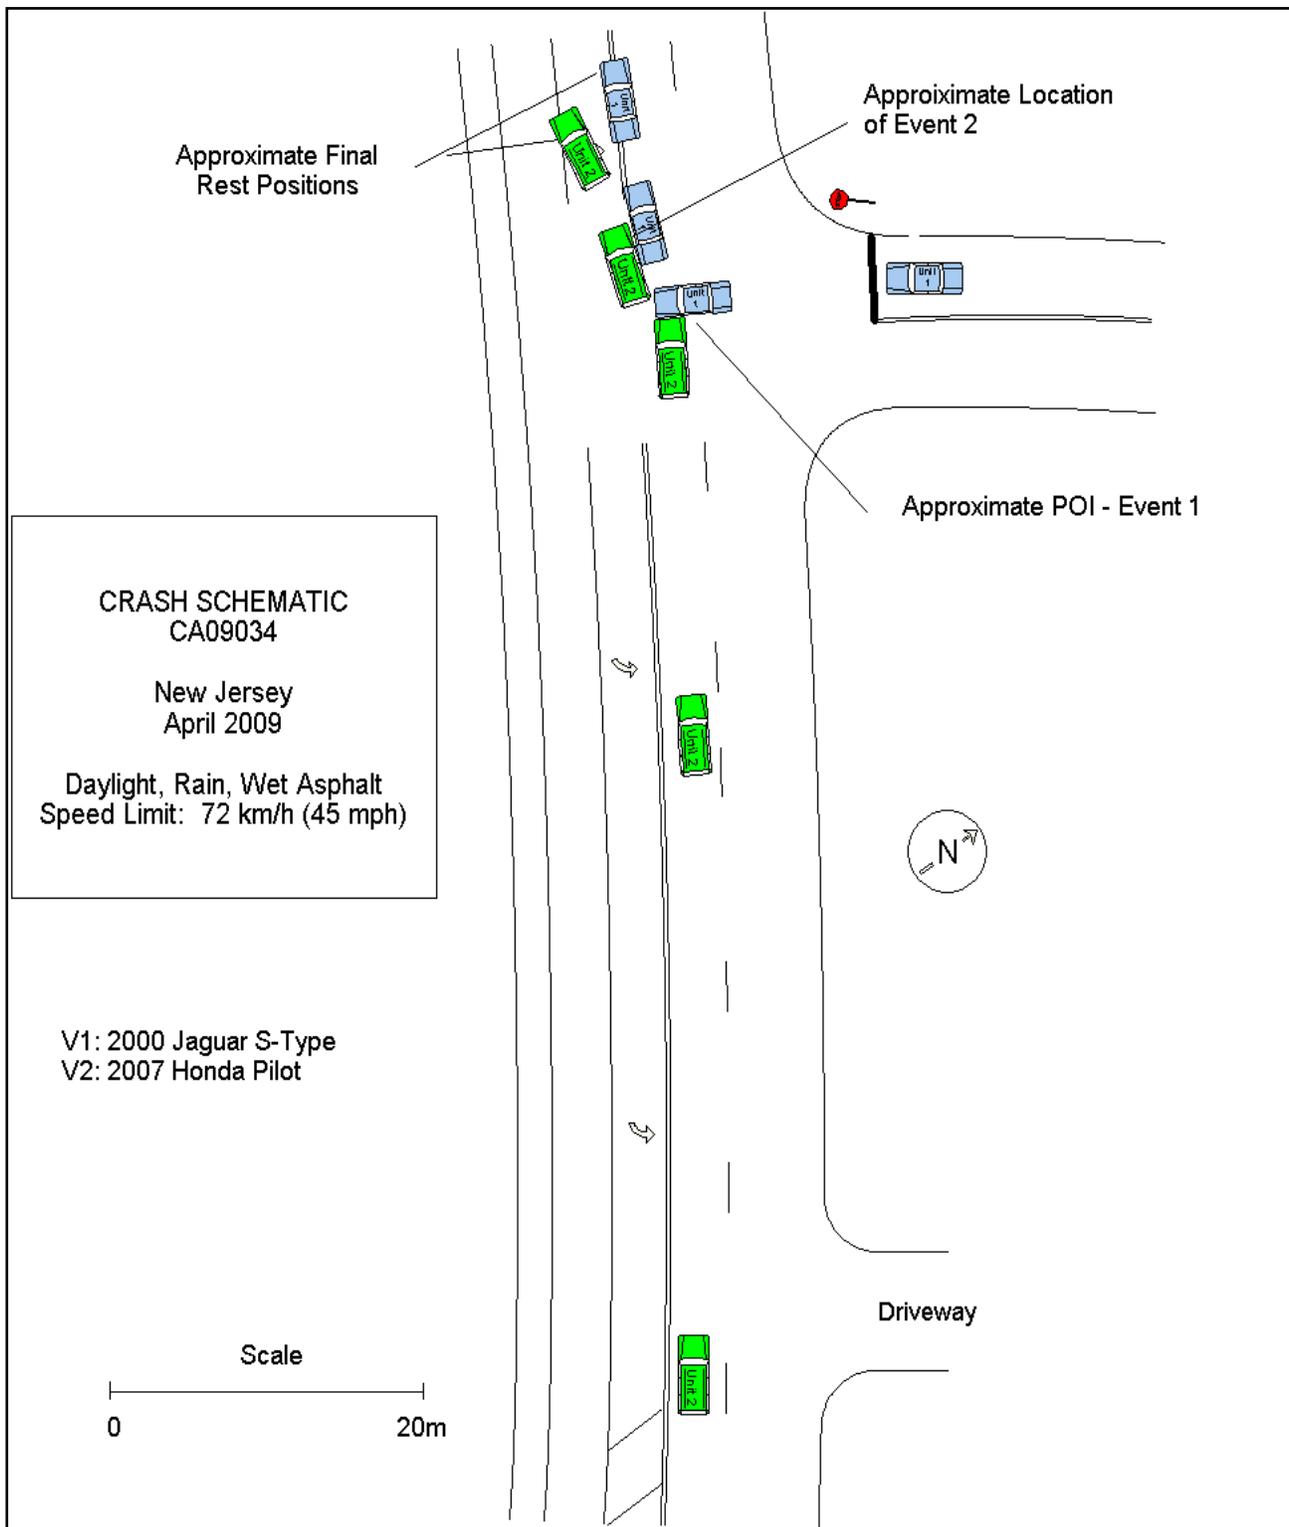
Figure 9: Scene Schematic

The 2000 Jaguar S-Type was stopped at the stop sign facing south and was operated by a 64-year-old restrained female. It was the driver's intention to turn left and travel east. The 2007 Honda Pilot was westbound on the inboard lane operated by a 25-year-old restrained female. The crash occurred when the Jaguar accelerated forward into the path of the Honda. A schematic of the crash is attached to the end of this report, **Figure 9**.
