ON-SITE ROLLOVER INVESTIGATION

CASE NUMBER - IN09035
LOCATION - NEBRASKA
VEHICLE - 2008 CHRYSLER ASPEN LIMITED
CRASH DATE - August 2009

1. <i>Report No.</i> IN09035		2. <i>Government Accession No.</i>		3. <i>Recipient's Catalog No.</i>	
4. <i>Title and Subtitle</i> On-Site Rollover Investigation Vehicle - 2008 Chrysler Aspen Limited Location - Nebraska			5. <i>Report Date:</i> April 19, 2010

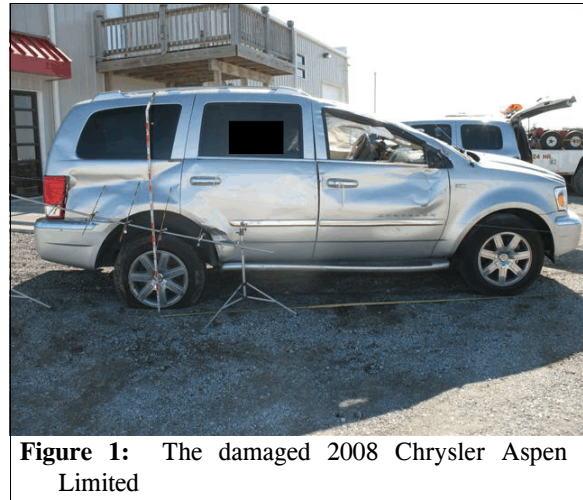
Figure 1: The damaged 2008 Chrysler Aspen Limited

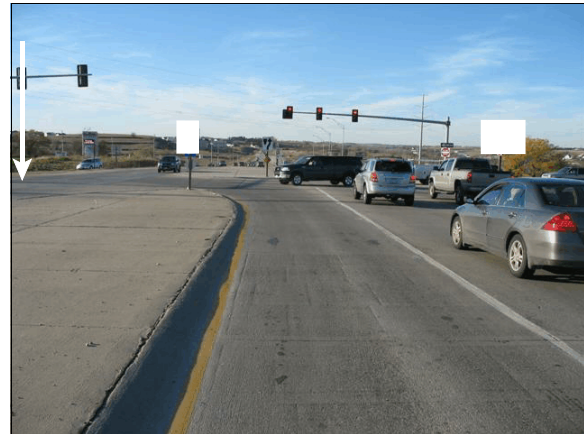
Pre-Crash: The Chrysler was occupied by a restrained 23-year-old male driver. The vehicle was traveling northwest in the left turn lane (Figure 2) and the driver was in the process of executing a left turn onto the entrance ramp to the interstate highway. The Dodge was occupied by a restrained 24-year-old female driver. The vehicle was traveling southeast in the first through lane from the right (Figure 3) and the driver intended to continue straight through the intersection. The driver of the Chrysler made no avoidance maneuvers prior to the crash. The crash occurred in the 4-leg intersection of the 2 trafficways.

Figure 2: Approach of the Chrysler to the intersection; arrow shows the area of impact

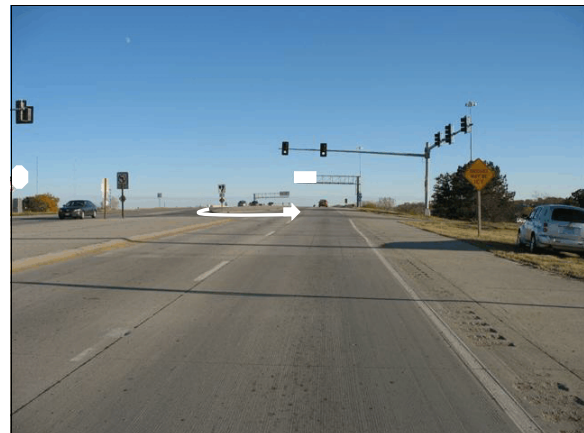
Figure 3: Approach of the Dodge; arrow shows the approach of the Chrysler to impact area

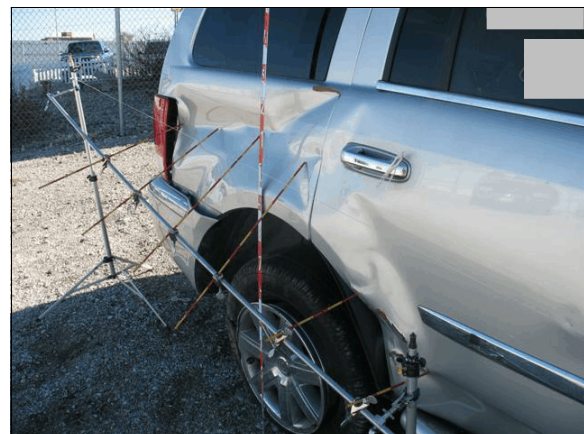
Crash: The Chrysler was impacted on the right quarter panel (Figure 4, event 1) by the front plane of the Dodge. The force direction was within the 2 o'clock sector and the impact force was sufficient to trigger deployment of the right rollover/side impact inflatable curtain (IC) air bag. The impact caused the Chrysler to rotate clockwise. The vehicle was equipped with Electronic Stability Control (ESC), but the impact-induced rotation was significant and the vehicle departed the south edge of the road (Figure 5) where it rolled over (Figure 6, event 2) left side leading 6 quarter turns. The left side IC air bag also deployed during the crash. The Chrysler came to final rest on its top plane heading northwest.

Figure 4: Damage to the right quarter panel of the Chrysler from the impact by the front plane of the Dodge

There was direct damage on the right rear door, right rear wheel, quarter panel, and the right side of the back bumper fascia. The direct damage began 248 cm (97.6 in) rear of the right front axle and extended 129 cm (50.8 in) rearward along the side of the vehicle. The maximum residual crush was 12 cm (4.7 in) occurring at C₁. The induced damage involved the quarter panel and right rear door. The right side wheelbase was reduced 1 cm (0.4 in). The table below shows the right side crush profile.

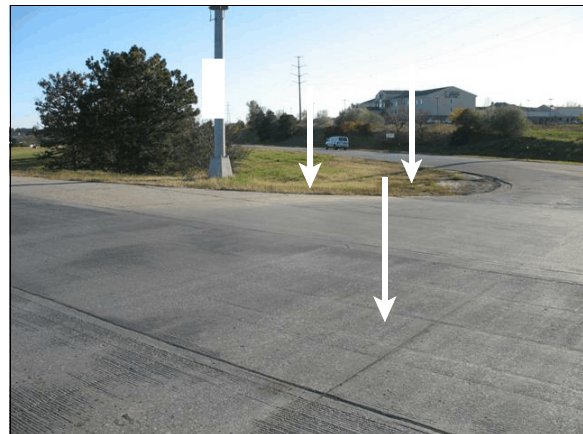
Figure 5: View west; arrow in foreground shows area of impact with the Dodge (event 1); arrow on left in background shows area where the Chrysler rolled over (event 2); arrow on right in background shows area final rest of the Chrysler

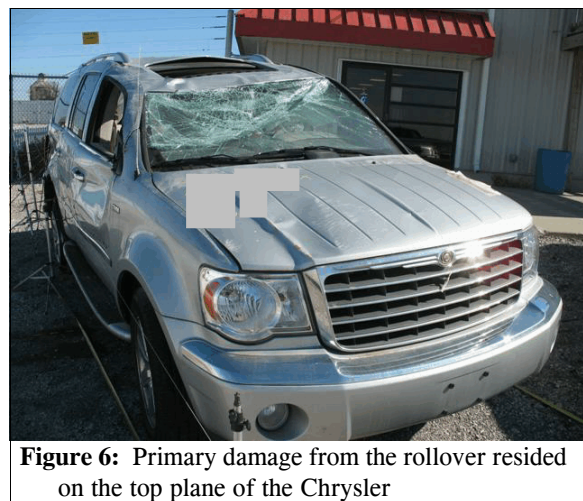
Figure 6: Primary damage from the rollover resided on the top plane of the Chrysler

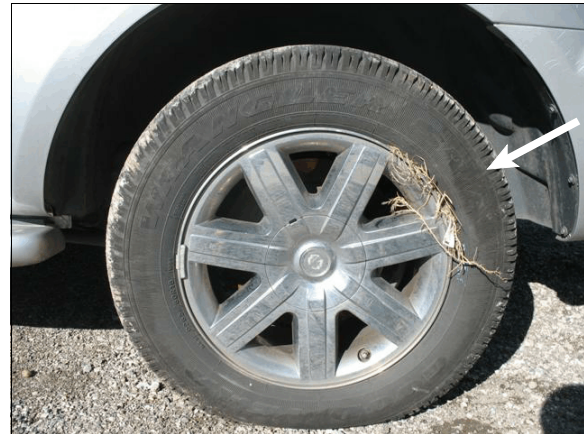
The rollover of the Chrysler was initiated following the impact with the Dodge. The Chrysler rotated clockwise an estimated 35 degrees from its original heading as it departed the south side of the road. The left rear wheel (Figure 7) furrowed into the ground and the vehicle tripped and rolled over left side leading. The vehicle rolled over 6 quarter turns across a distance of approximately 21 m (68.9 ft) and came to final rest on its top heading northwest.

Figure 7: Abrasions on sidewall of the Chrysler’s left rear tire and grass embedded in the bead

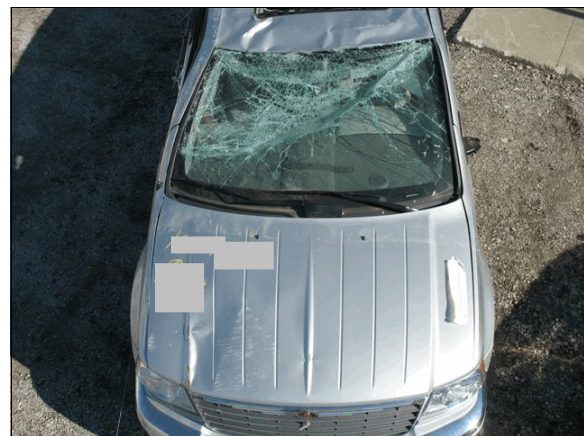
The rollover involved the top plane and both side planes. The direct damage on the top plane began at the front of the hood and extended across the full width of the roof, 117 cm (46.1 in) at the windshield header and the sunroof (Figures 8 and 9). The direct damage extended along the right roof side rail to approximately midway between the right B- and C-pillars. The direct damage on the left side plane (Figure 10) extended intermittently along the full length of the vehicle and involved the left fender, both of the left side doors, the left roof side rail, and the quarter panel. The direct damage on the right side plane (Figure 11) began on the right A-pillar and extended rearward the remaining length of the

Figure 8: Direct damage to the hood, windshield, and front portion of the roof from the rollover

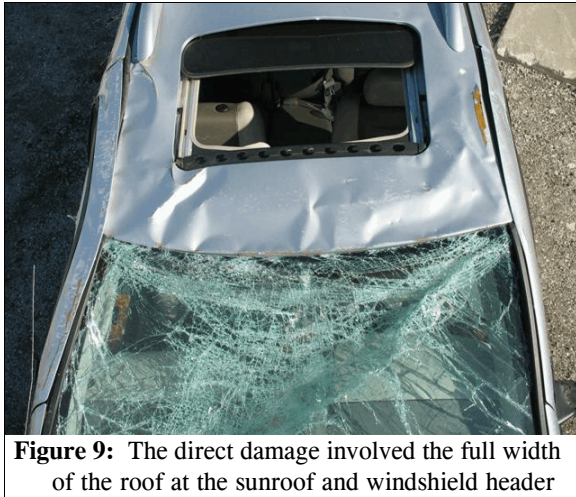
Figure 9: The direct damage involved the full width of the roof at the sunroof and windshield header

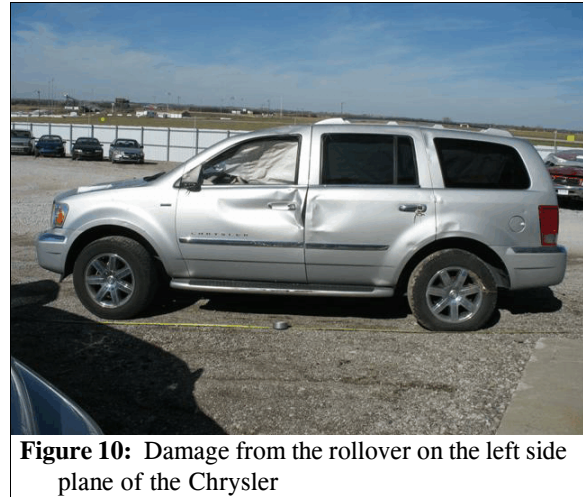
Figure 10: Damage from the rollover on the left side plane of the Chrysler

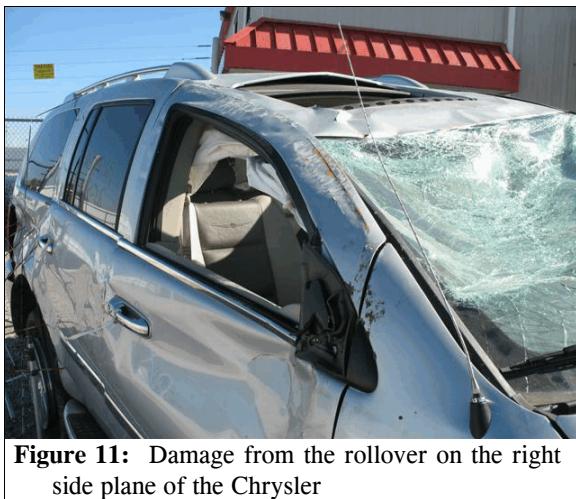
Figure 11: Damage from the rollover on the right side plane of the Chrysler

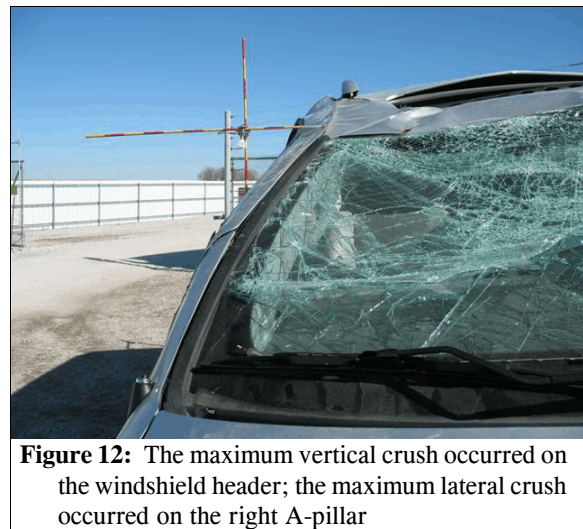
vehicle. The maximum vertical crush (**Figure 12**) was 12 cm (4.7 in) and occurred on the windshield header near the right A-pillar. The maximum residual lateral crush was 3 cm (1.2 in) and occurred at the top of the right A-pillar (**Figure 12**).

Figure 12: The maximum vertical crush occurred on the windshield header; the maximum lateral crush occurred on the right A-pillar

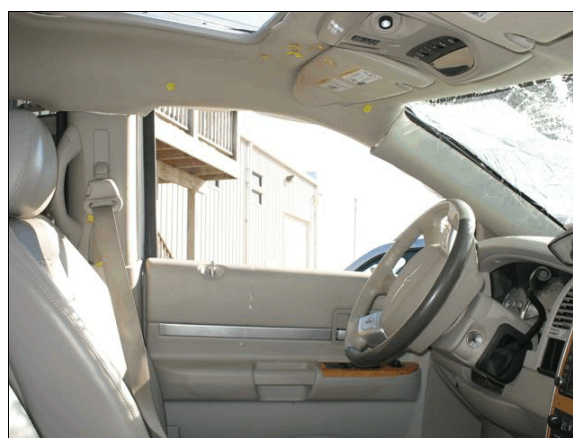
Vehicle Interior: The inspection of the interior revealed a few small hair transfers on the driver's sunvisor, roof, and left roof side rail (**Figures 13 and 14**). There was also a small cut on the sunvisor. There was no discernable evidence of occupant contact on the left IC air bag. There was no damage on the steering wheel and no compression of the energy absorbing steering column.

Figure 13: Yellow tape shows areas of occupant contact on the sunvisor, roof, and left roof side rail

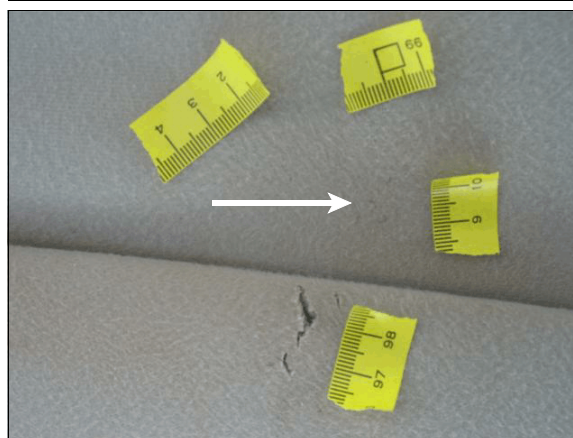
Figure 14: Close view of small cut on sunvisor and a few small hair transfer's on the roof (arrow)

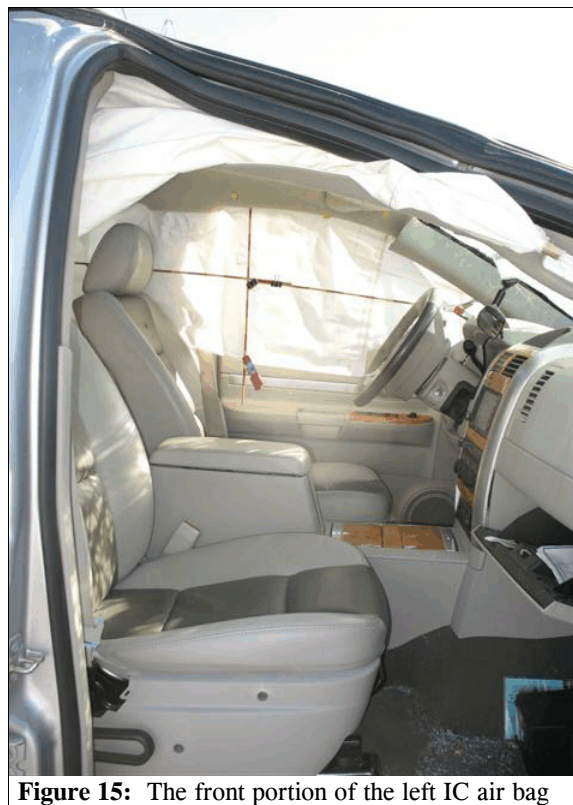
Figure 15: The front portion of the left IC air bag

The IC air bags (**Figure 15**) were located along the roof side rails inside the headliner and extended from the top of the A-pillar to the D-pillar. They were designed with inflation chambers adjacent to the outboard seat positions. The deployed IC air bags were 230 cm (90.6 in) in width and 48 cm (18.9 inches) in height. A triangular-shaped fabric panel that was 27 cm (10.6 in) in width was located at the front of the IC air bag. It was attached to the A-pillar by a 9 cm (3.5 in) rope tether. The IC air bags extended 13 cm (5.1 in) below the beltline. There was no gap between the IC air bags and the A-pillars. Inspection of the IC air bags revealed no discernable evidence of occupant contact and no damage.

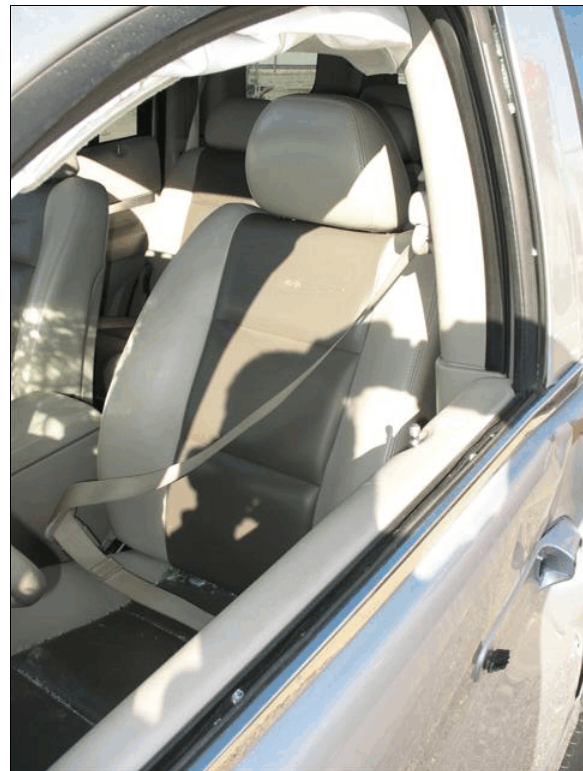
Inspection of the driver's safety belt assembly revealed that the pretensioner had actuated during the crash. The retractor was jammed with a length of belt webbing extended out of the retractor consistent with usage (**Figure 16**). Light load abrasions were present on the safety belt webbing located 88 cm (34.6 in) above the stop loop. The latch plate showed historical usage scratches and light load abrasions were present on the latch plate belt guide. There were also light load abrasions on the D-ring. This evidence indicated that the driver was restrained by the lap-and-shoulder safety belt at the time of the crash. The remaining seat positions were unoccupied.

Figure 16: The driver's safety belt in the latched position; the retractor was jammed
