**CALSPAN ON-SITE SIDE IMPACT INFLATABLE
OCCUPANT PROTECTION SYSTEM CRASH INVESTIGATION**

SCI CASE NO: CA09036

VEHICLE: 2009 NISSAN VERSA

CRASH DATE: APRIL, 2009

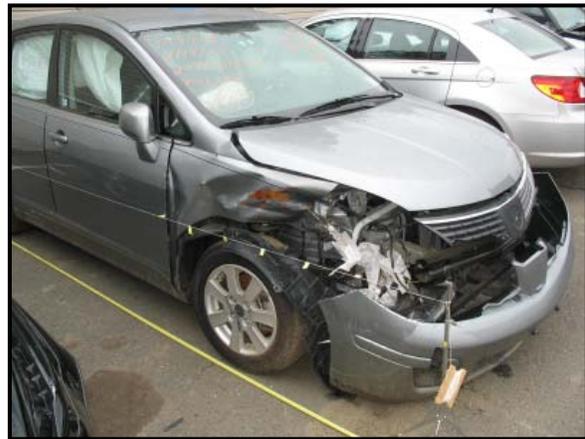
Figure 1 depicts the Nissan's right side damage caused by the initial impact. The direction of the impact force was in the 2 o'clock sector for the Nissan. The impact force deployed the right IC air bag and the CAC frontal air bags of the Nissan. The Nissan was driven by a 53-year-old unrestrained male and occupied by a 65-year-old unrestrained female in the front right passenger position. The driver and passenger had police reported complaints of chest and neck pain and were transported to a local hospital. The direction of the impact force was in the 11 o'clock sector for the Chevrolet. The Chevrolet's frontal air bags did not deploy. The Chevrolet was occupied by a 75-year-old restrained driver, an 80-year-old restrained female front right passenger and an 82-year-old restrained female in an unknown rear seat position. The driver of the Chevrolet had a reported knee contusion. The passengers in the Chevrolet sustained police reported complaints of pain. All the occupants of the Chevrolet were transported to a local hospital.

Figure 1: Front right oblique view of the Nissan Versa.

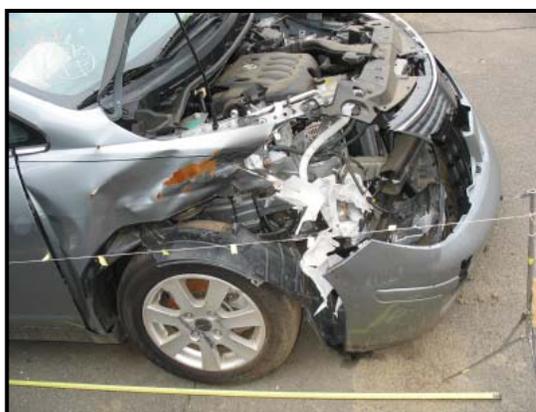
The Exterior of the Nissan sustained two areas of damage to the right side plane during the multiple event crash sequence. **Figure 3** is a view of the damage to the right fender (Event 1). The direct contact damage began at the trailing edge of the fender and extended 105 cm (41.3 in) forward to the right corner. The impact resulted in lateral deformation to the fender, the right side of the engine compartment and the front bumper reinforcement. Black vinyl transfer marks were noted to the right front wheel. There was no right front suspension damage or right wheelbase reduction. The crush profile was measured along the mid-door level and was as follows: C1 = 2 cm (0.8 in), C2 = 6 cm (2.4 in), C3 = 14 cm (5.5 in), C4 = 29 cm (11.4 in), C5 = 35 cm (13.8 in), C6 = 33 cm (13.0 in). The maximum crush was located at C5. The Collision Deformation Classification was 02RFEW3.

Figure 3: Right lateral view of the impact damage (Event 1).

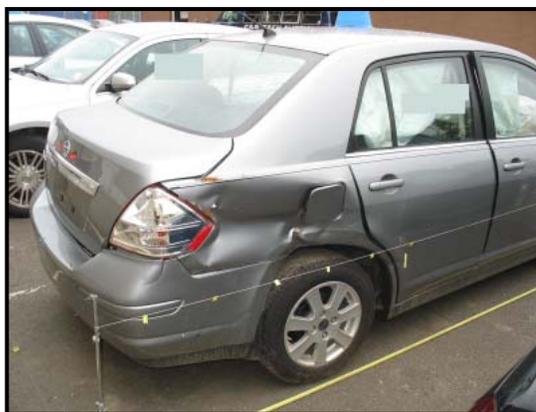
The Nissan rotated counterclockwise as a result of the initial impact and the vehicles contacted in a secondary side slap (Event 2). **Figure 4** is a right rear oblique view of the side slap impact damage. The contact damage began 43 cm (17 in) forward of the right rear axle and extended 129 cm (50.8 in) rearward to the right rear corner. Direct contact was noted to the right rear wheel rim. The residual crush profile was as follows: C1 = 4 cm (1.6 in), C2 = 6 cm (2.4 in), C3 = 11 cm (4.3 in), C4 = 10 cm (3.9 in), C5 = 1 cm (0.8 in), C6 = 0. The CDC was 03RZEW2.

Figure 4: Right rear oblique view of the side slap damage (Event 2).

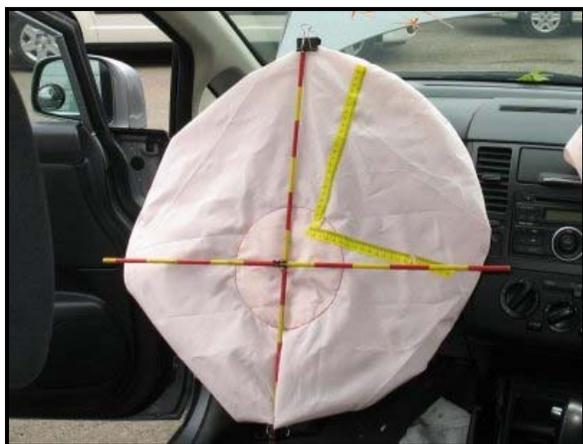
The frontal air bag system in the Nissan Versa consisted of CAC air bags for the driver and front right passenger. The frontal air bags deployed as a result of the initial impact with the Chevrolet. The driver air bag module was located in the center hub of the steering wheel rim. The module cover flaps were an asymmetrical design consisting of five individual flaps. There was no noted contact to the cover flaps. The deployed driver air bag measured 55 cm (21.6 in) in its deflated state, **Figure 5**. It was tethered by two straps and vented by two 4 cm (1.5 in) diameter ports. Multiple scattered scuff marks were observed in the 1 to 3 o'clock sectors on the face of the bag. The contact area measured 15 cm x 18 cm (5.9 in x 7.1 in). The scuff marks were related to probable driver contact to the inflated air bag.

Figure 5: Nissan driver air bag.

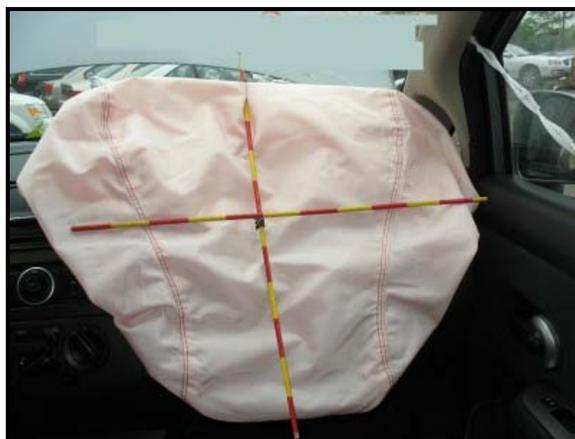
The front right passenger air bag, **Figure 6**, was a top-mount design located in right aspect of the instrument panel. The module cover flaps were symmetrical and constructed of vinyl. Each flap measured 5 cm x 22 cm (2.0 in x 8.7 in). The face of the passenger air bag measured 48 cm (18.9 in) in width at its top aspect and tapered to a 28 cm (11.0 in) width. The height of the air bag measured 48 cm (18.9 in). The bag was not tethered. The rearward excursion of the bag from the module measured 54 cm (21.7 in). The bag was vented from the side panels by two 6 cm (2.4 in) diameter ports. There was no contact evidence on the air bag.

Figure 6: Front right passenger air bag.

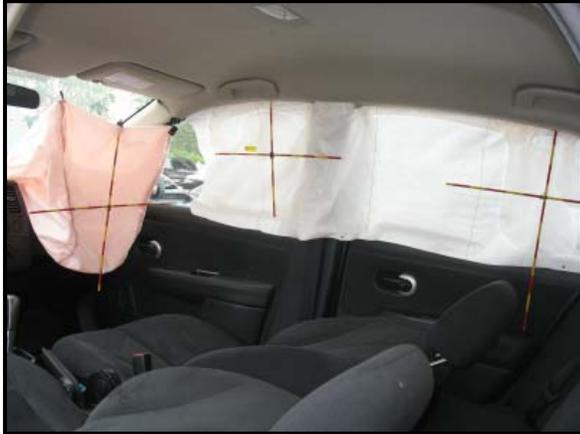
The Nissan Versa was equipped with IC air bags mounted to the roof side rails. The right curtain deployed as a result of the crash. The IC air bag measured 140 cm x 42 cm (55.1 in x 16.5 in) length x height in overall dimensions and provided coverage from the upper aspect of the A- to C-pillar area (**Figure 7**). A trapezoidal shaped void at the forward third of the front glazing was not protected by the deployed curtain. This area measured 40 cm x 35 cm (15.7 in x 13.8 in) length x height. A 35 cm (13.8 in) long tether extended from the A-pillar and was sewn to the forward aspect of the membrane. The vertical coverage of the curtain extended 2 cm (1 in) below the beltline in both the front and second row.

Figure 7: Nissan deployed right curtain.

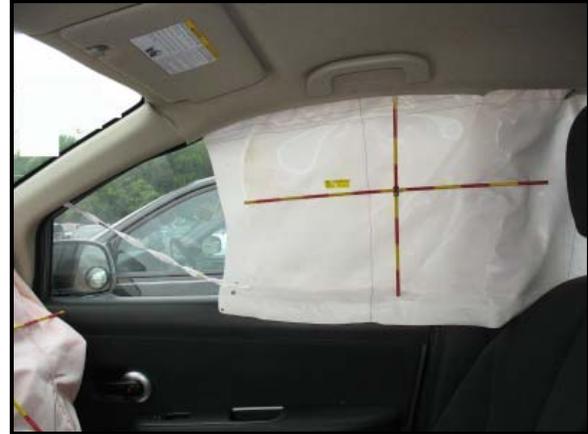
A scuff mark from probable front right passenger head contact was observed on the IC air bag **Figure 8**. The mark measured 2 cm (0.8 in) in length and was located 15 cm (5.9 in) below the roof rail and 26 cm (10.2 in) forward of the right B-pillar.

Figure 8: View of the contact evidence to the right curtain.

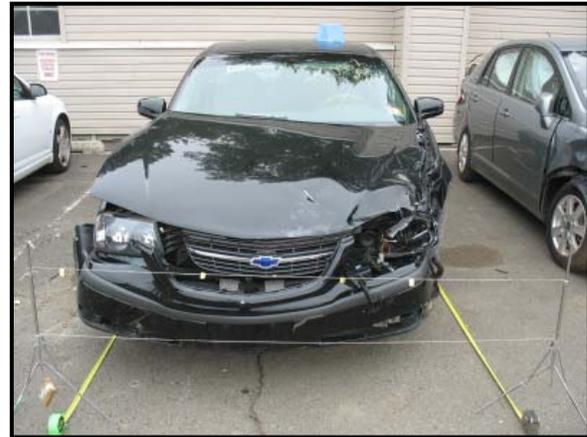
The Chevrolet Impala, **Figure 9**, sustained front and left plane damage as a result of the crash sequence. The Event 1 frontal damage consisted of deformation to the bumper fascia, bumper reinforcement beam, left head lamp assembly, hood and left fender. The direct contact damage began on the vehicle's centerline and extended 78 cm (30.7 in) to the left front corner. This contact pattern wrapped around the Chevrolet's left corner during the later stage of Event 1, as the Nissan rotated CCW due to the force of the impact. The direct contact damage extended from the left corner rearward on the left fender 73 cm (28.7 in). Contact abrasions were noted on the left front wheel rim. The crush profile measured along the bumper reinforcement was as follows: C1 = 21 cm (8.3 in), C2 = 20 cm (7.9 in), C3 = 19 cm (7.5 in), C4 = 14 cm (5.5 in), C5 = 15 cm (5.9 in), C6 = 9 cm (3.5 in). The CDC was 11FYEW1.

Figure 9: Front view of the Chevrolet.

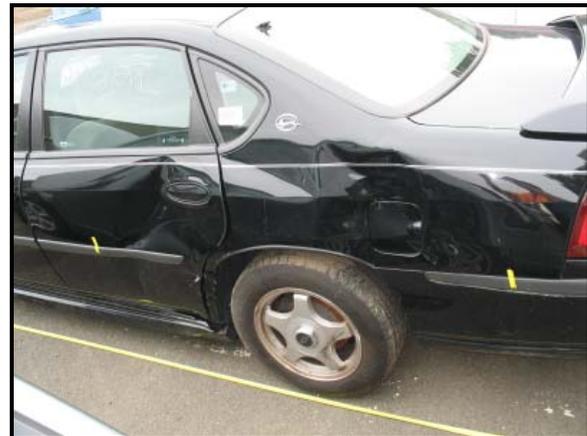
The left plane of the Chevrolet sustained a combined length of direct contact and induced damage that measured 158 cm (62.2 in), **Figure 10** as a result of the secondary side slap (Event 2). The damaged region began on the mid-aspect of the left rear door and ended at the mid-aspect of the quarterpanel. The direct contact region measured 119 cm (46.9 in) in length. The maximum deformation was 6 cm (2.5 in). The CDC was 09LZEW1.

Figure 10: Side slap damage to the left plane of the Chevrolet.
